# MAIN GRADE ROAD BRIDGE NO. 3 SPECIAL COATINGS REPORT – OCTOBER 2017

PREPARED FOR THE SOUTHWEST FLORIDA WATER MANAGEMENT DISTRICT  
JEFFREY HAGBERG, FIELD OPERATIONS MANAGER

**GPI** Greenman-Pedersen, Inc.

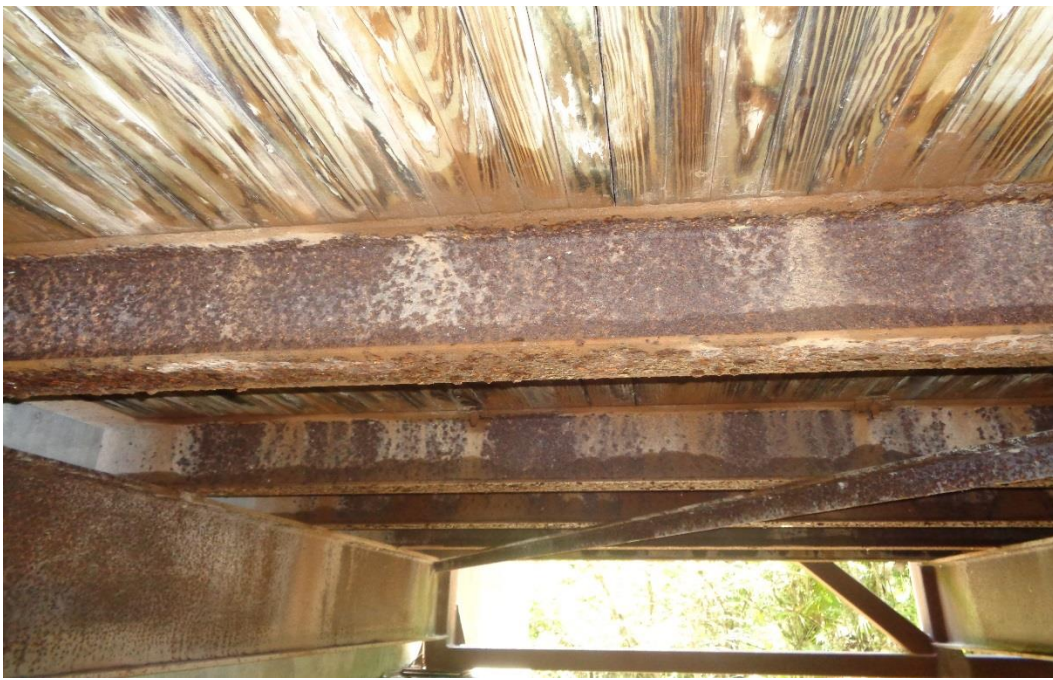
**Photograph No. 5 – General View from Underneath  
Extensive Pitting**

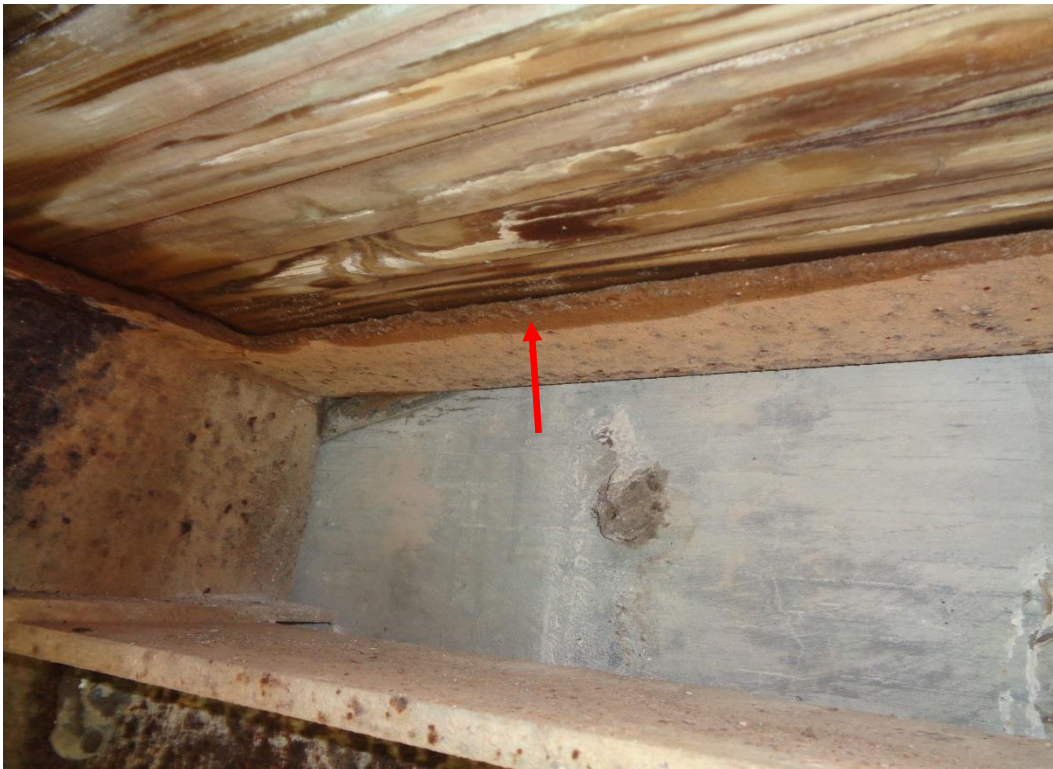
**Photograph No. 7 – Corrosion of Top Flange Caused by Entrapment/Holding of Moisture by the Wooden Deck**

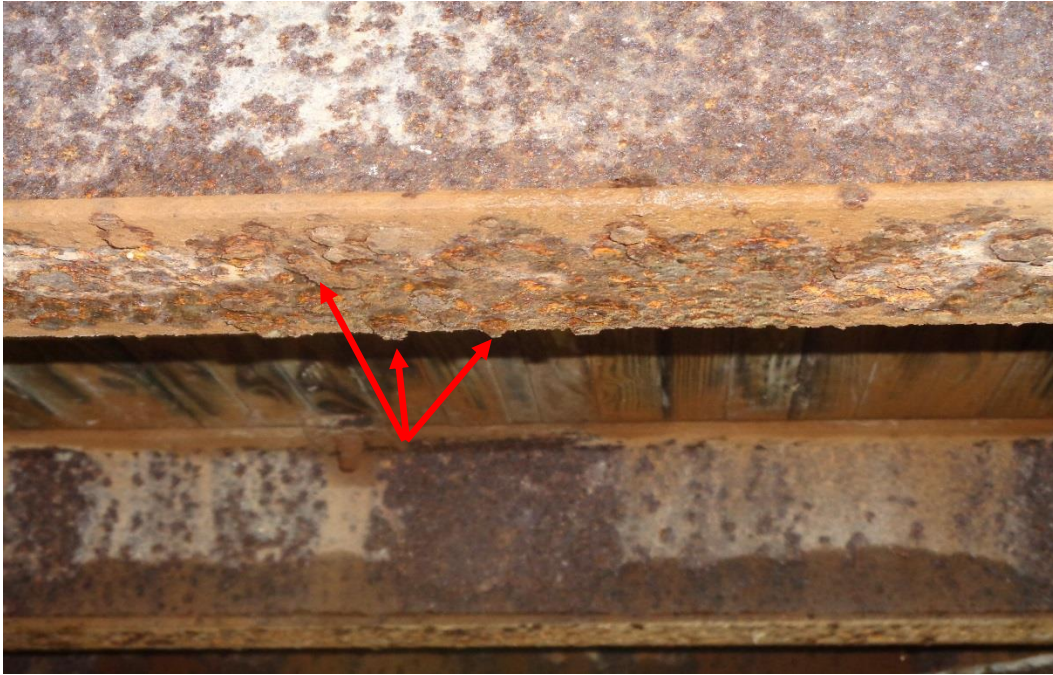
**Photograph No. 8 - Rust Nodules on Bottom Flange Caused by Condensate**

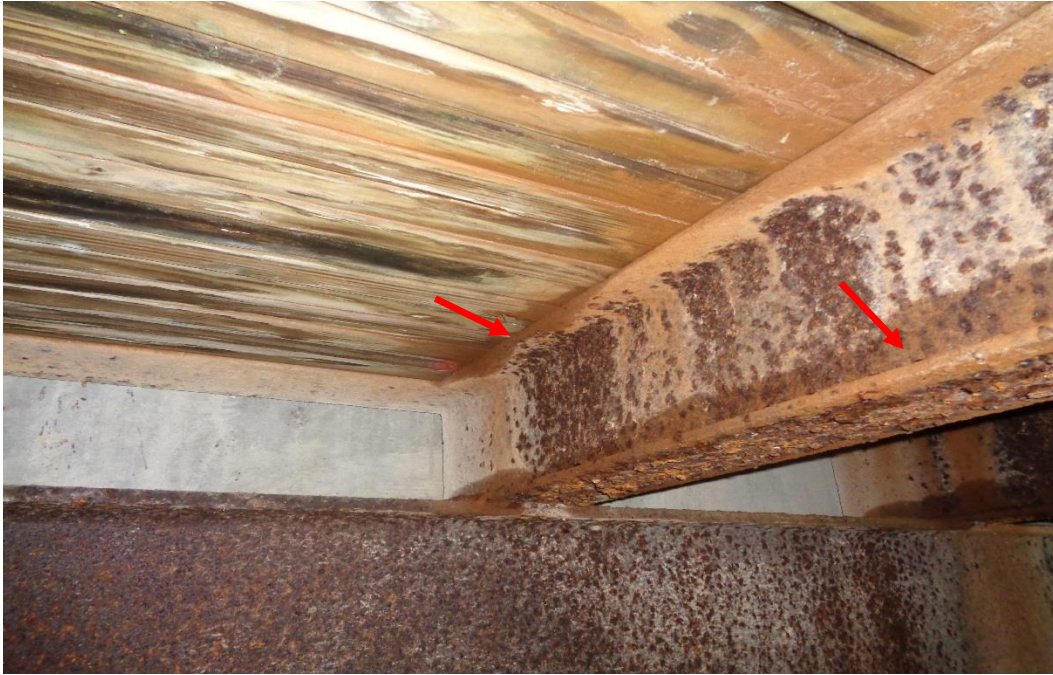
**Photograph No. 10 – Moisture is Still Present Even Though Photo was Taken at the Peak of the Day Heat, approximately 2:00 pm**

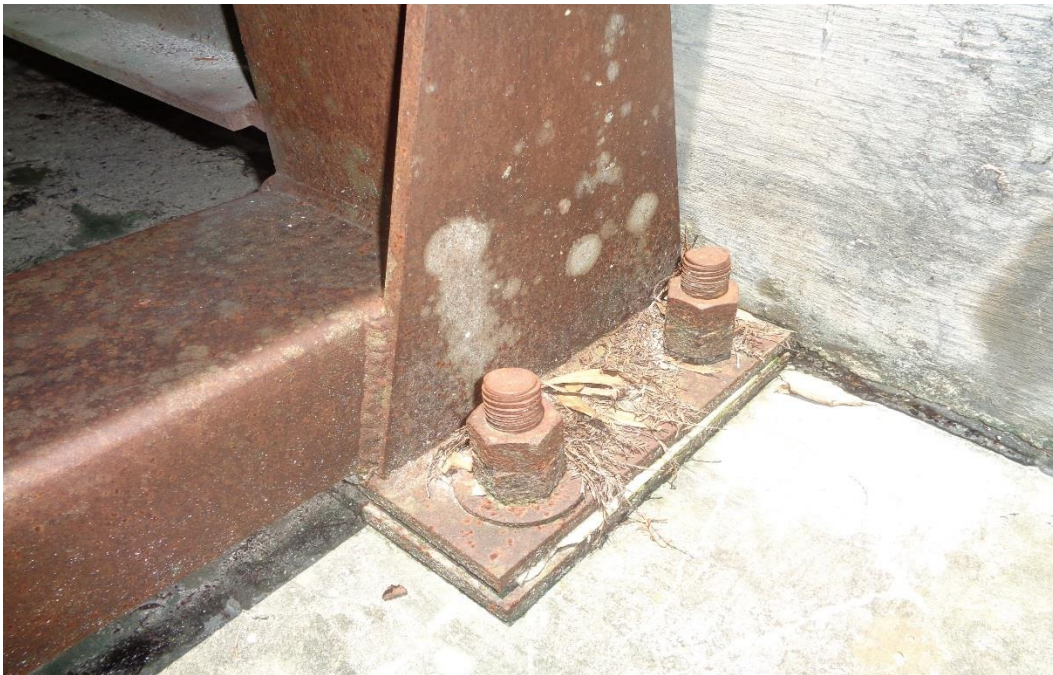
**Photograph No. 11 – Typical Condition of Fasteners**
