## Underwater Inspection Report

### Lake Pretty Water Control Structure

Southwest Florida Water Management  
District

## **Structural Inspection Report**

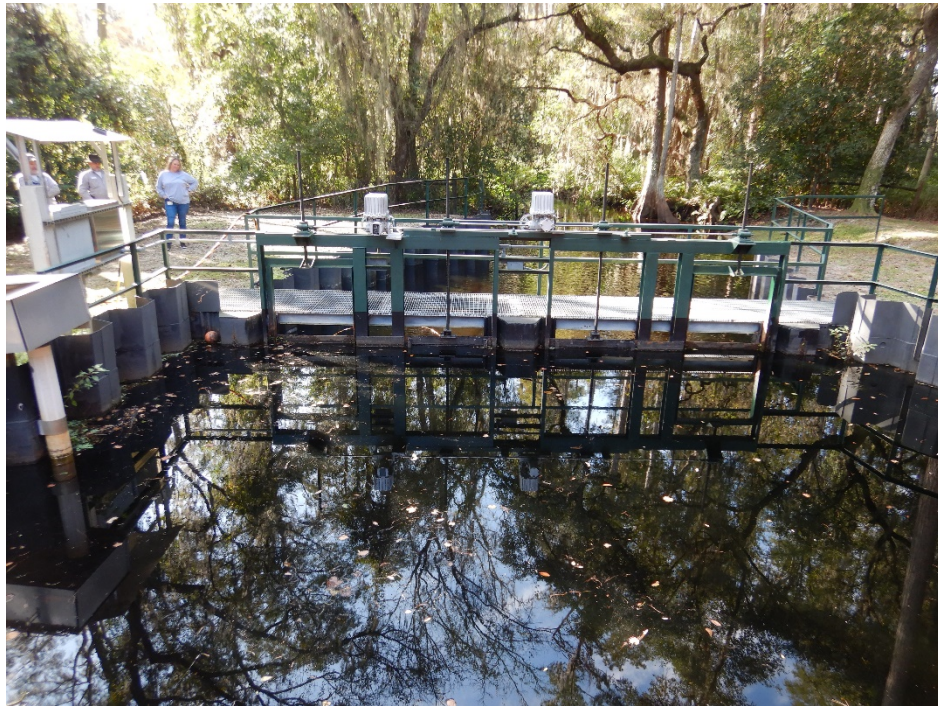
Photograph 1: Upstream face of structure (facing south)

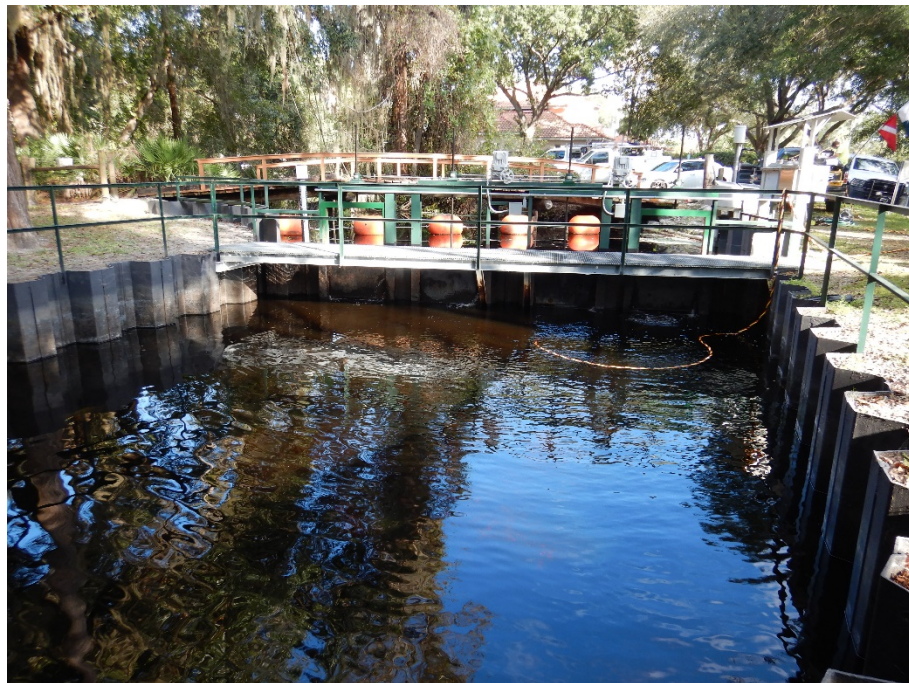
Photograph 2: Downstream face of structure (facing north)

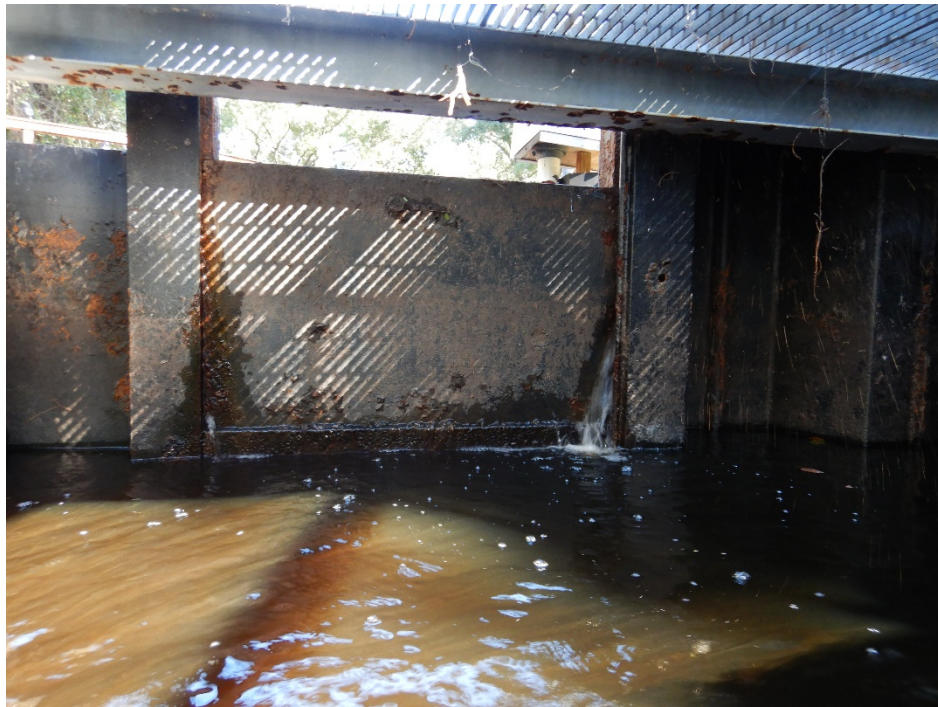
Photograph 3: East crest gate from downstream side.

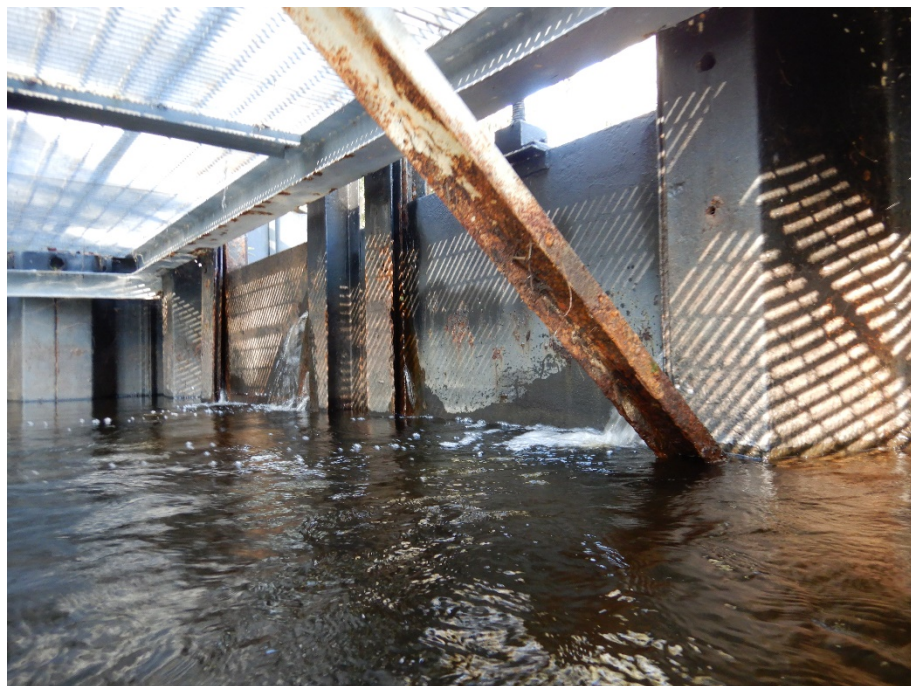
Photograph 4: View of service platform knee bracing, note moderate corrosion, walkway will be replaced).

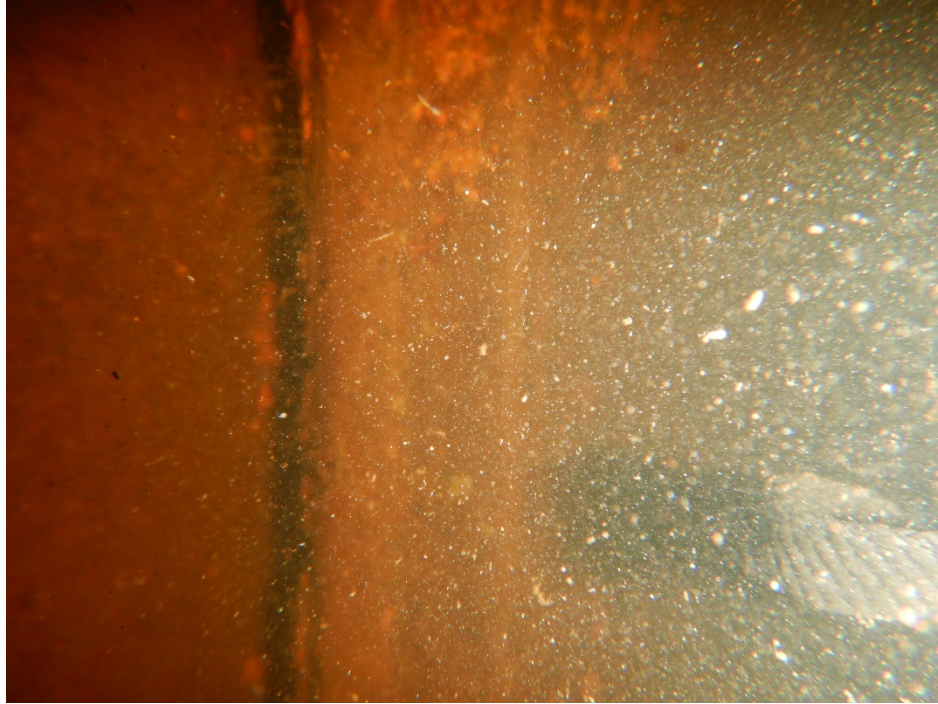
7. Moderate corrosion was observed along the sheetpile weir, particularly at the joints.
8. The upstream and downstream channel sheetpile were in good condition; ultrasonic thickness measurements averaged 0.440 inches

Photograph 5: Typical view of condition of sheetpile weir  
beneath water line

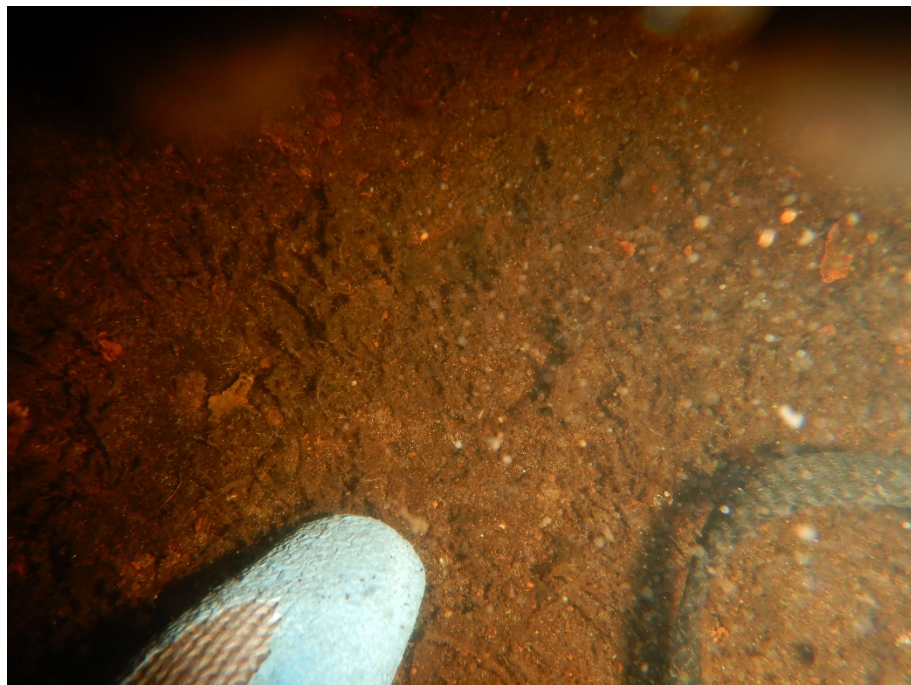
9. Minor scaling of the concrete surface with a depth of penetration of between  $\frac{1}{4}$  and  $\frac{1}{2}$  inch was observed, with no exposed reinforcing steel.

Photograph 6: Condition of concrete sill

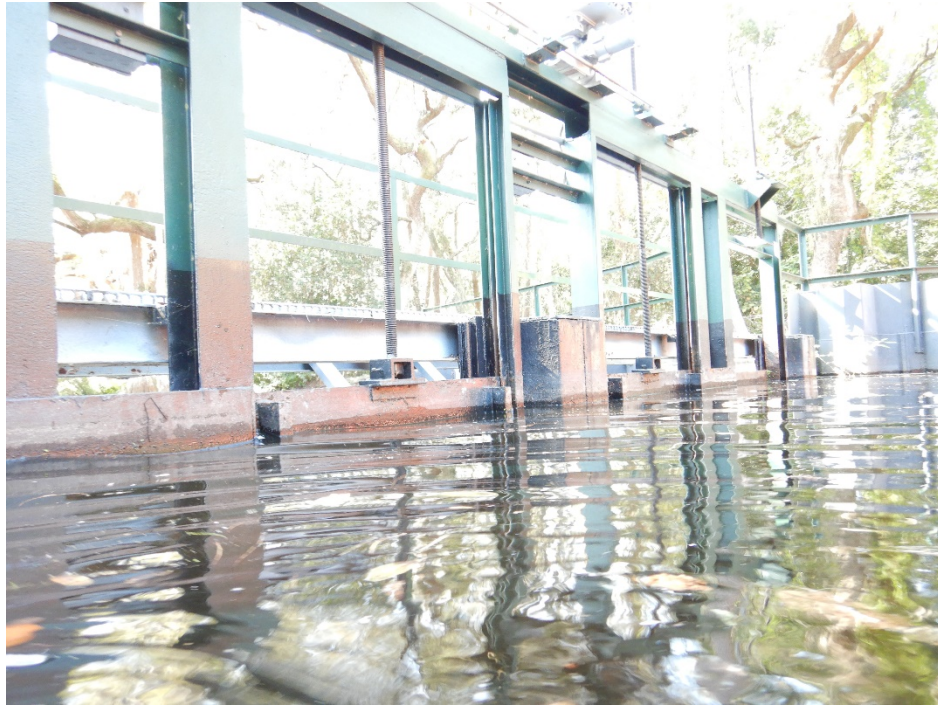
1. Silt was present along the upstream edge of the structure, approximately flush with the top of the concrete sill.
2. The depth and condition of the north and bottom faces of the concrete sill could not be verified along the upstream side of the structure.

Photograph 7: Typical view of upstream side of structure.

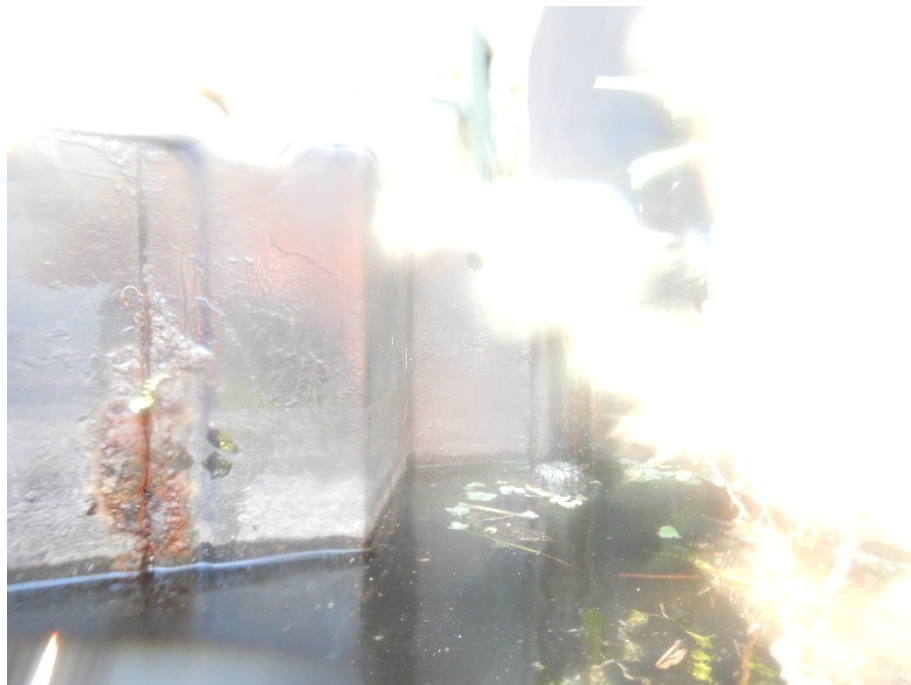
Photograph 14: Heavy Corrosion on Upstream Weir Gate Seat - See Note 14
