**Results of Blue Sink Pumping Test No. 2  
Hillsborough County, Florida**

**Hydrologic Evaluation Section  
Southwest Florida Water Management District**

**September 2009**

**By Jason Patterson and Ron Basso, P.G.**

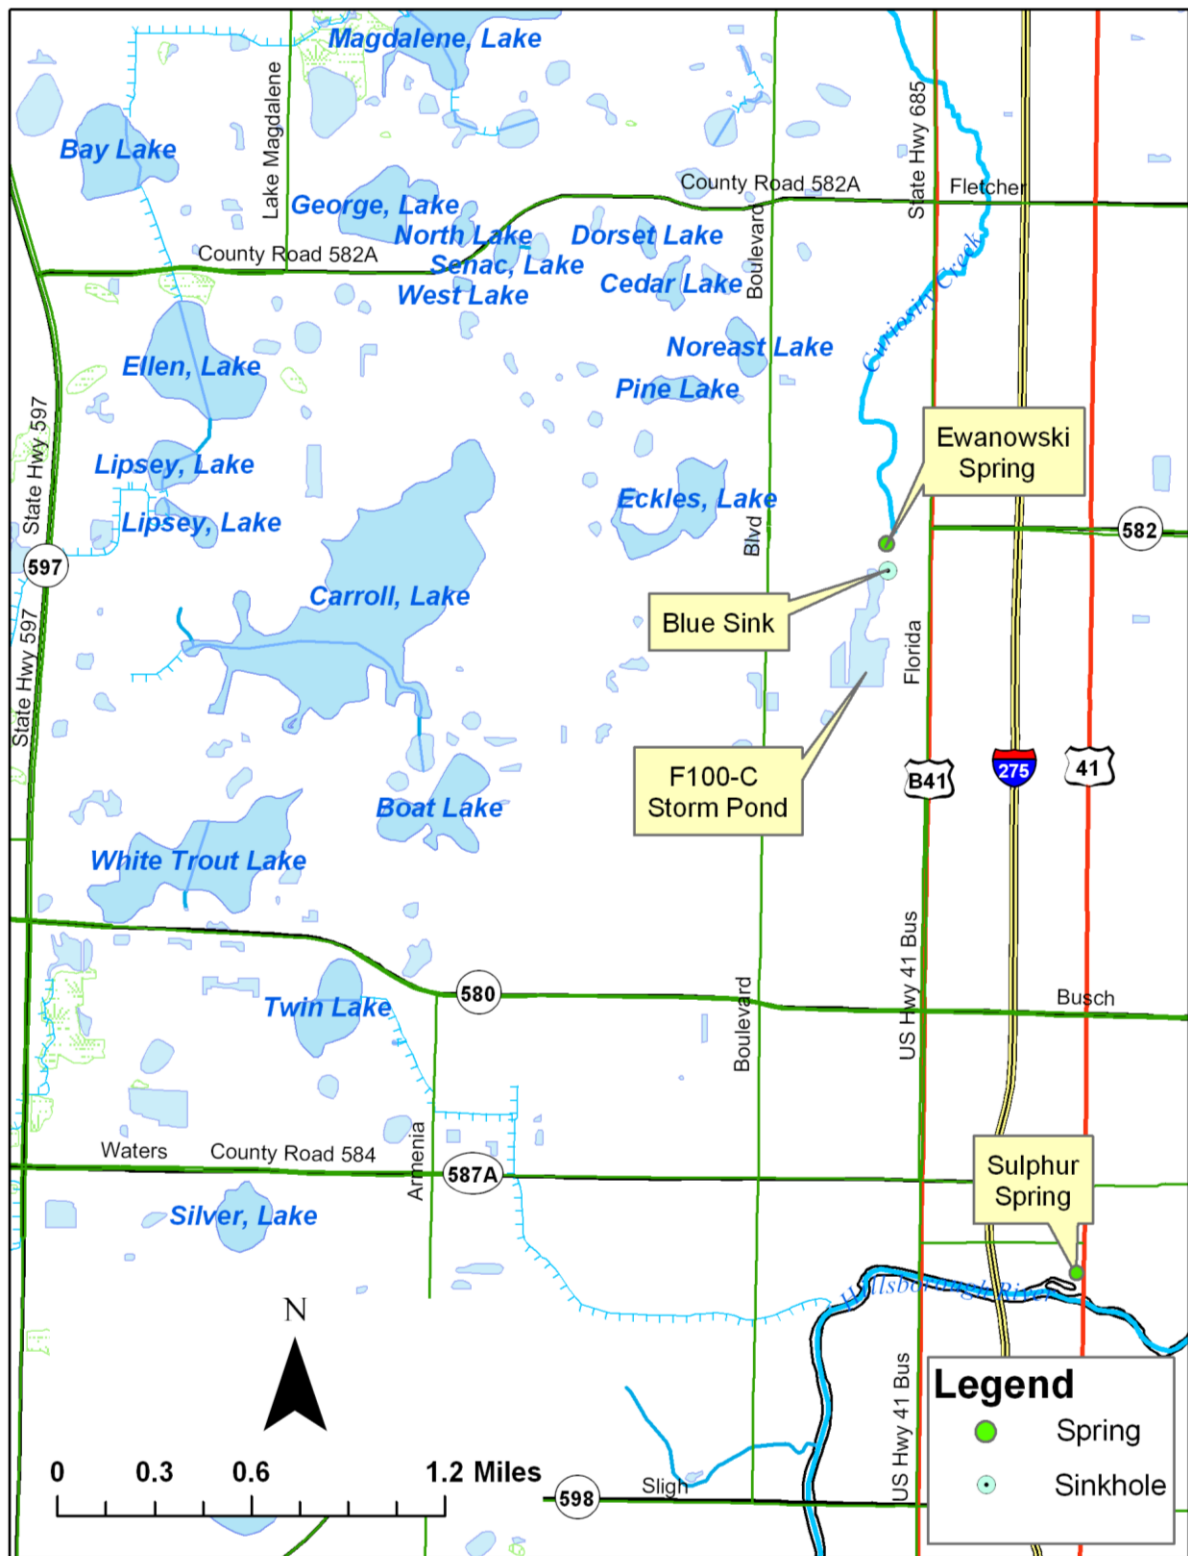
Figure 2. Location of Blue Sink, Ewanowski Spring, and the F100-C stormwater pond.

began to deteriorate – a combined result of trash and debris accumulation and sediment deposition. By the 1980s, the connection between Blue Sink and Sulphur Springs was totally blocked. As a result, water in Curiosity Creek began to back up and flooding incidents in the area began to increase. In order to remove the excess storm and surface waters from the closed Curiosity Creek watershed, the City of Tampa constructed a retention pond (known as F100-C) adjacent to Blue Sink, and in 2002, installed a permanent lift station at the south end to convey water out of the watershed and transport it to the Hillsborough River (Figure 2).

Continuous water level monitoring equipment was installed by District staff at Blue Sink and Ewanowski Spring (Figure 2). Permission to gain access to these sites was obtained from the individual land owner. Ewanowski Spring is hydraulically connected to Blue Sink via a small channel and is approximately 350 ft northwest of Blue Sink.

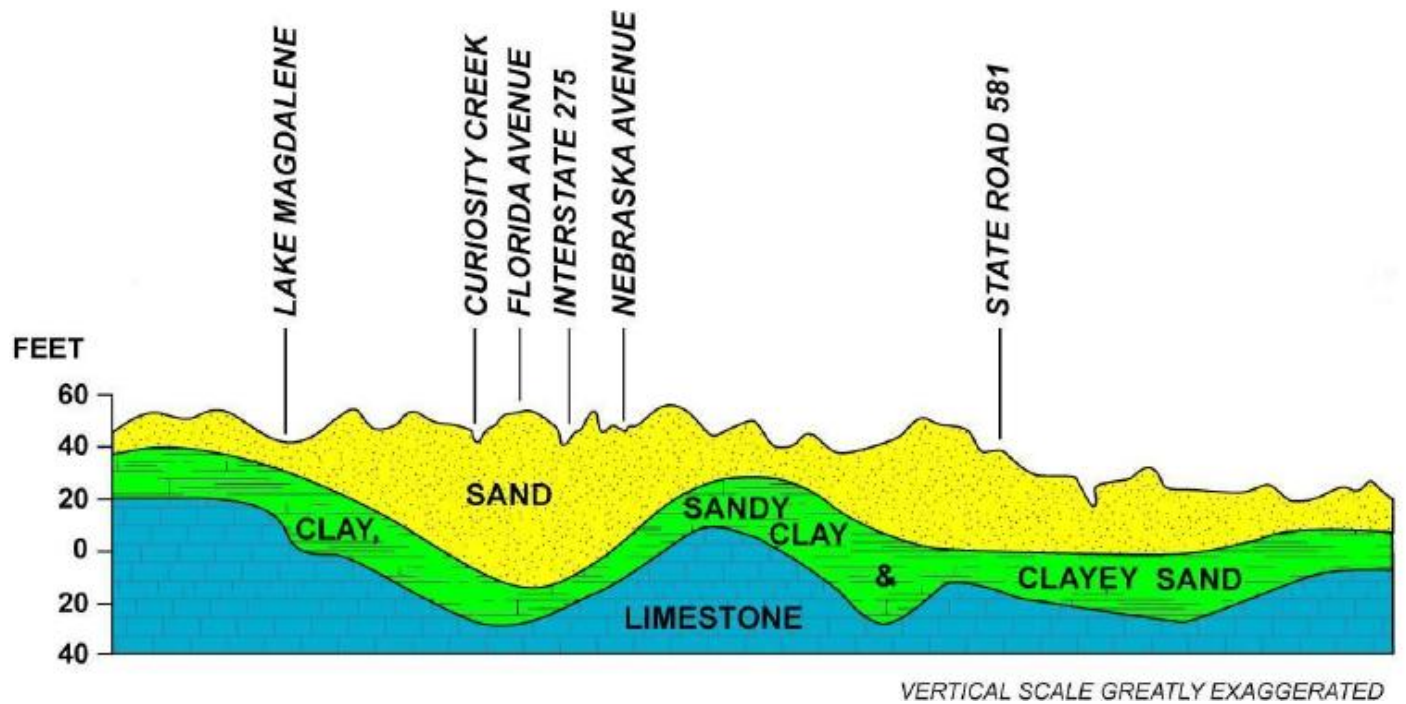
Figure 3. West to east hydrogeologic cross-section near the Blue Sink area.

The Blue Sink complex of sink features is located within the Sulphur Springs contributing area. Sulphur Springs is located about 2.3 miles south of Blue Sink and discharges an average of 44 cfs to the lower Hillsborough River. According to well installation logs in the area, the lithology within the vicinity of Blue Sink consists of fine sand to approximately 20 ft below land surface (bls), clay from approximately 20 to 25 ft bls and limestone below approximately 25 ft bls. A hydrogeologic cross section of the Blue Sink area is presented in Figure 3.

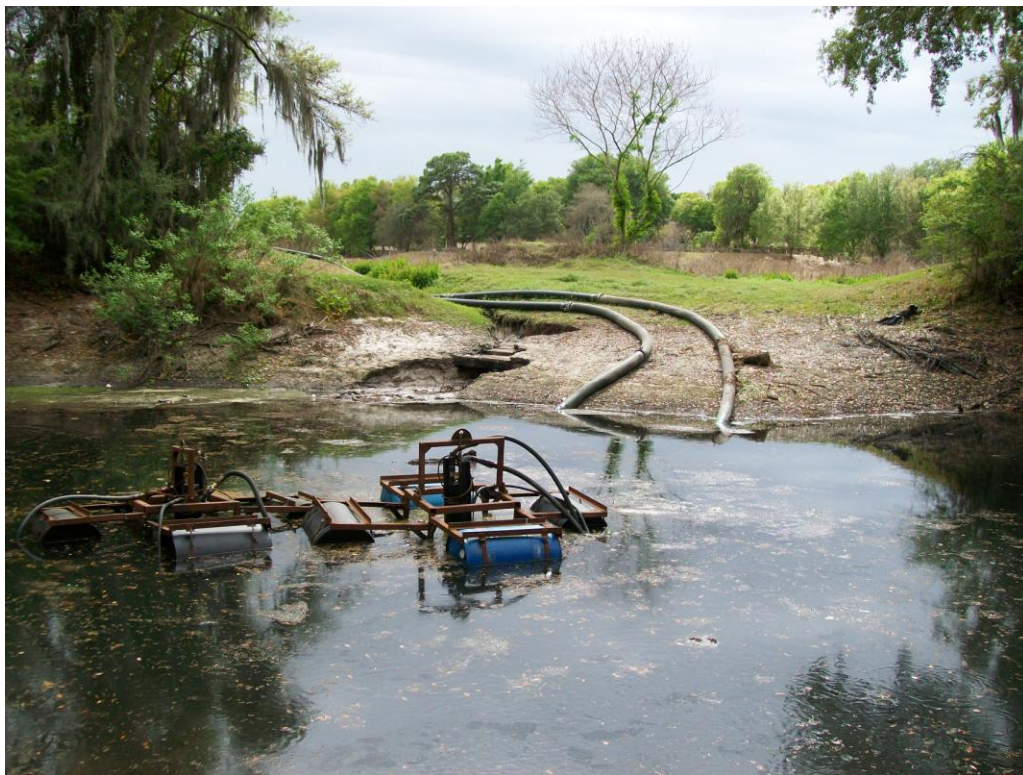
Figure 4. Pumps and discharge lines used in the Blue Sink test.

The pumping test was initiated at 9 a.m. on March 2, 2009 and ended at 9 a.m. on April 1, 2009. Prior to the pumping test, two pumps were installed in Blue Sink (Figure 4). Each pump was capable of discharging approximately two (2) mgd for the 30-day period. The intake features for each pump were mounted on barrel floats in the sink.

Two pumps were set-up so that continuous pumping could occur during the test while one motor was shut down for maintenance. Only one pump discharged water at any given time. The water discharged from the sink was directed via a pipeline into the City of Tampa's storm water pond (F100-C), located approximately 1,200 ft south of Blue Sink (Figure 2). At the end of the discharge pipe, flow data was collected by an in-line flow meter and two (2) manometers at 15-minute intervals. Thick plastic matting was also installed where the water discharged into the pond to prevent erosion.

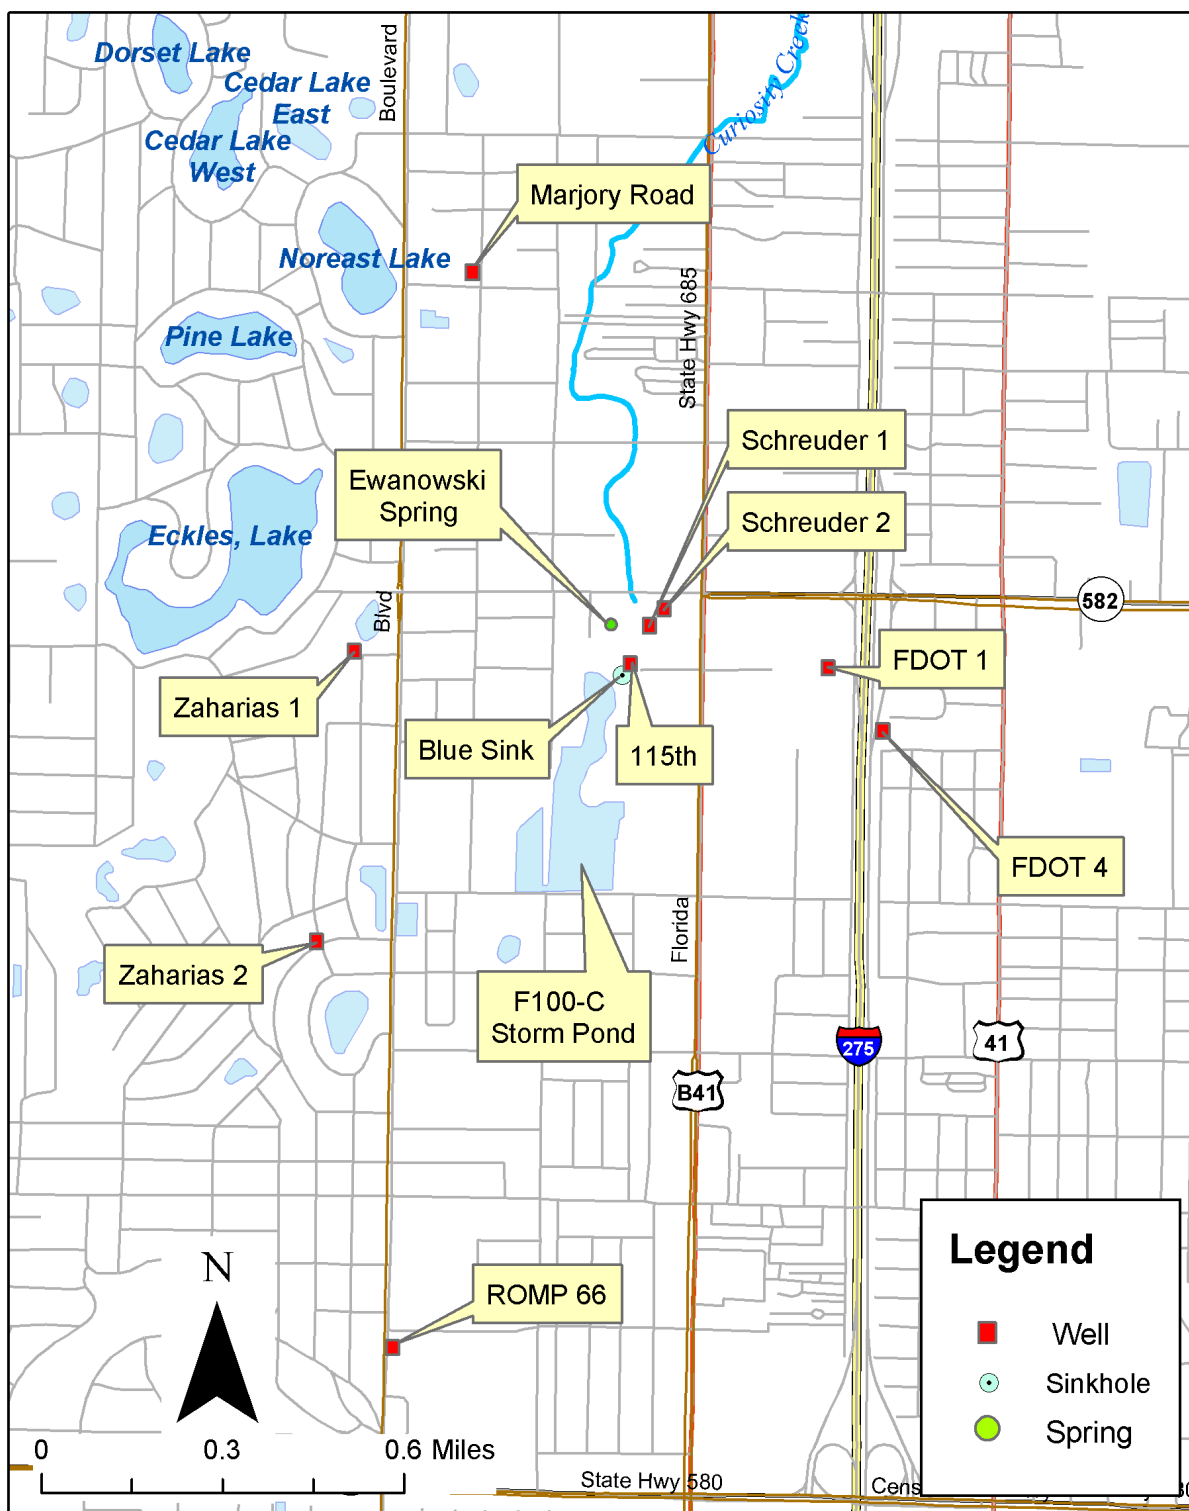
Figure 5. Location of Blue Sink, Ewanowski Spring, Upper Floridan aquifer wells, and lakes monitored during the pumping test.

ROMP 66 Tampa Suwannee well is located within the Blue Sink area approximately 6,300 ft south of the sink (Figure 5). Although ROMP 66 is within the Blue Sink area,

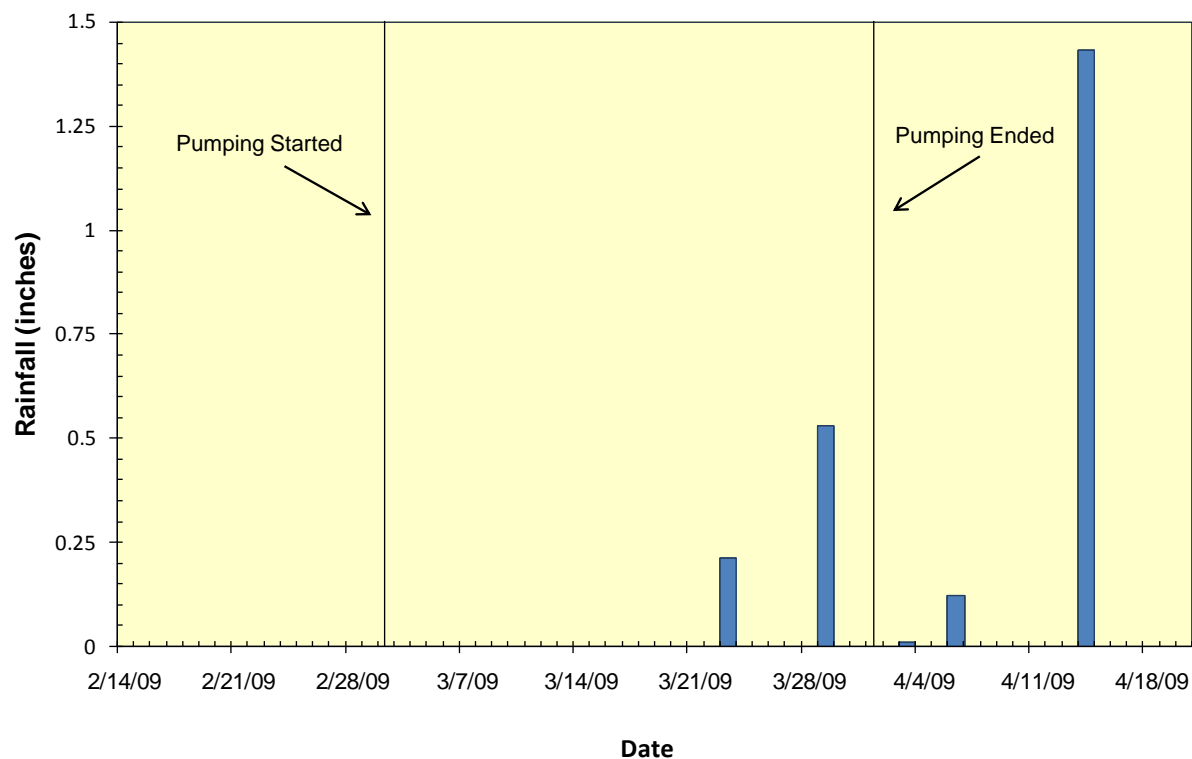
Figure 6. Rainfall recorded at the Marjory Road site from February 14 to April 20, 2009.

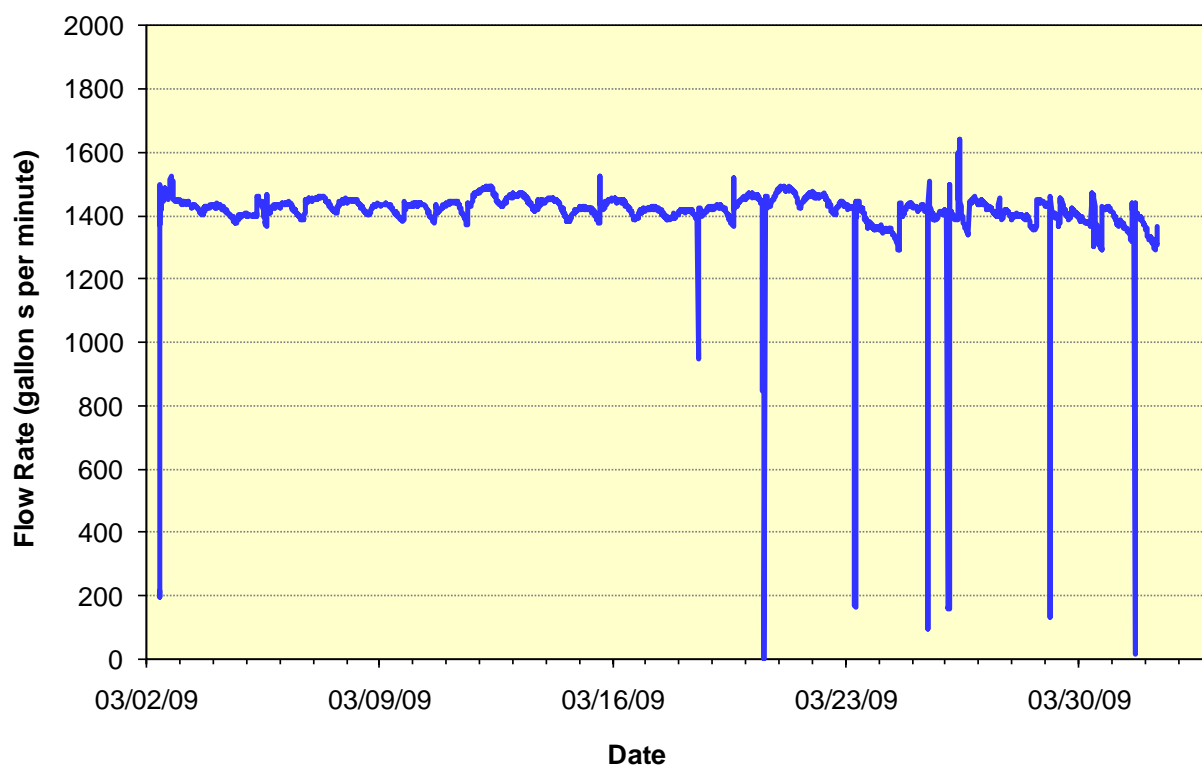
Figure 7. Discharge rate from Blue Sink (15-minute interval).

Flow was measured using a flow meter and two manometers at 15-minute intervals during the pumping test (Table 4 and Figure 7). Data from the flow meter was not available due to a mechanical failure caused by sediment and other debris. The measured flow rates from Manometer 1 were essentially the same as Manometer 2 readings. The average flow rate during the pump test was 1,412 gpm from Manometer 1 and 1,411 gpm from Manometer 2. The average from both manometers was 1,412 gpm or approximately two mgd. The largest 15-minute fluctuations between Manometer 1 and Manometer 2 ranged from -25 percent to 34 percent (Table 4). Total discharge from Blue Sink was approximately 61 million gallons during the 30-day test.

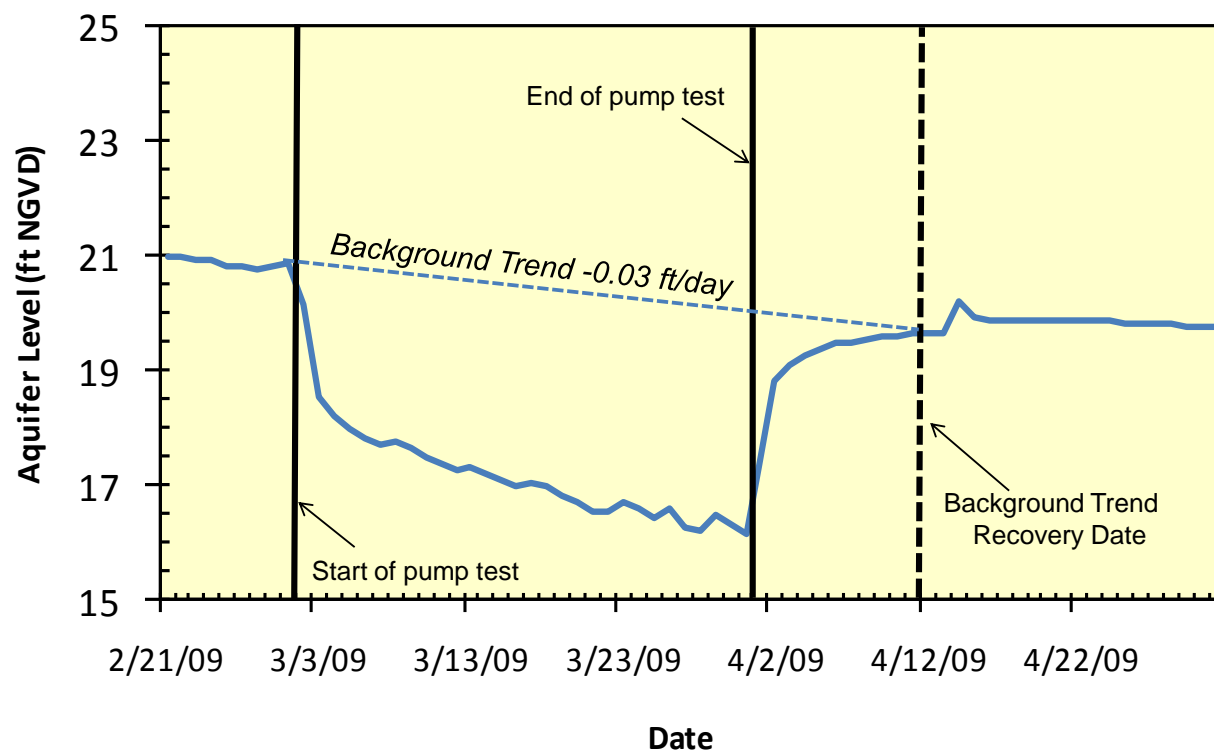
Figure 8. Hydrograph of Blue Sink stage with background trend.

The background water level trend for each monitor site was determined by the difference in water level just prior to the start of pumping on March 1 (8:45 am) and the water level on April 12<sup>th</sup> at 8:45 am or 11 days after pumping was discontinued at Blue Sink. The selection of April 12<sup>th</sup> was based on examination of Blue Sink stage recovery after pumping was terminated. Water level rise in the sink had slowed to just 0.01 feet per day after 11 days of recovery (Figure 8). On April 14<sup>th</sup>, a major rainfall event took place with 1.43 inches of rain recorded at the Marjory Road site.

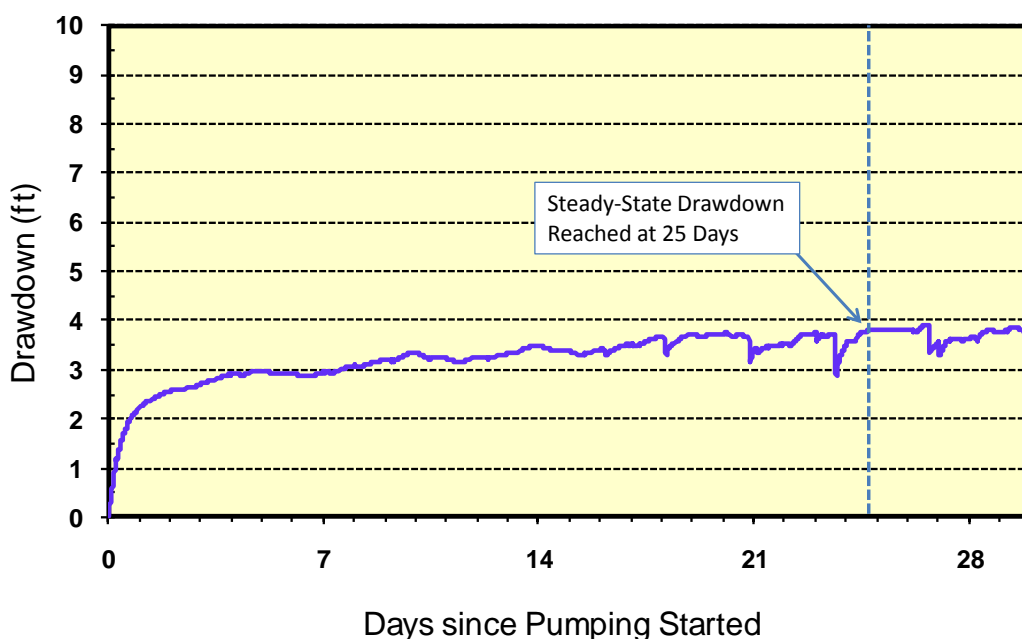
Figure 9 . Drawdown in Blue Sink stage during the duration of the 30-day test.

Blue Sink drawdown approached a quasi steady-state condition after about 25 days of withdrawals as it remained relatively steady around 3.7 ft (Figure 9). This condition was also reflected in Ewanowski Spring pool stage and UFA monitor wells surrounding the sink (Appendix C). The minor oscillations in drawdown depicted below after 25 days were mainly due to small alterations in the pumping rate.

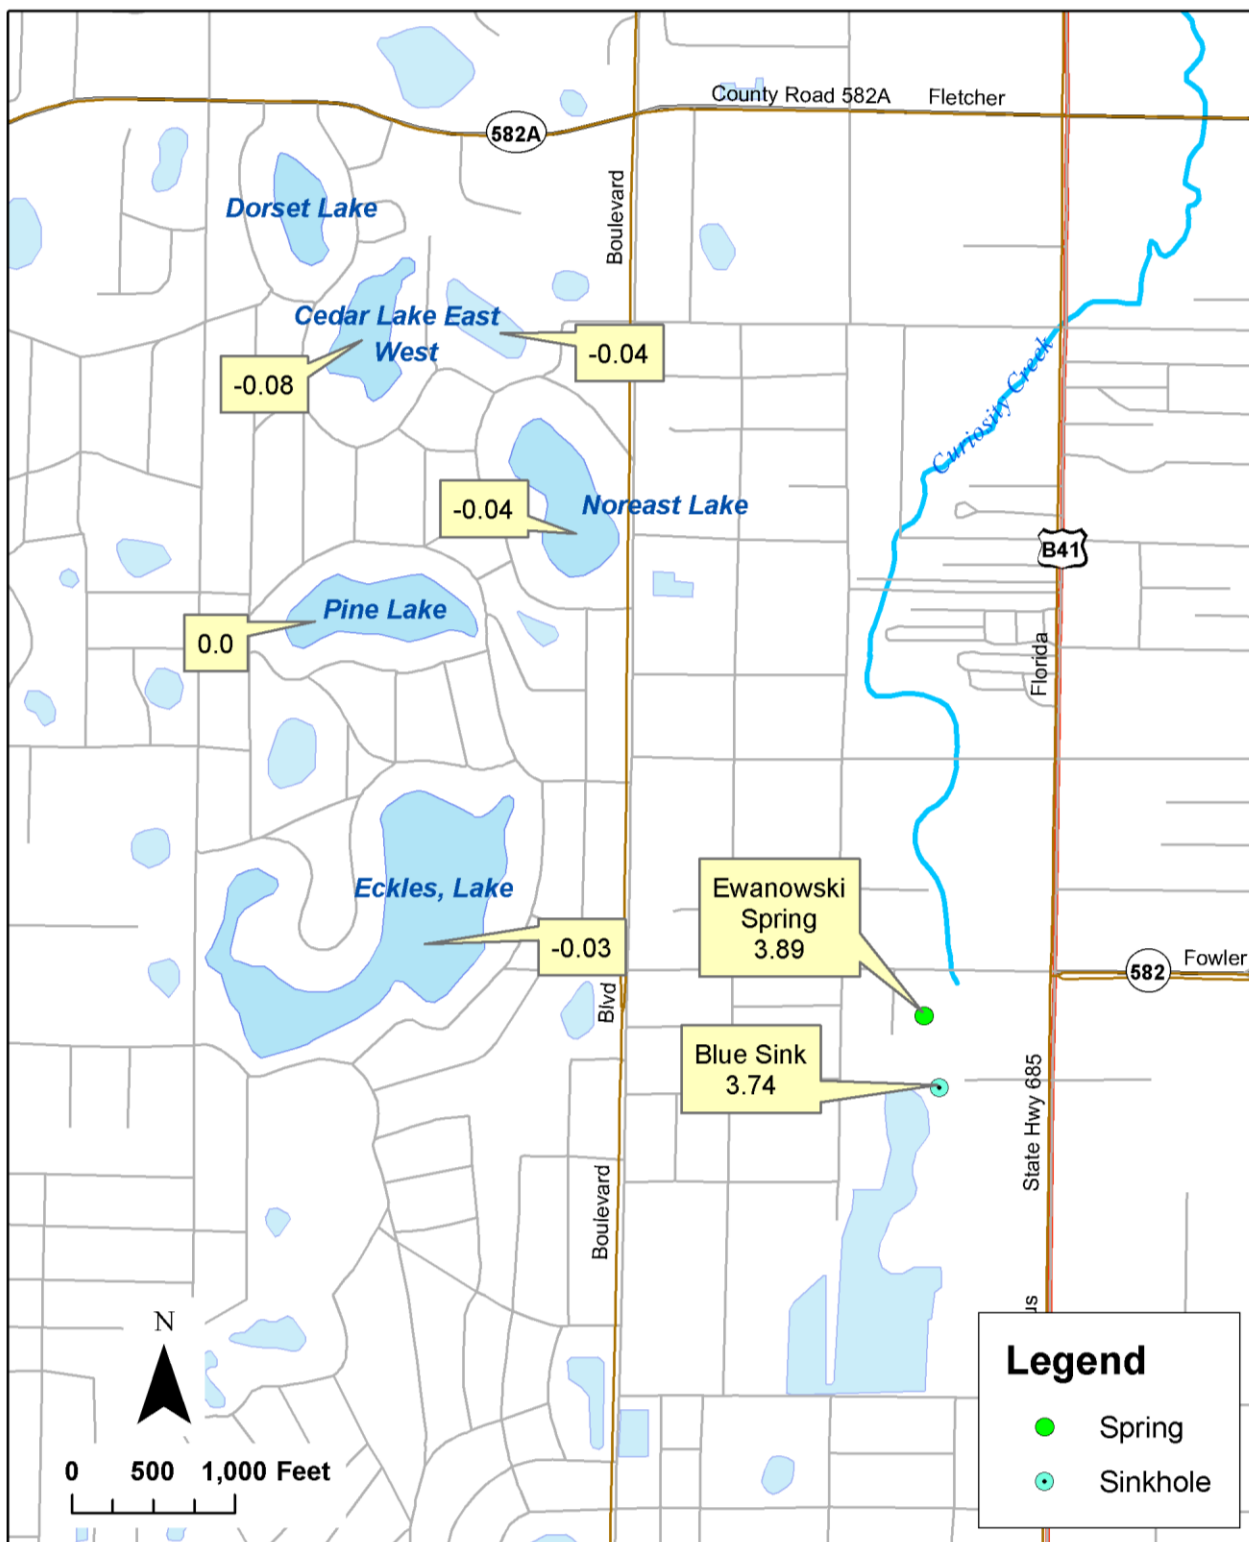
Figure 10. Lake drawdown calculated from the Blue Sink pumping test (note: negative values indicate increasing water levels at the end of 30 days of withdrawals).

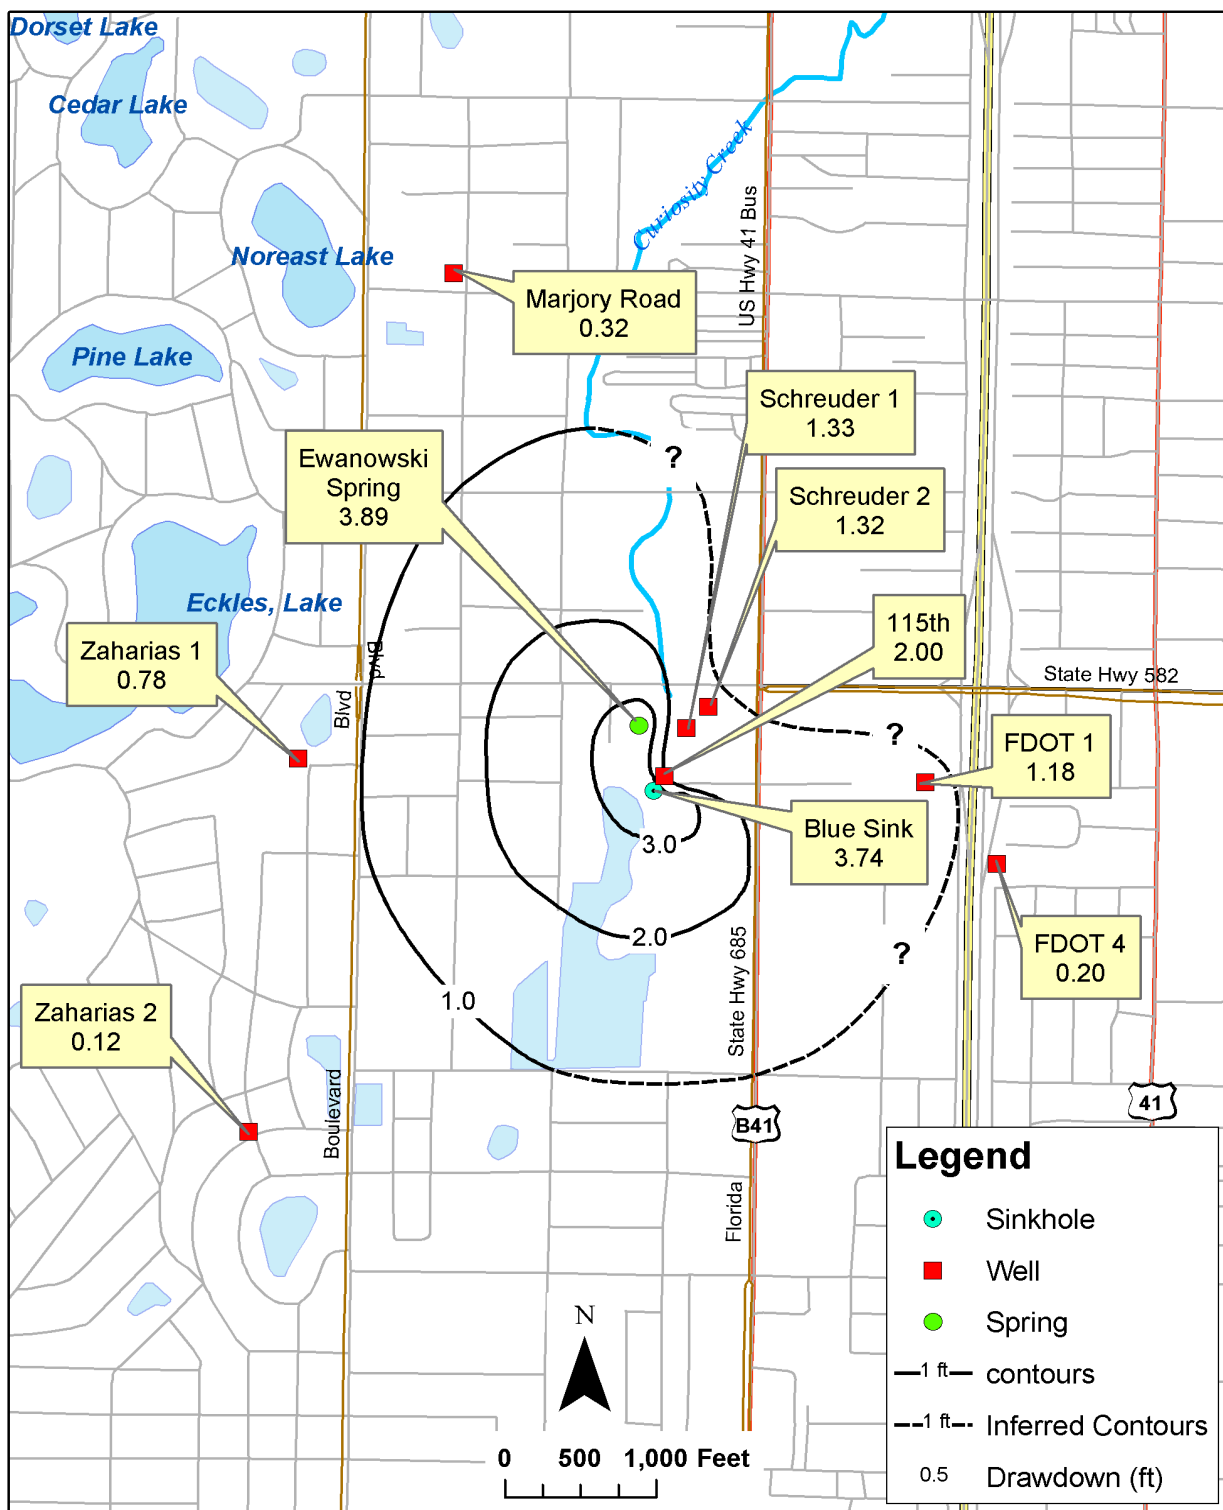
Figure 11. Drawdown in the Upper Floridan aquifer from the Blue Sink pumping test.

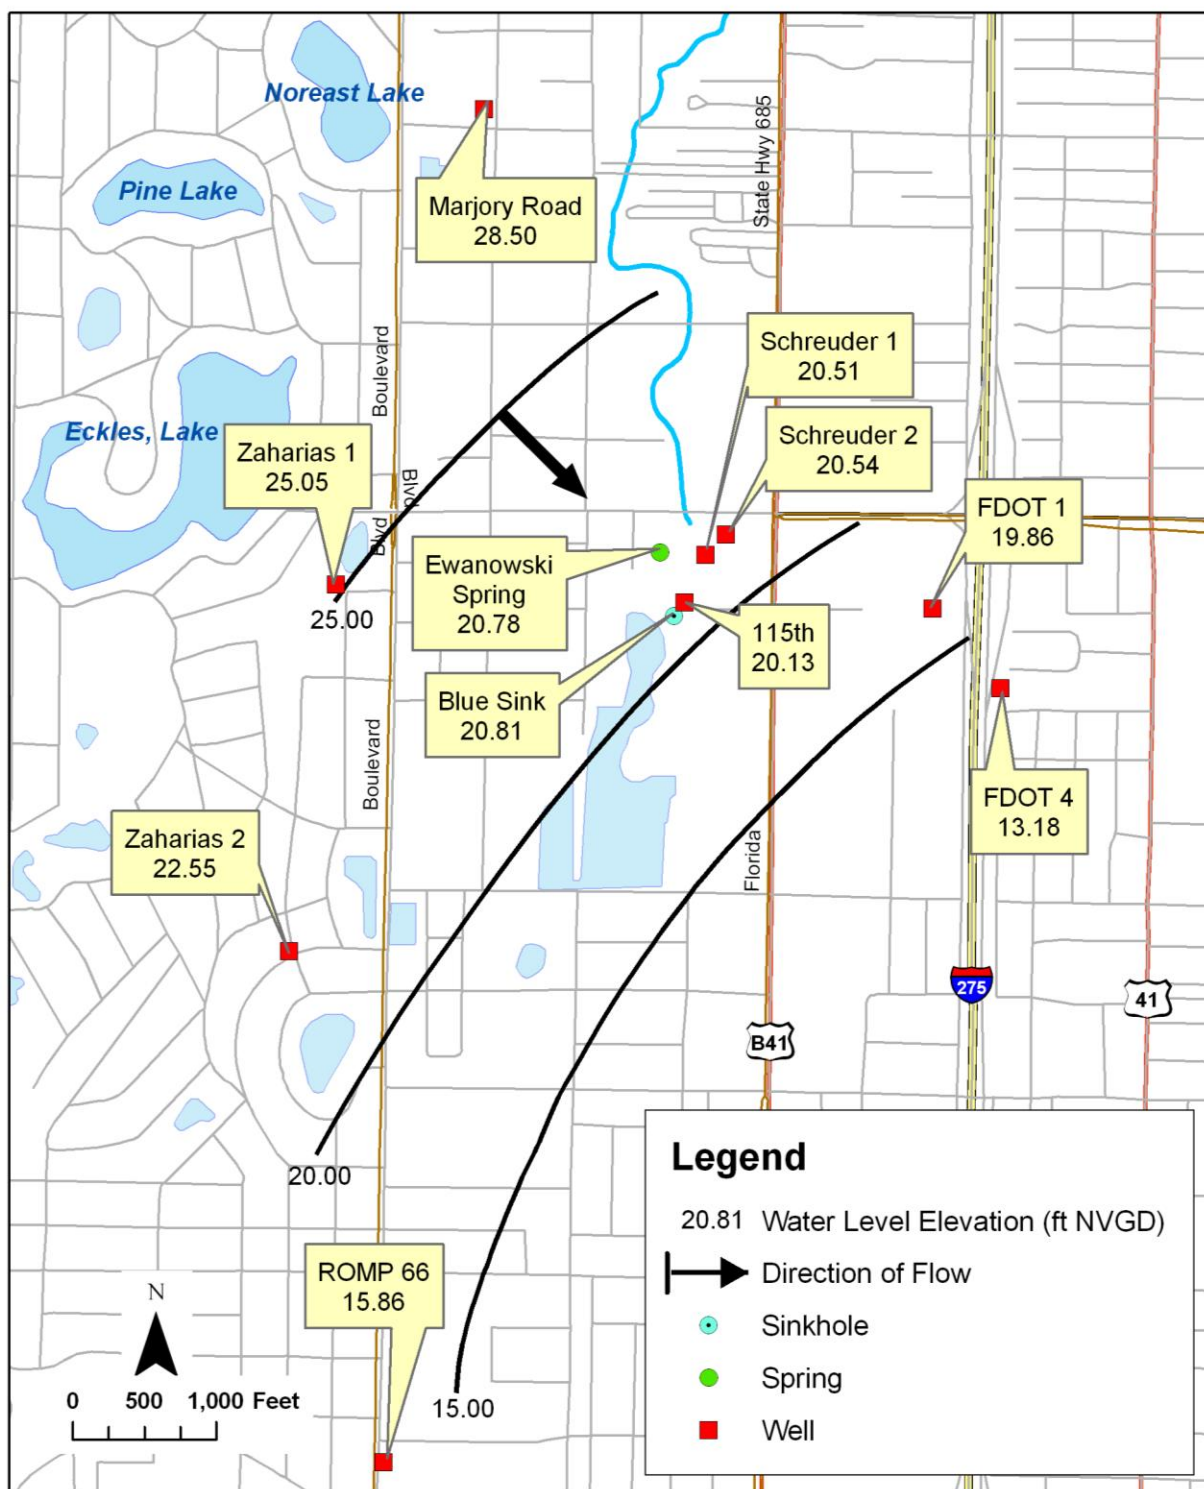
Figure 12. Groundwater flow direction and potentiometric surface of the Upper Floridan aquifer, February 25, 2009.

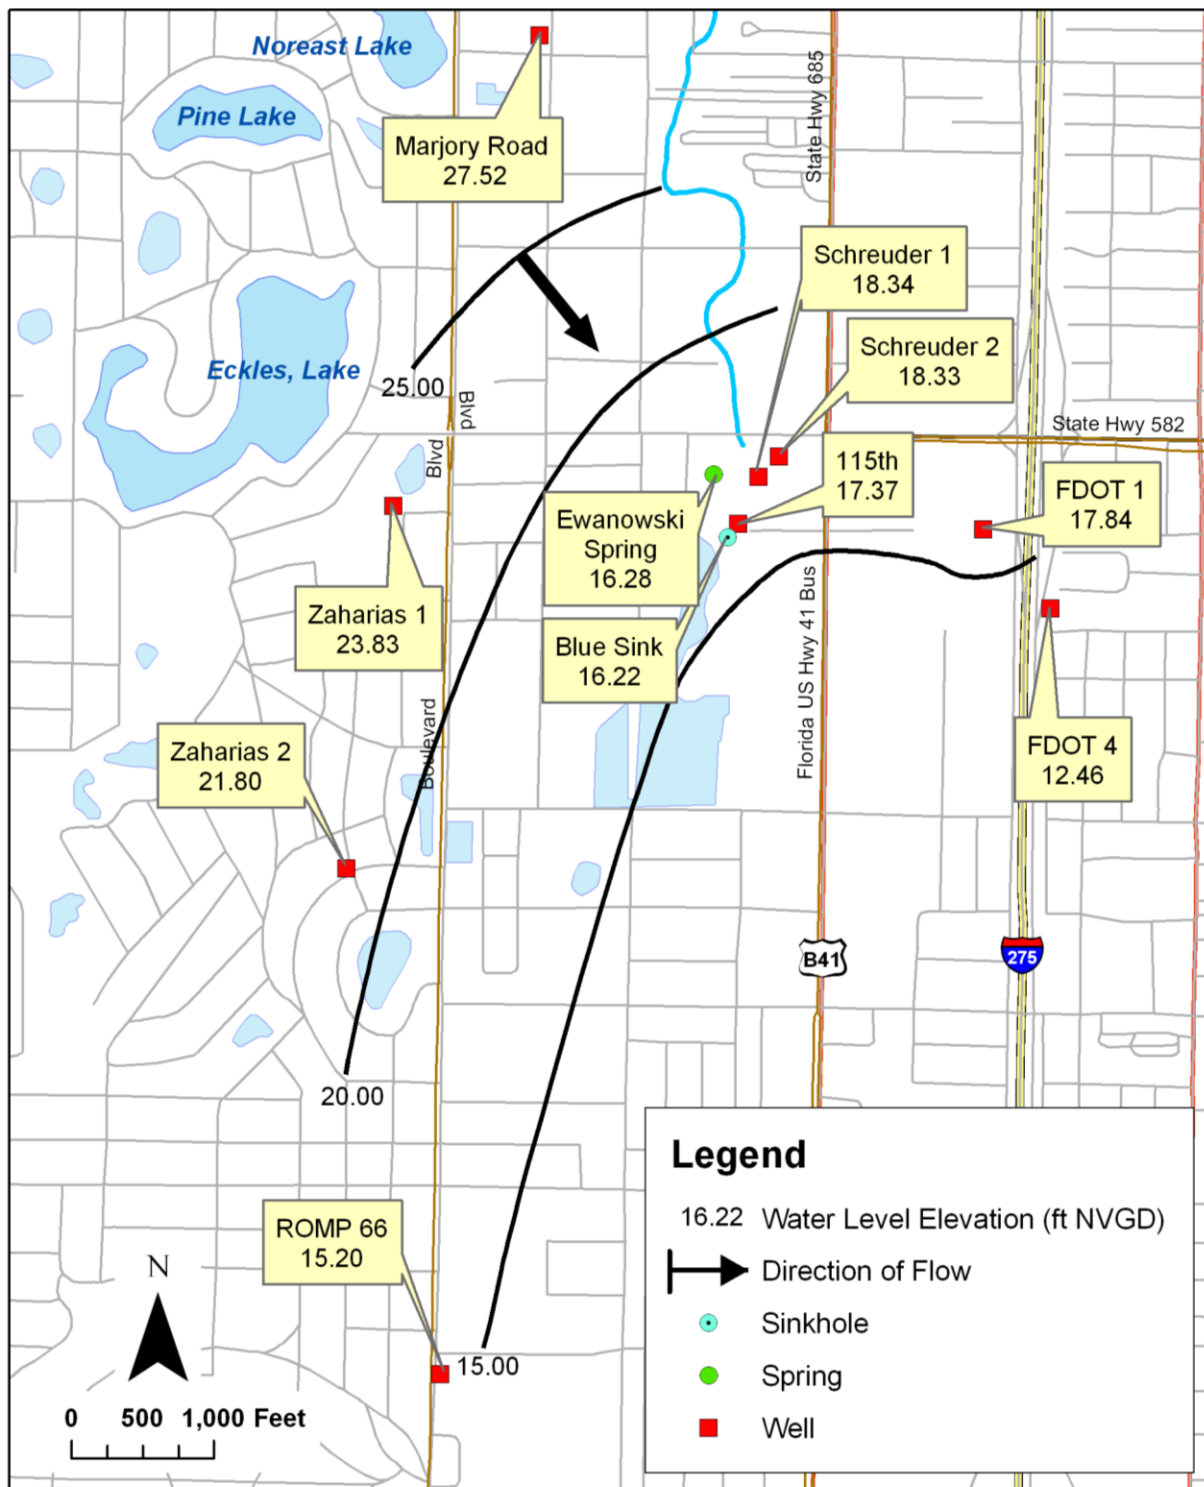
Figure 13. Groundwater flow direction and potentiometric surface of the Upper Floridan aquifer, March 28, 2009.

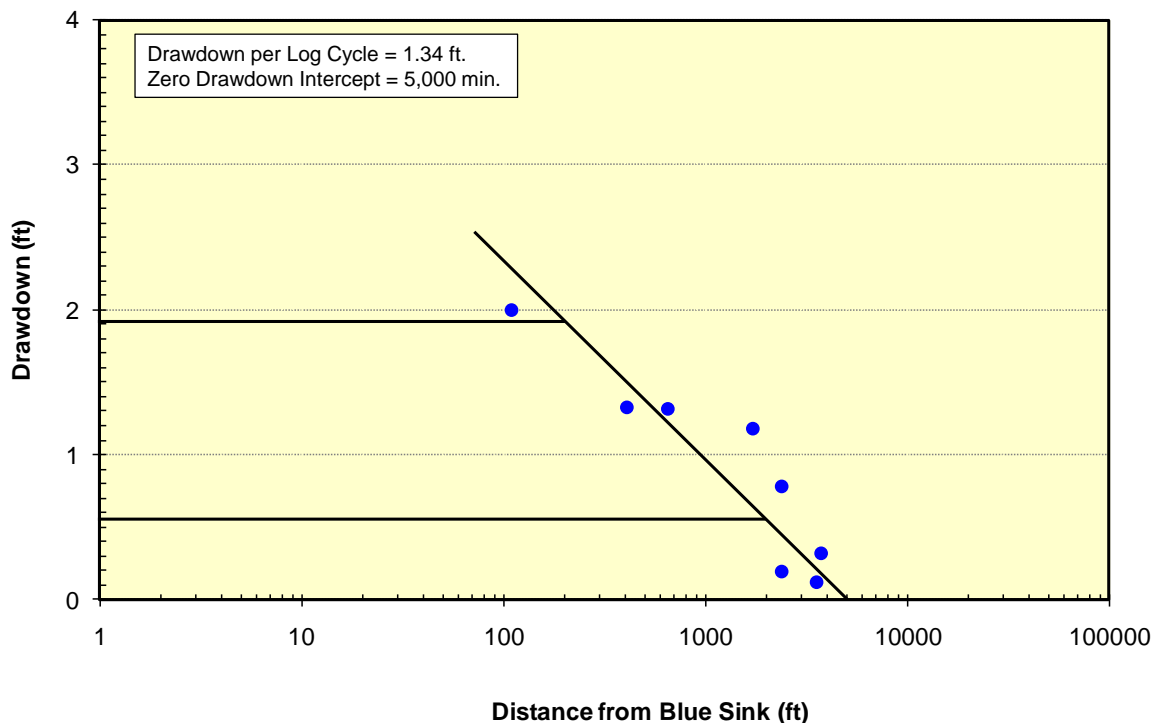
$$\text{Transmissivity} = 74,000 \text{ ft}^2/\text{d}$$

$$\text{Storage Coefficient} = 0.20$$

Figure 14. Distance-drawdown plot from the Blue Sink pumping test.

The transmissivity value of 74,000 ft<sup>2</sup>/d is slightly higher than the results of 63,000 ft<sup>2</sup>/d determined from a 24-hour aquifer test performed on an 80-foot temporary well installed near well FDOT-2 (Schreuder, 2001). Additionally, this transmissivity result is also slightly higher than 66,000 ft<sup>2</sup>/d from first Blue Sink test conducted by the District in May 2008.

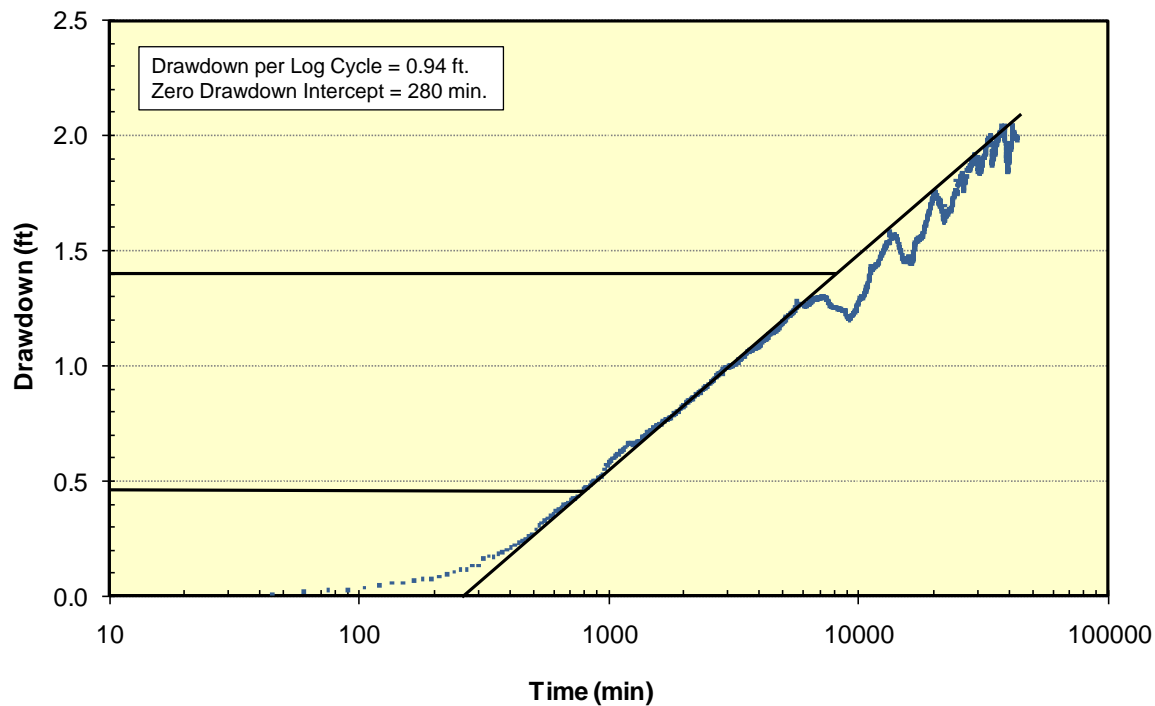
Figure 15. Drawdown versus time analysis using the Cooper-Jacob method for the 115<sup>th</sup> Avenue well.

$$T = (2.3 \cdot Q / 12.57 (h_o - h))$$

$$S = 2.25 \cdot T \cdot t_o / r^2$$

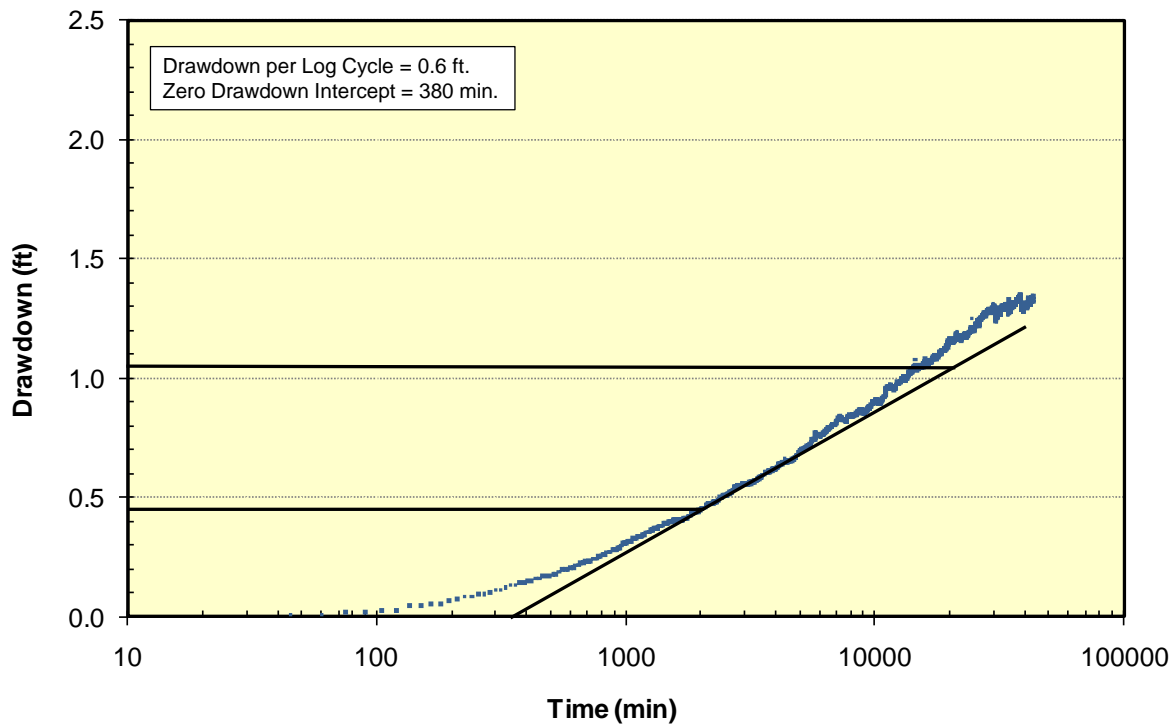
Figure 16. Drawdown versus time analysis using the Cooper-Jacob method for the Schreuder 1 well.

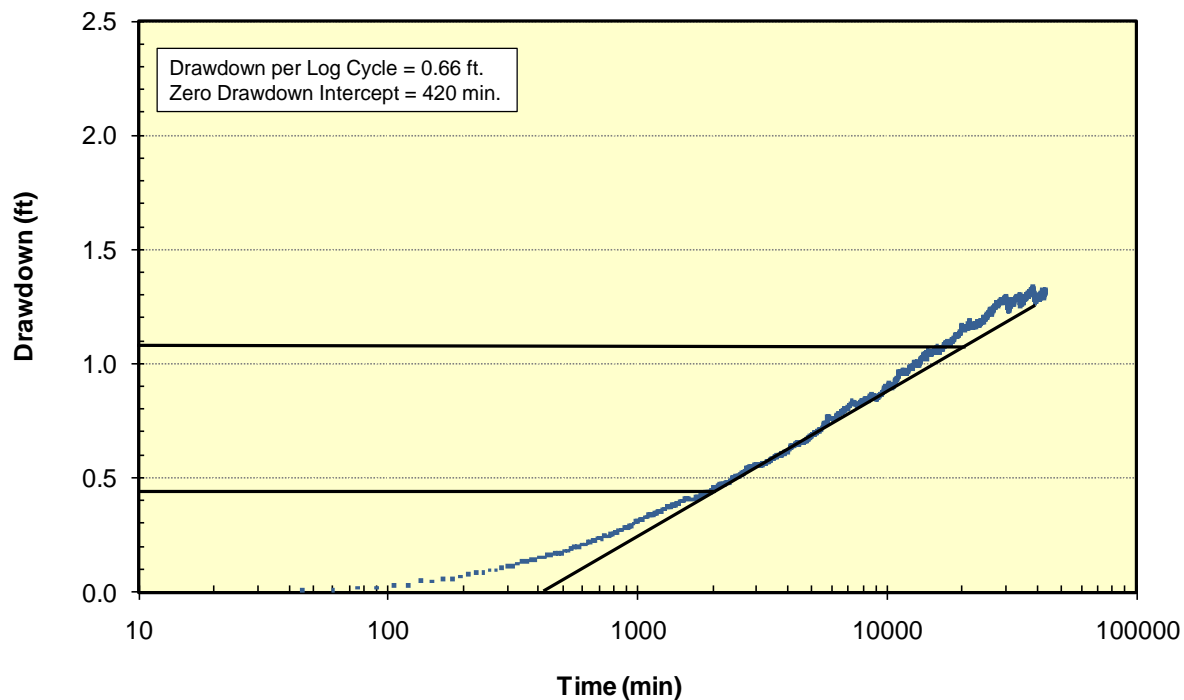
Figure 17. Drawdown versus time analysis using the Cooper-Jacob method for the Schreuder 2 well.

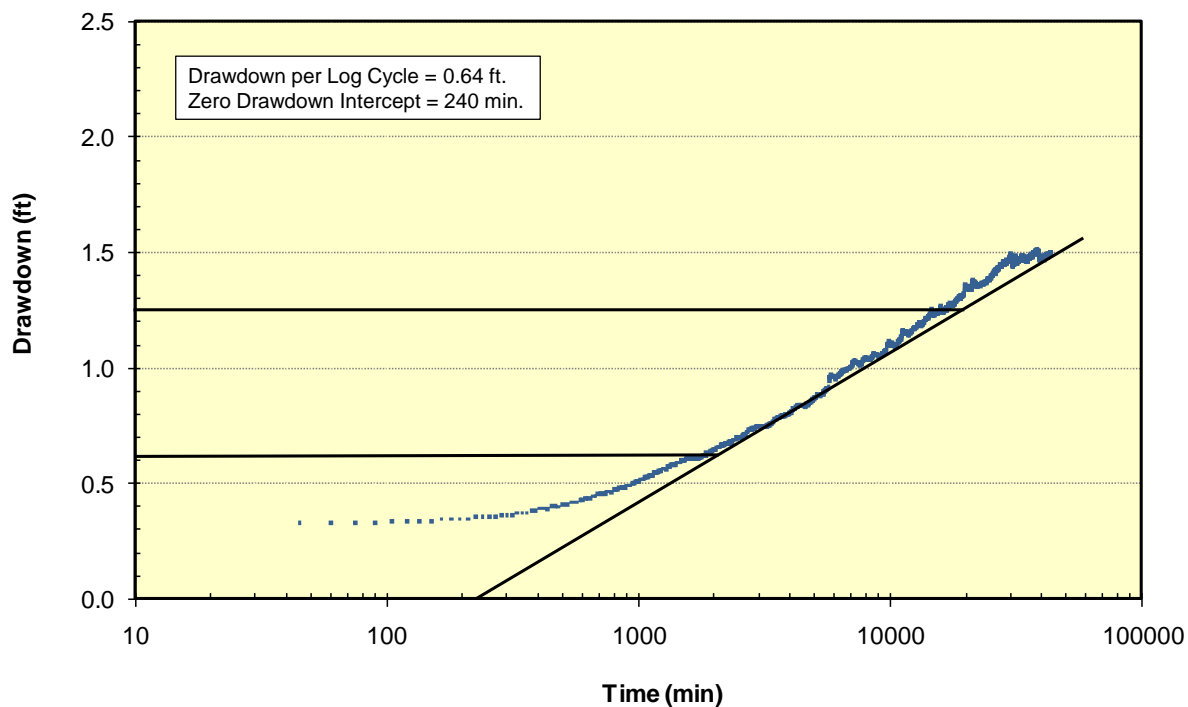
Figure 18. Drawdown versus time analysis using the Cooper-Jacob method for the FDOT 1 well.

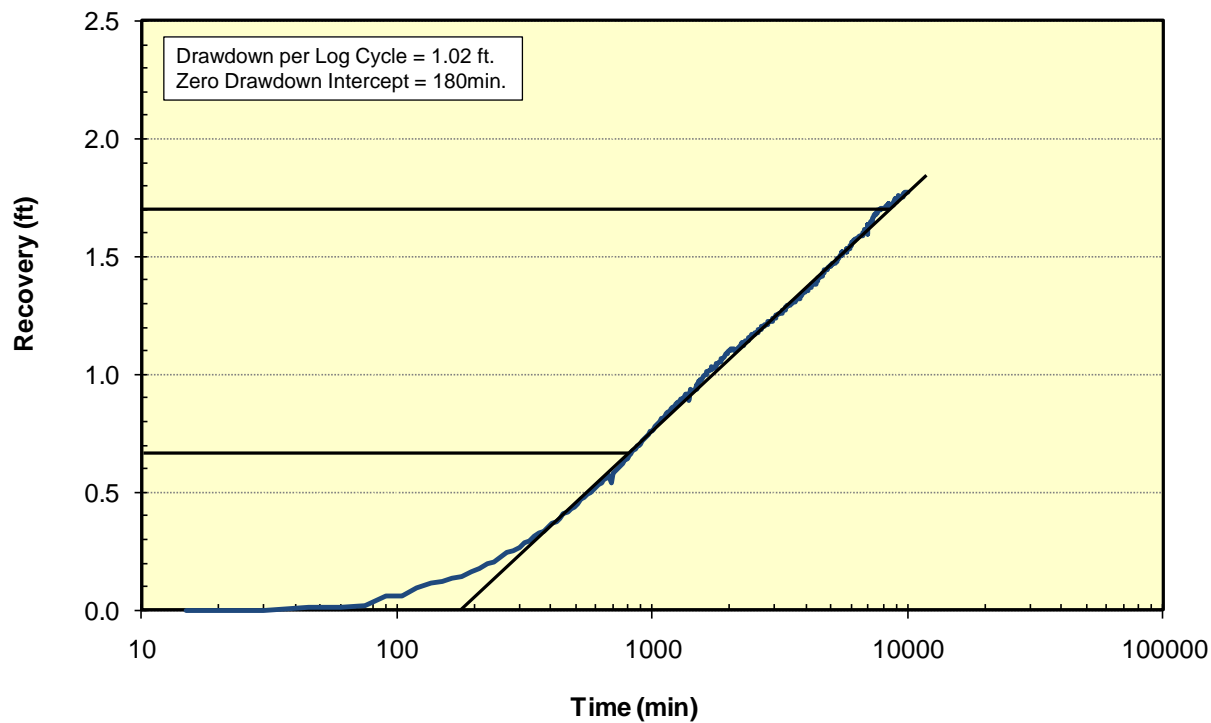
Figure 19. Recovery analysis using the Cooper-Jacob method for the 115<sup>th</sup> Avenue well.
