**Results of Blue Sink Pumping Test No. 2  
Hillsborough County, Florida**

**Hydrologic Evaluation Section  
Southwest Florida Water Management District**

**September 2009**

**By Jason Patterson and Ron Basso, P.G.**

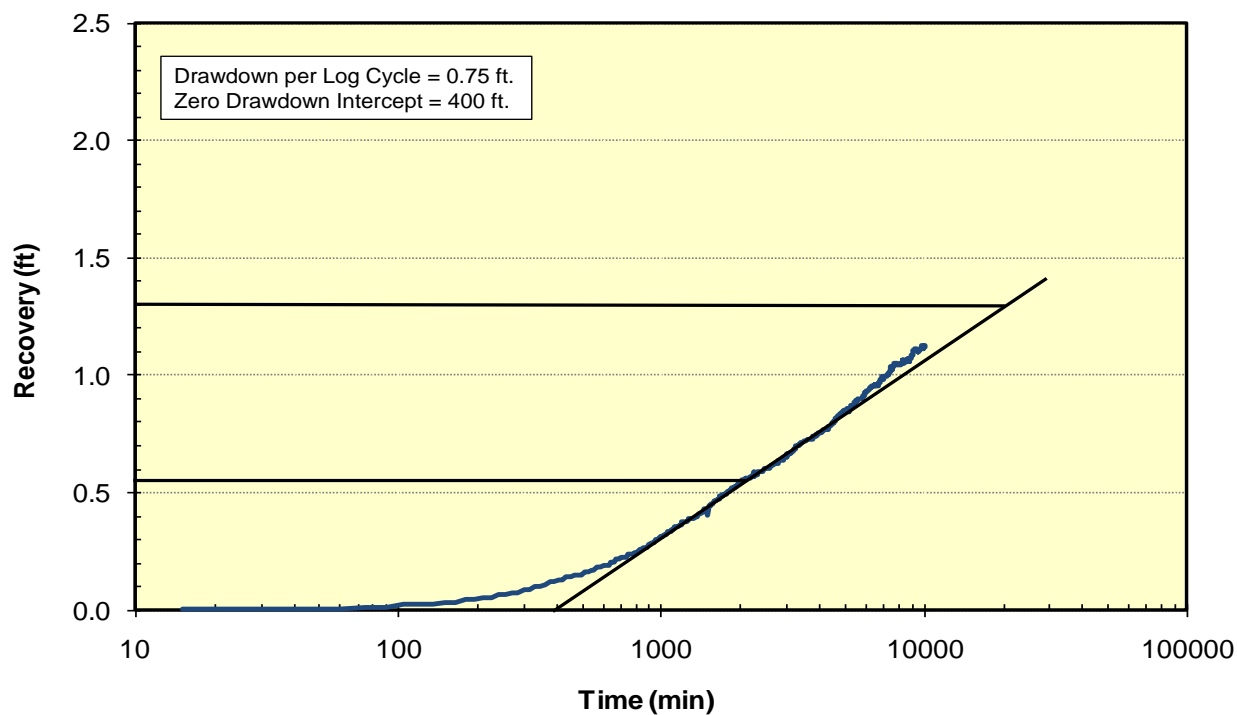
Figure 20. Recovery analysis using the Cooper-Jacob method for the Schreuder 1 well.

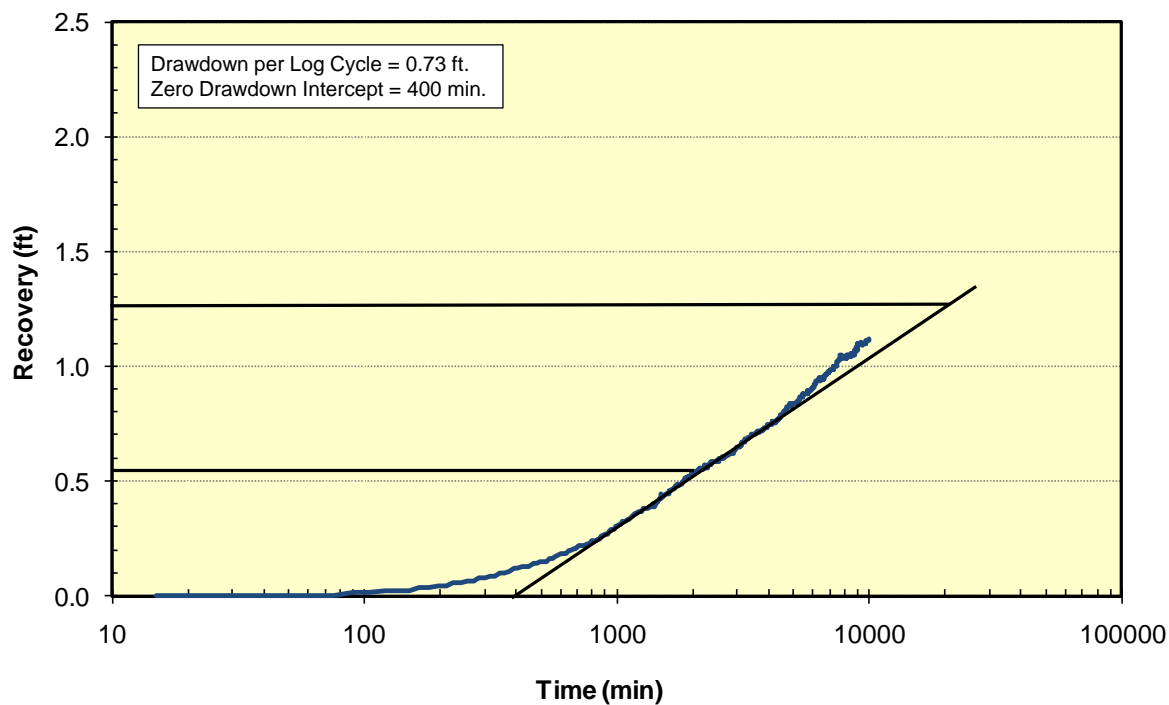
Figure 21. Recovery analysis using the Cooper-Jacob method for the Schreuder 2 well.

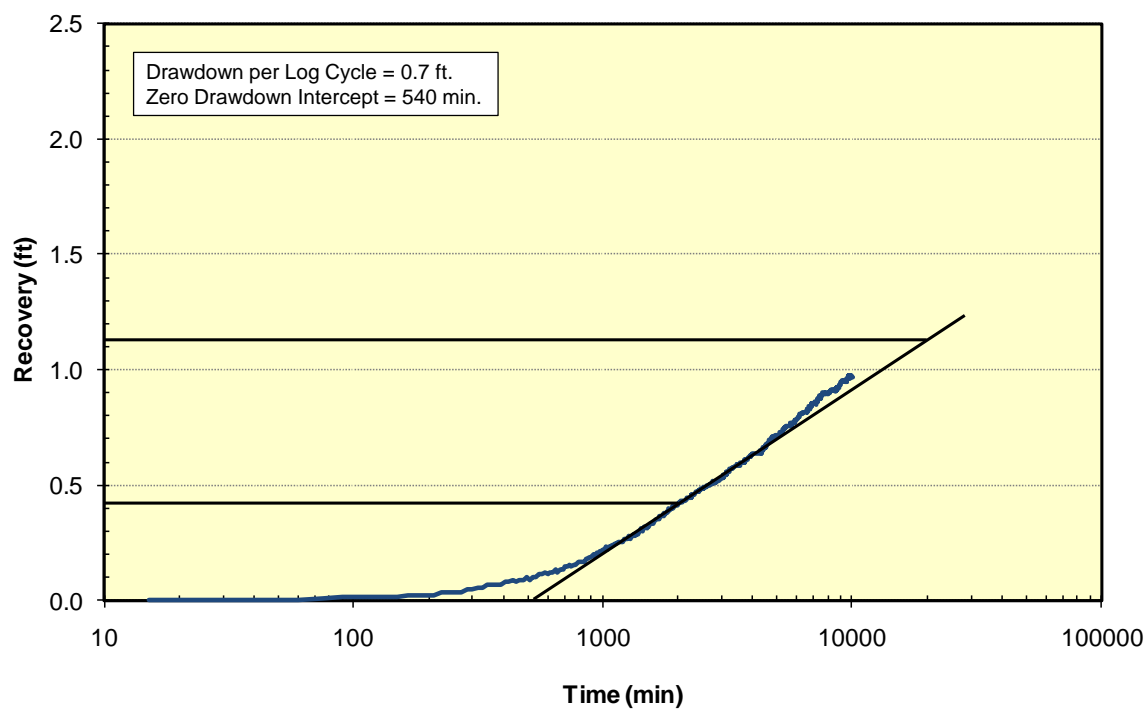
Figure 22. Recovery analysis using the Cooper-Jacob method for the FDOT 1 well.
