Minimum and Guidance Levels for Tsala Apopka Lake in Citrus County, Florida

January 17, 2007

Ecologic Evaluation Section
Resource Conservation and Development Department

Southwest Florida
Water Management District

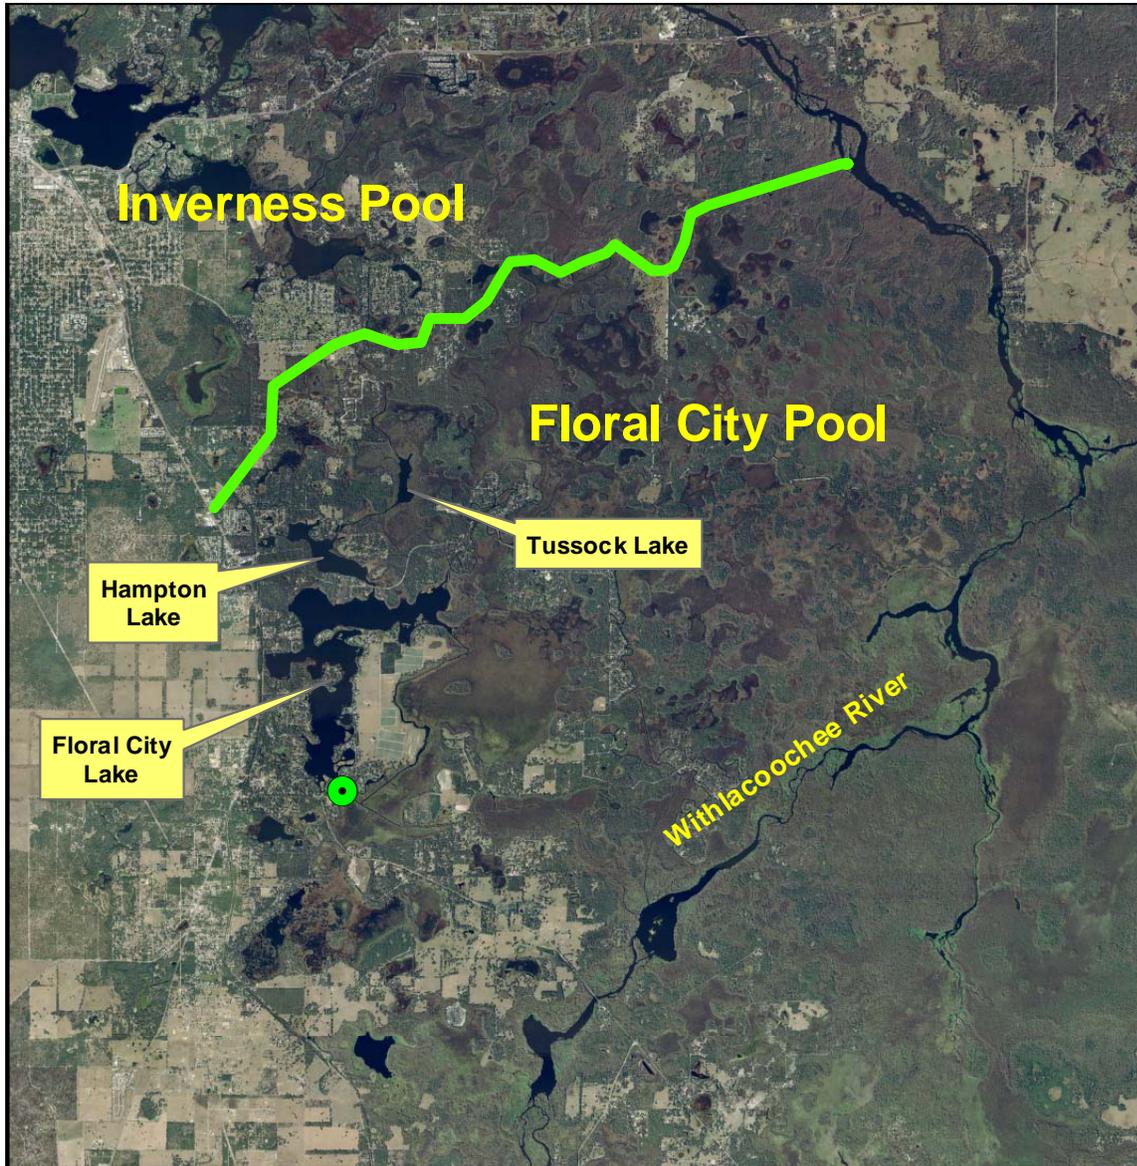
Figure 3. Generalized area map of the Floral City Pool of Tsala Apopka Lake. Major open-water bodies (lakes), the Withlacoochee River and approximate boundary between the Floral City and Inverness Pools are identified, along with the location of the District's water level gauging station for the Florida City Pool.

For descriptive and water management purposes, open water and wetland areas of the lake system are grouped into three pools. The southernmost, the Florida City Pool, includes Floral City Lake, Hampton Lake, Tussock Lake and extensive marshes and forested wetlands lying between the lakes and the Withlacoochee River (Figure 3). Water levels in the Florida City Pool are monitored at a site along the south shore of Floral City Lake. The central pool is known as the Inverness Pool, and includes Davis Lake, Spivey Lake, Henderson Lake, Little Henderson Lake and interconnecting wetlands (Figure 4). Water levels for the Inverness Pool are monitored at a gauging station on the north shore of Lake Henderson, just east of the connection between Lakes Henderson and Little Henderson. The Hernando Pool is located to the north of the Inverness Pool, and includes Point Lonesome Lake, Van Ness Lake, Croft Lake, Hernando Lake, Todd Lake, Bellamy Lake, Dodd Lake and extensive wetland areas (Figure 5). Water levels in the Hernando Pool are monitored at a gauge site on the southwest shore of Hernando Lake.

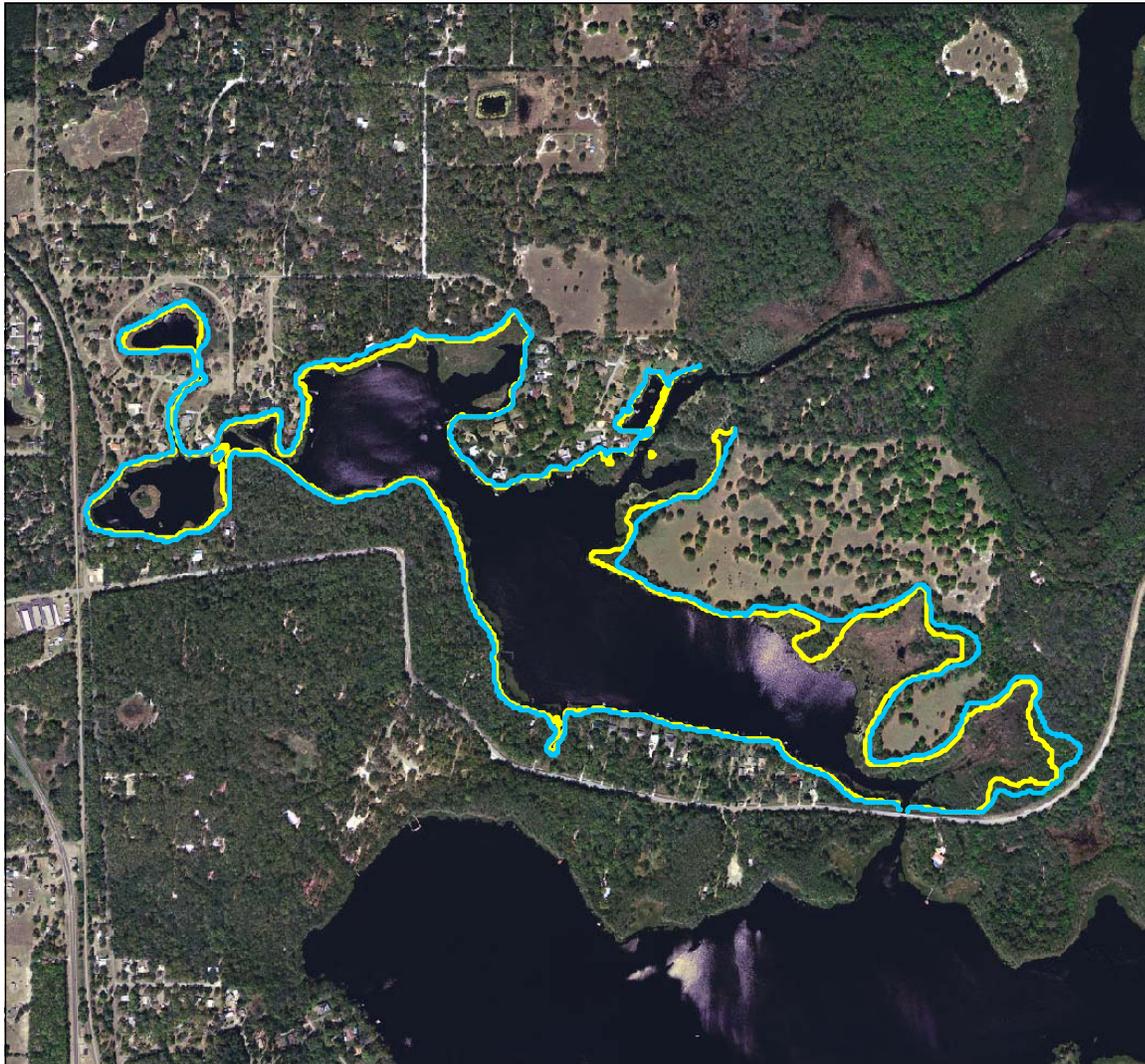
Figure 37. Approximate location of the Minimum Lake Level (MLL) and High Minimum Lake Level (HMLL) for the Floral City Pool in the Hampton Lake basin.

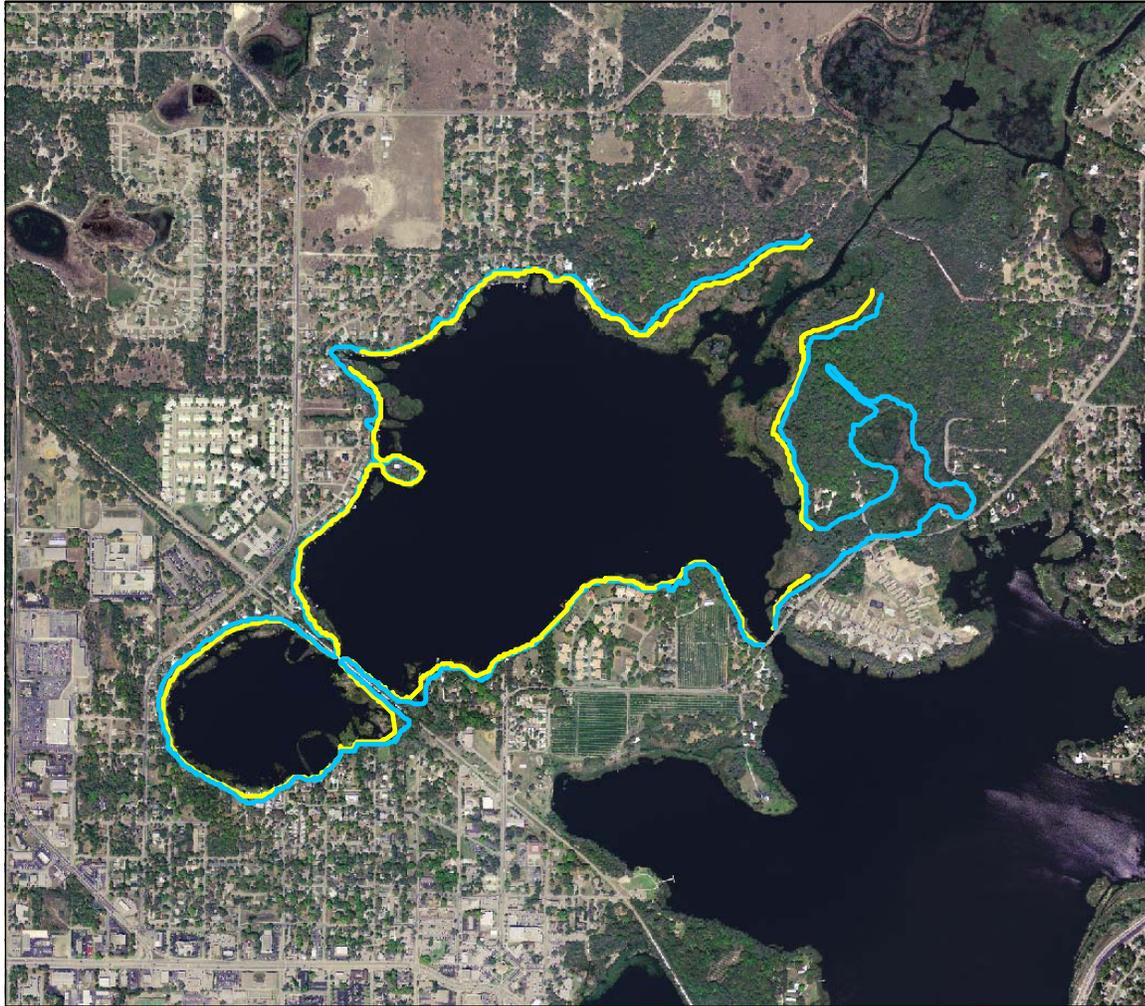
Figure 40. Approximate location of the Minimum Lake Level (MLL) and High Minimum Lake Level (HMLL) for the Inverness Pool in the Little Henderson Lake basin.

— MLL = 38.7 ft above NGVD
