Lake Tarpon Surface Water Improvement and Management (SWIM) Plan

July 2025

Southwest Florida
Water Management District
WATERMATTERS.ORG • 1-800-423-1476

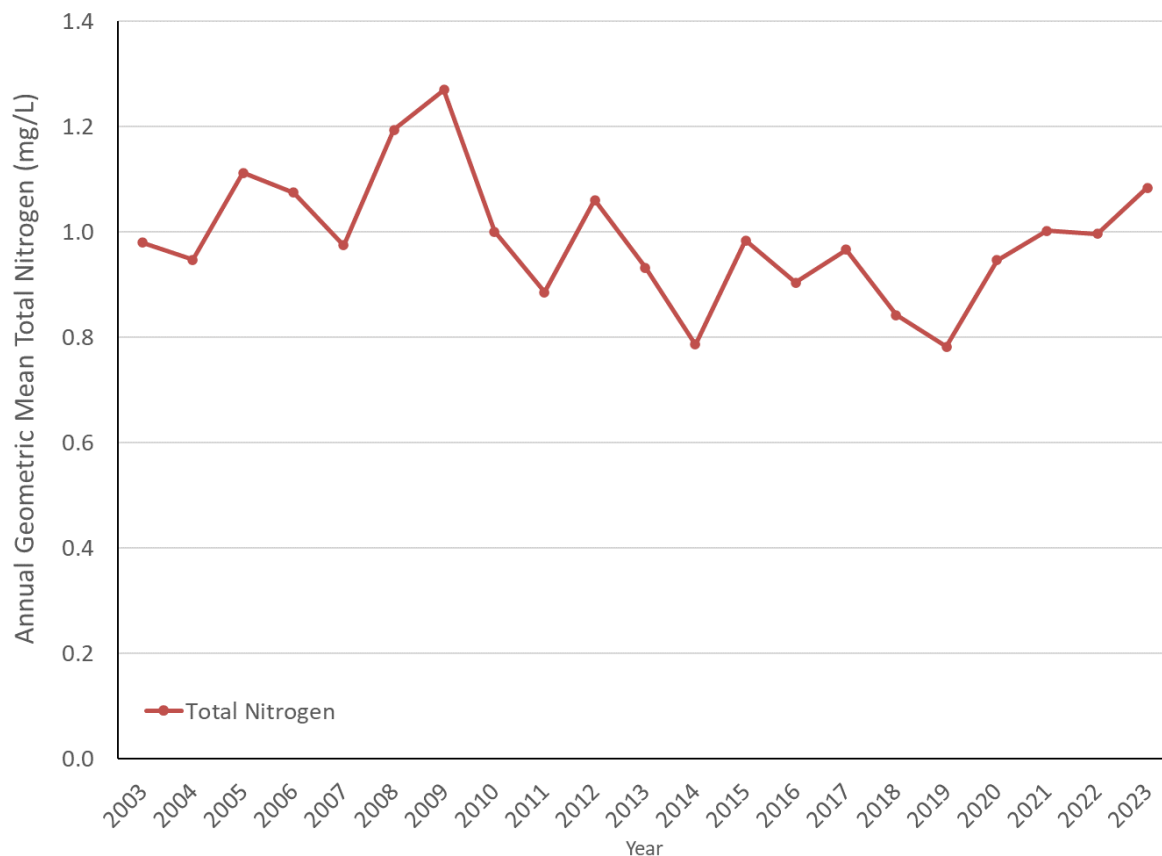
Figure 4 – Time series of TN (mg/L) annual geometric means for the period 2003 to 2023

Statistical analysis did not detect a significant trend

Annual geometric means for total nitrogen concentrations in Lake Tarpon over the period 2003-2023 ranged from approximately 0.8 – 1.27 mg/L (Figure 4). At no time did the TN concentration exceed the TN NNC of 1.27 mg/L. In 2009, the annual geometric mean equaled the TN NNC (Figure 4). As the data sets met the requirements of parametric statistical analysis of normality and homogeneity of variance, linear regression was used. This analysis did not detect a trend over the period 2003-2023 ($p>0.05$). Pinellas County noted an increasing TN trend for the period 2014 to 2023 (Figure 4) in their 2023 Annual Water Quality Report (<https://pcdem.shinyapps.io/dashboard/#section-annual-report>). The 2014 to 2023 concentrations remain below the TN NNC and fall within the mean concentration over the period shown in Figure 4. Water quality is closely monitored by Pinellas County.
