# WITHLACOOCHEE/TSALA APOPKA

## Lake Panasoffkee Water Clarity, Water Quality and the Importance of Submerged Vegetation to Lake Health

#### Lake Panasoffkee Fisheries

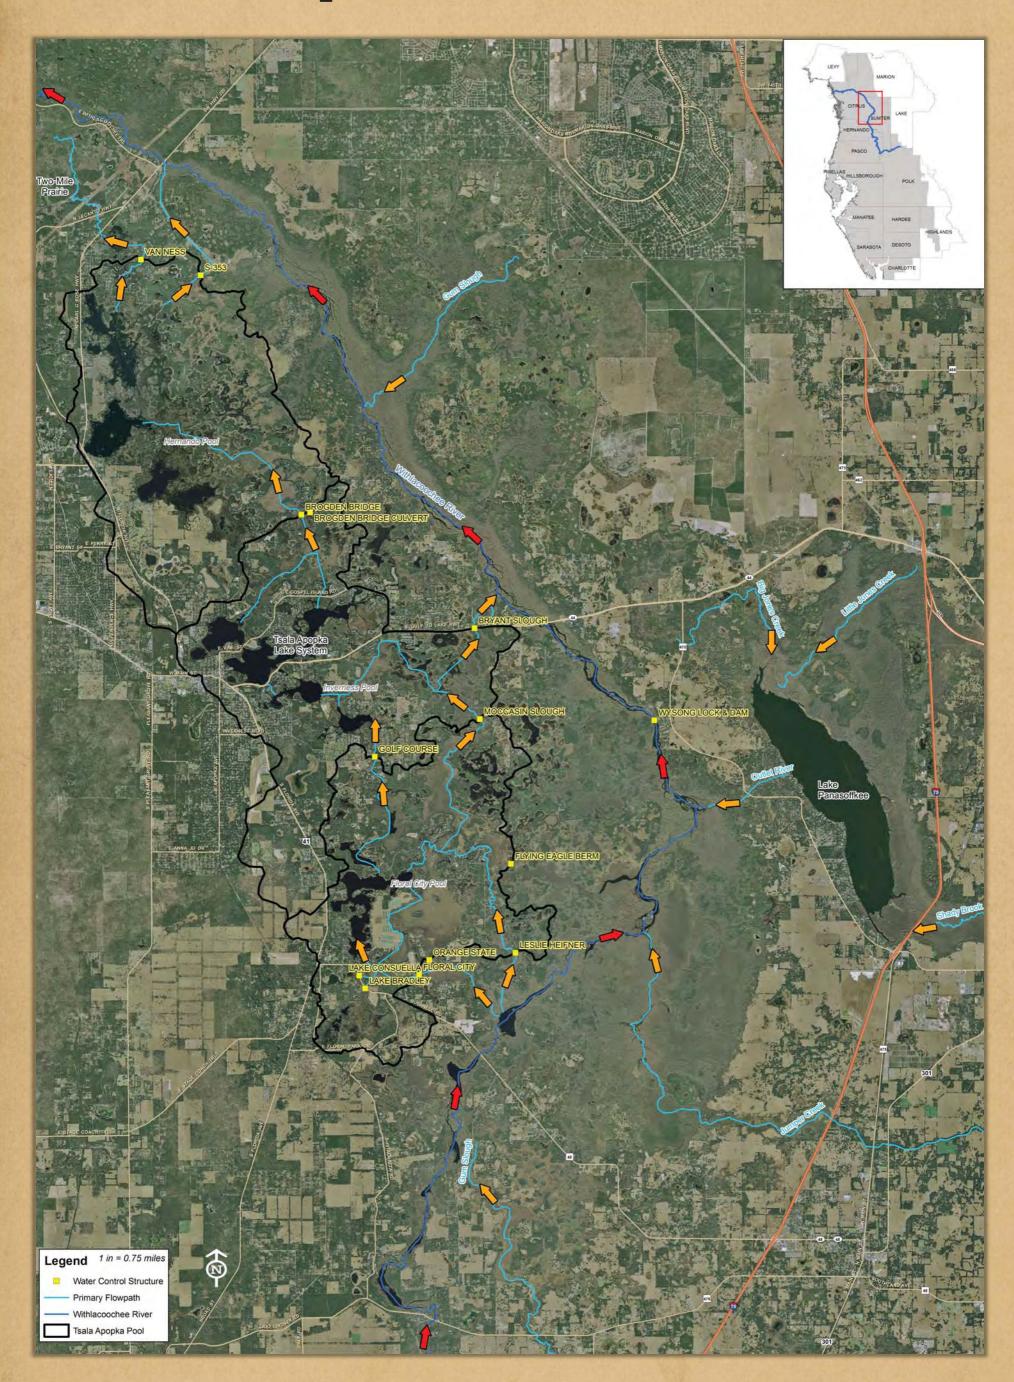
Flowpaths/Structures/Pools

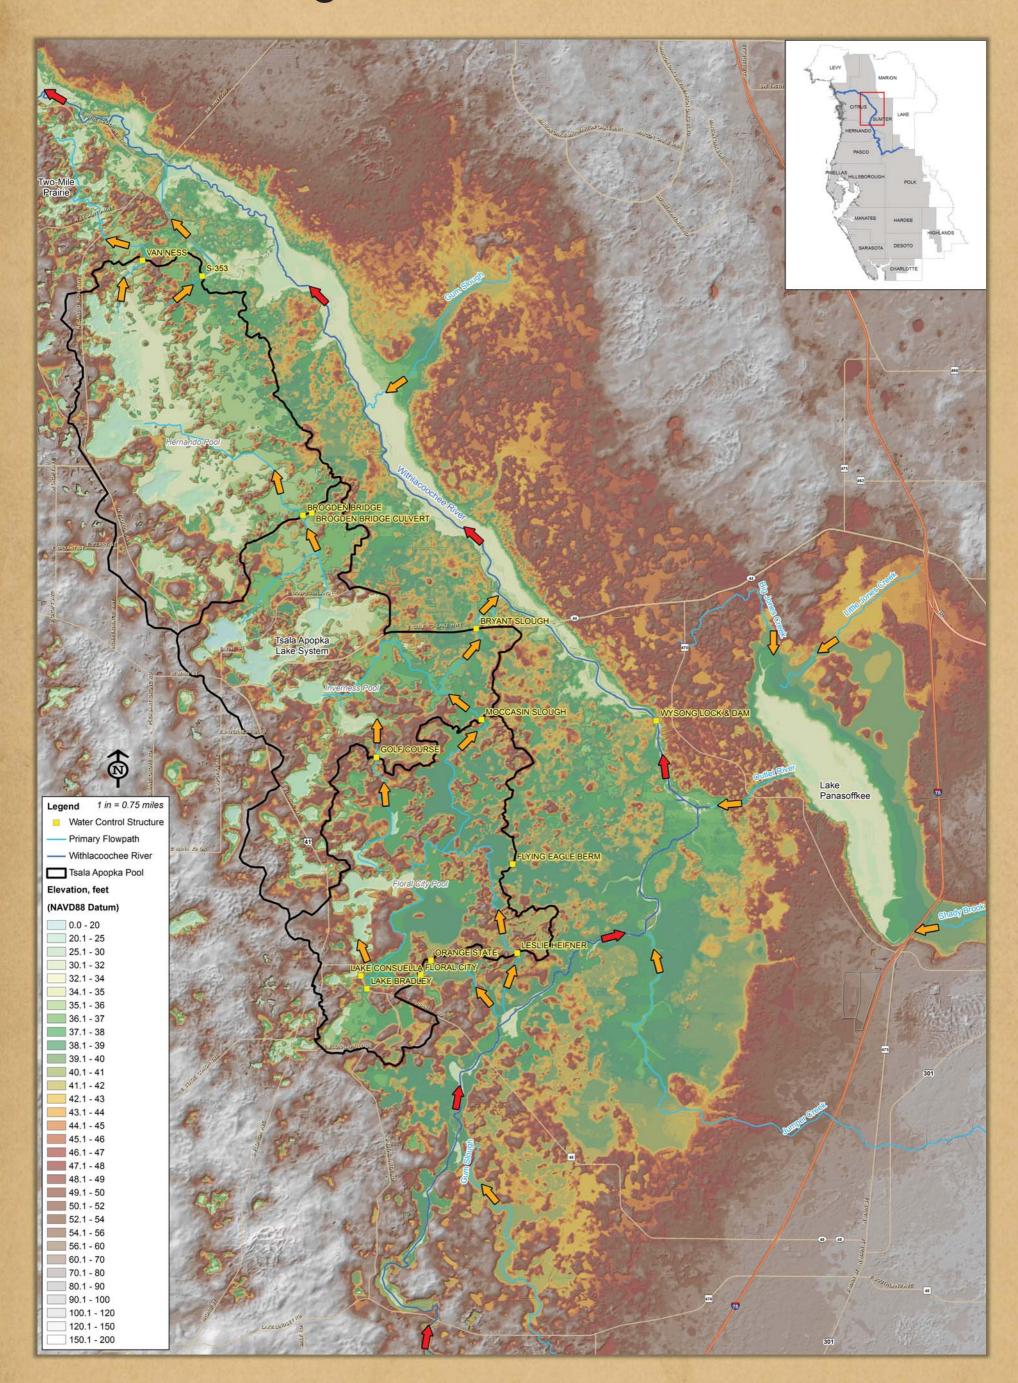
Digital Elevation Model

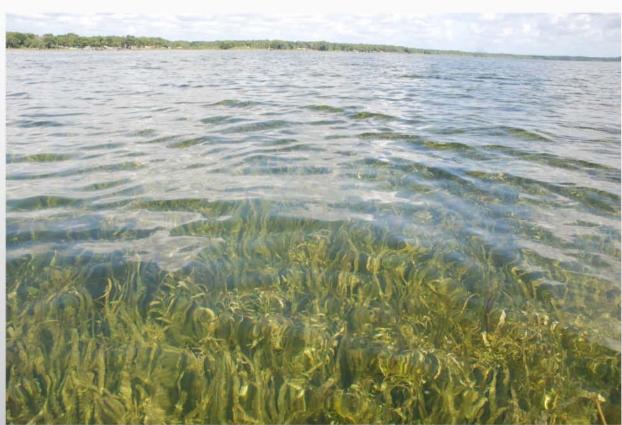
Environmental Scientists and Chemists from the Southwest Florida Water Management District monitor water clarity and submerged vegetation and analyze water quality

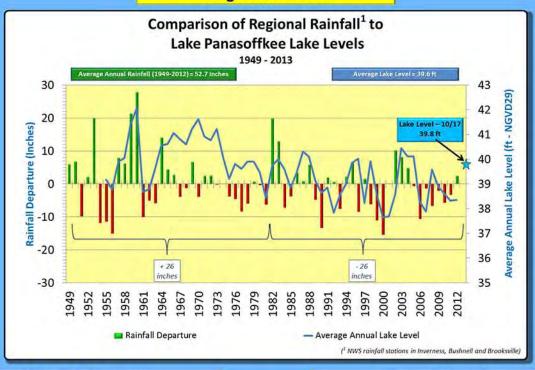
#### **Long Term Trends**

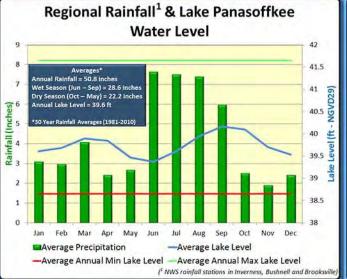
#### **Monthly Averages**

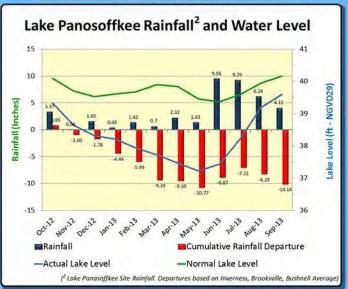
#### **Recent Trends**
