MEMORANDUM

SUBJECT: Proposed minimum and guidance levels for Strawberry (North Crystal) Lake in Hillsborough County, Florida

Strawberry (North Crystal) Lake

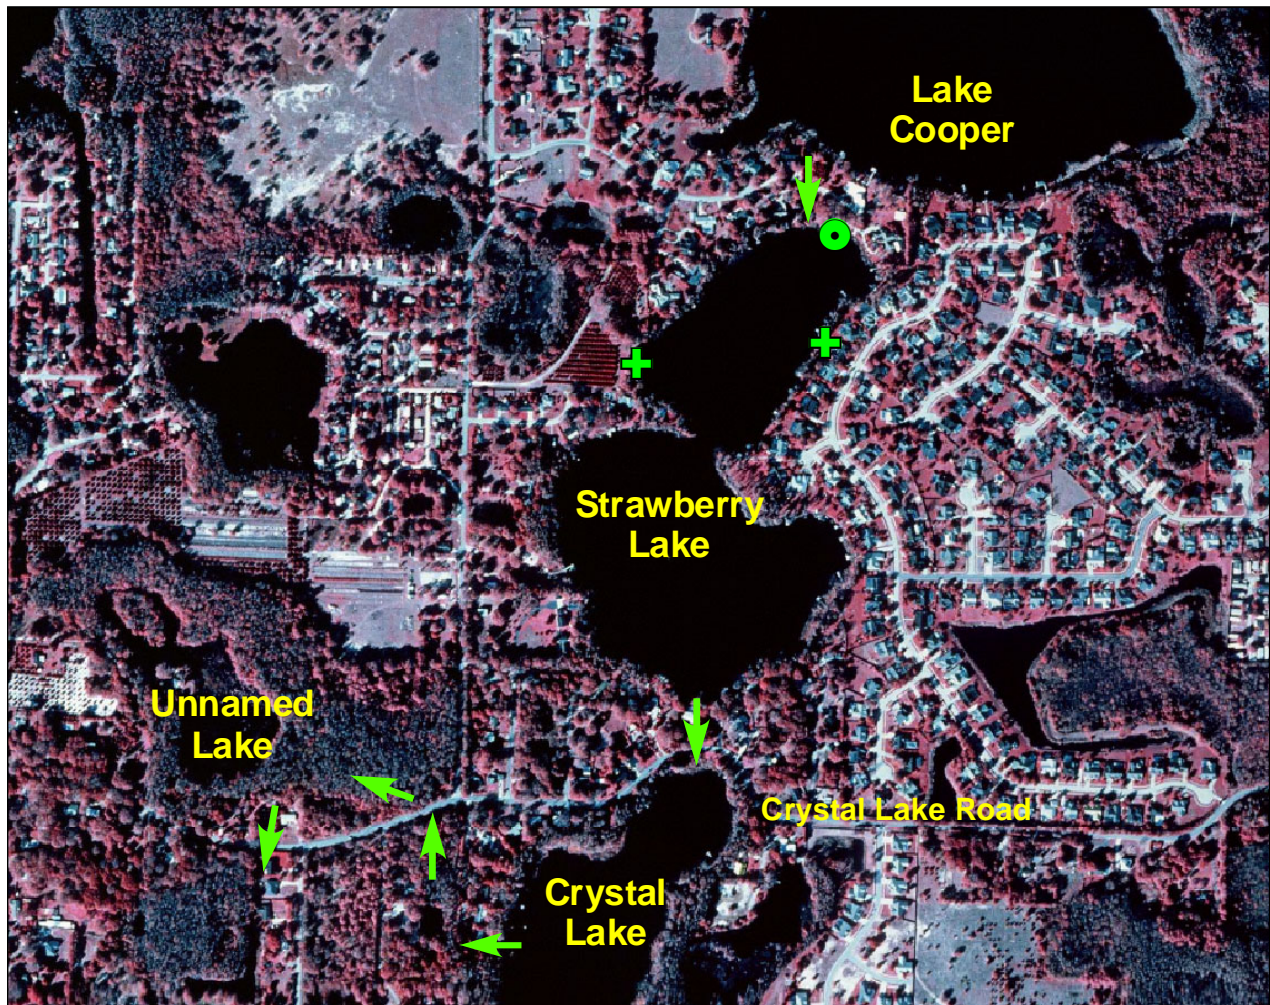
Figure 2. Location of District lake-level gauge, inlet, outlet and sites where hydrologic indicators were measured at Strawberry (North Crystal) Lake in Hillsborough County, Florida.

Hydrologic data are available for Strawberry (North Crystal) Lake (District Universal ID Number STA 416 417) from June 1971 through the present date (Figure 5, see Figure 2 for current location of the SWFWMD lake-level gauge). Note that hydrologic data record is not continuous; *i.e.*, there are some months during the period of record when water level data were not recorded. Monthly mean water surface elevations, along with proposed guidance and minimum levels are graphed in Figure 6. Historic data are not available. For the period of record from January 1985 through the present, the hydrologic data are classified as Current data. This period of record was selected based on regional wellfield pumpage and structural modifications to the Strawberry Lake and Crystal Lake outlet conveyance system in the 1980s. Current data collected through January 2003 were used to calculate the Current P10, P50, and P90 (Table 3).

The Normal Pool elevation was established at 62.3 ft above NGVD based on elevations associated with the buttressing of large cypress (*Taxodium* sp.) trees along the west and east shores of the north basin (Table 4, Figure 2). The low floor slab elevation, extent of structural alteration and the control point elevation were determined using available one-foot contour interval aerial maps and field survey data collected in June, July and August 2003 (Table 3). The control point elevation was established at 59.3 ft above NGVD, based on the ground elevation at the north end of a reinforced concrete pipe running under Crystal Lake Road at the outlet from Crystal Lake (Figure 7). The Normal Pool elevation is higher than the control point elevation so the lake is considered to be Structurally Altered.

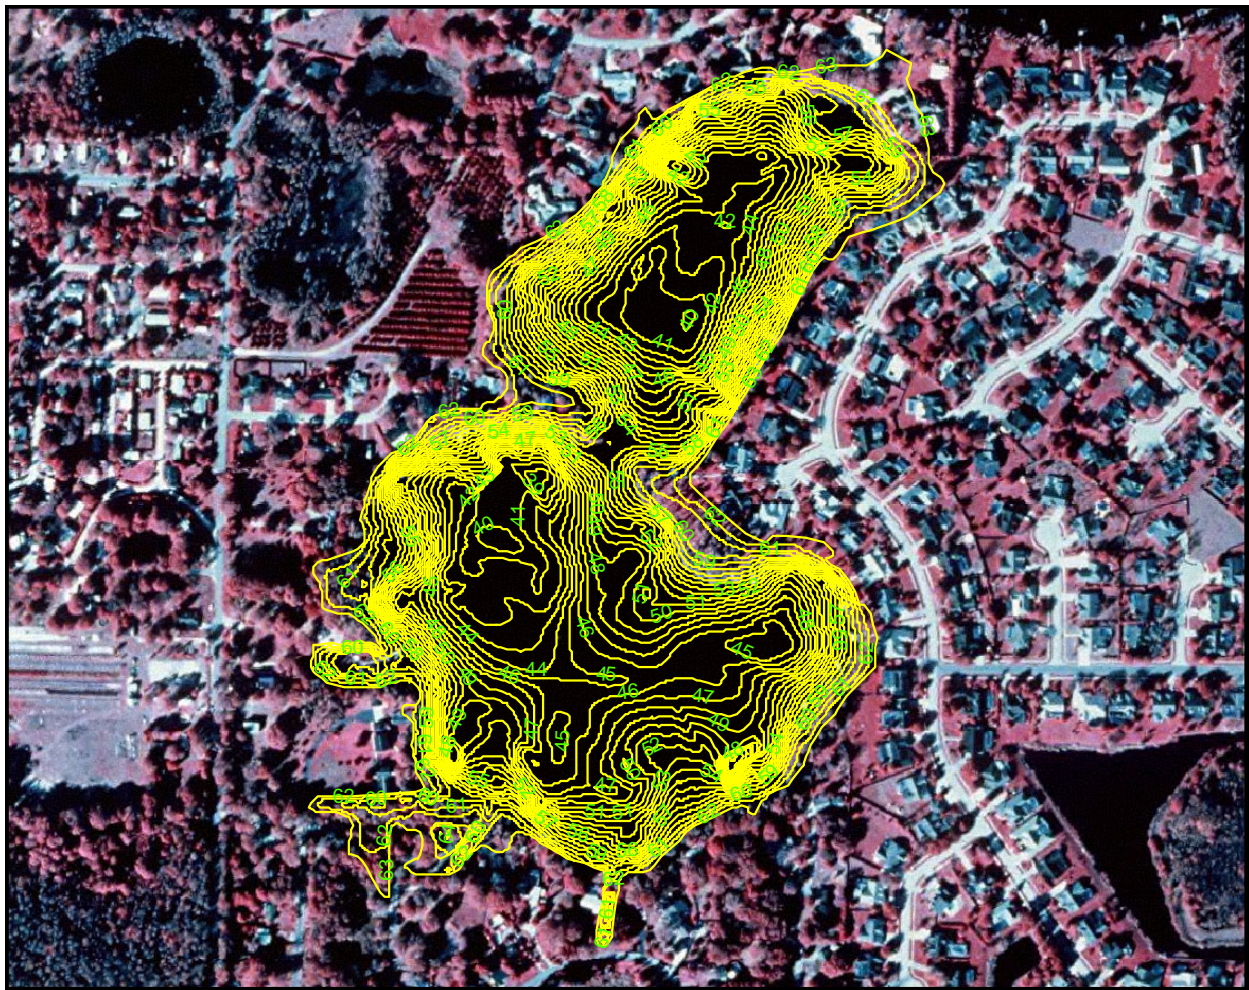
Figure 3. One-foot contours within the Strawberry (North Crystal) Lake basin in Hillsborough County, Florida. Values shown are elevations, in feet above the National Geodetic Vertical Datum of 1929.

Map prepared September 3, 2003 using 1999 USGS digital orthophotography, one-foot contour data from 1981 SWFWMD aerial photography maps (Sheet Nos. 11-27-18 and 14-27-18), and elevation data collected by Hillsborough County Stormwater Section staff on July 22, 1998.

The 1974 and 1987 (photorevised) United States Geological Survey 1:24,000 Lutz quadrangle maps do not include an elevation for the lake surface. The "Gazetteer of Florida Lakes" (Florida Board of Conservation 1969, Shafer *et al.* 1986) lists the lake's area at 41 acres at 60 ft above the National Geodetic Vertical Datum of 1929 (NGVD). A topographic map of the basin generated in support of minimum levels development (Figure 3) indicates that the lake extends over 42 acres at an elevation of 60 ft above NGVD. Data used for production of the topographic map were obtained from field surveys and aerial photography maps containing one-foot contour lines prepared using photogrammetric methods.

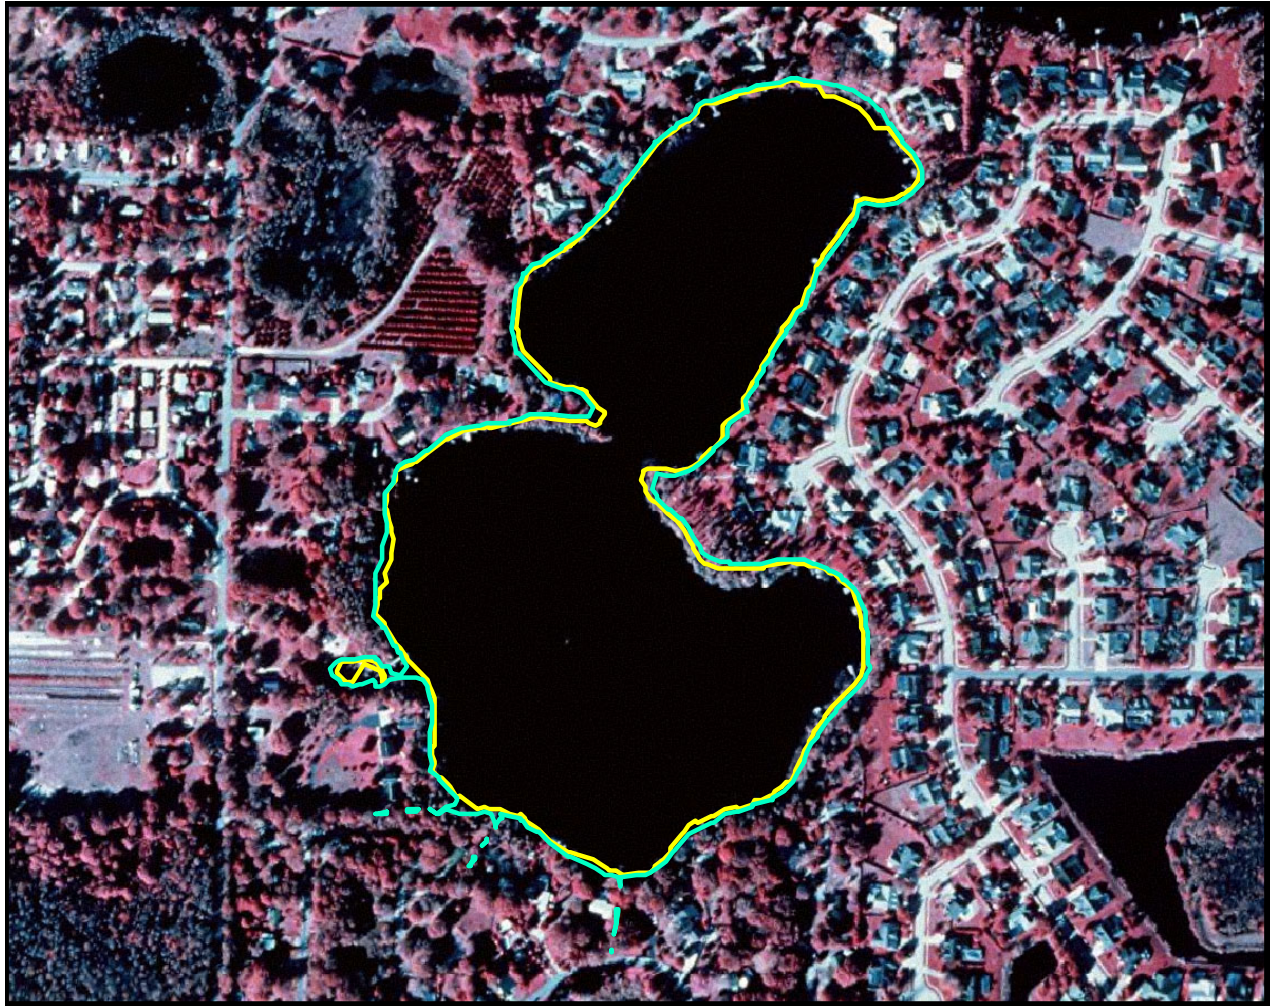
Figure 4. Approximate location of the proposed Minimum Lake Level (yellow) and proposed High Minimum Lake Level (blue) for Strawberry (North Crystal) Lake in Hillsborough County, Florida. Elevations listed are in feet above the National Geodetic Vertical Datum of 1929.

Map prepared September 3, 2003 using 1999 USGS digital orthophotography, one-foot contour data from 1981 SWFWMD aerial photography maps (Sheet Nos. 11-27-18 and 14-27-18), and elevation data collected by Hillsborough County Stormwater Section staff on July 22, 1998.

Strawberry_minimum_levels
Contour
— 59.1 ft above NGVD
— 60.1 ft above NGVD

Proposed Minimum and Guidance Levels were developed for Strawberry (North Crystal) Lake using the methodology for Category 3 Lakes described in current District Rules (Chapter 40D-8, Florida Administrative Code). Proposed levels, along with lake surface area values for each level are listed in Table 2. Locations of the proposed minimum levels within the lake basin are shown in Figure 4.

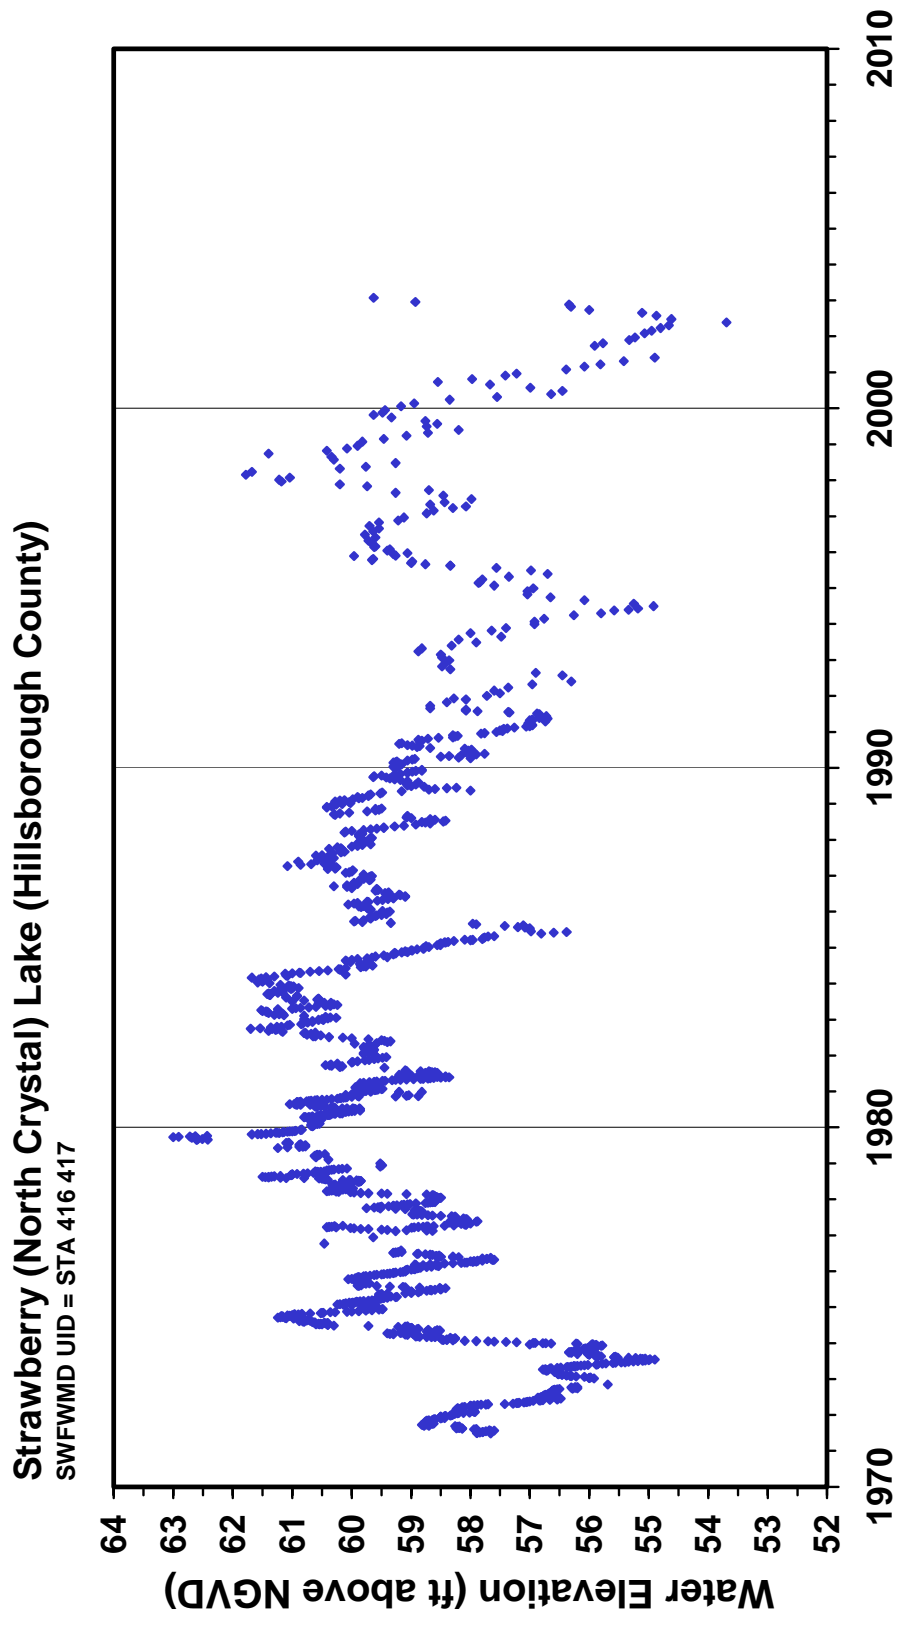
Figure 5. Surface water elevation at Strawberry (North Crystal) Lake in Hillsborough County, Florida. Data through January 2003 are shown.

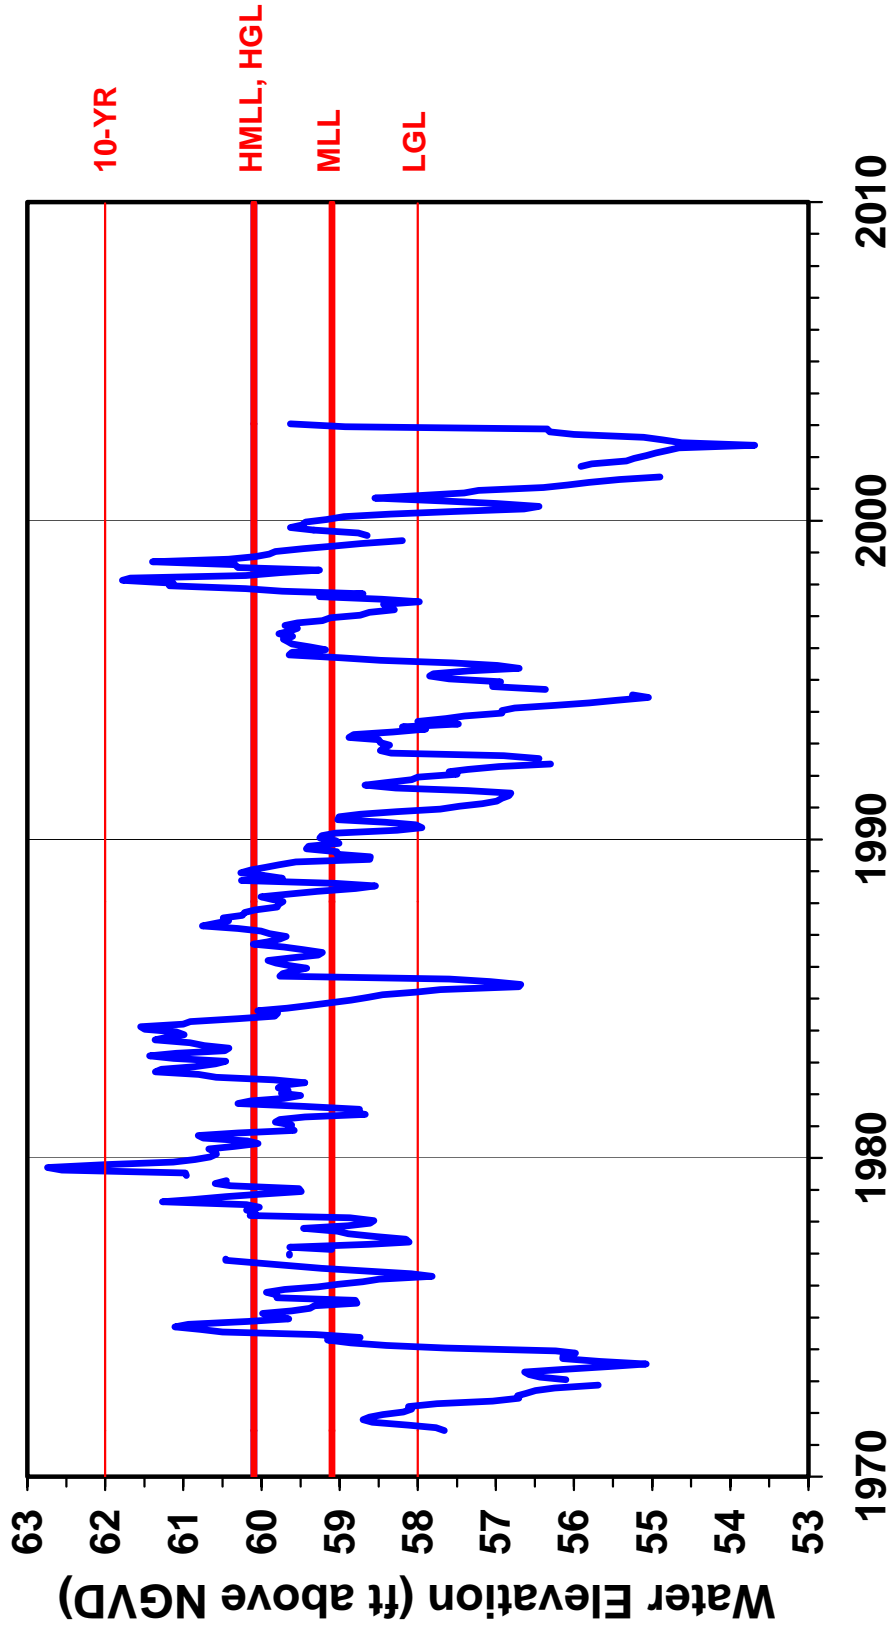
Figure 6. Mean monthly surface water elevation through January 2003, and proposed guidance and minimum levels for Strawberry (North Crystal) Lake in Hillsborough County, Florida. Proposed levels include the Ten Year Flood Guidance Level (10-YR), High Guidance Level (HGL), Low Guidance Level (LGL), High Minimum Lake Level (HMLL), and Minimum Lake Level.

SWFWMD UID = STA 416 417

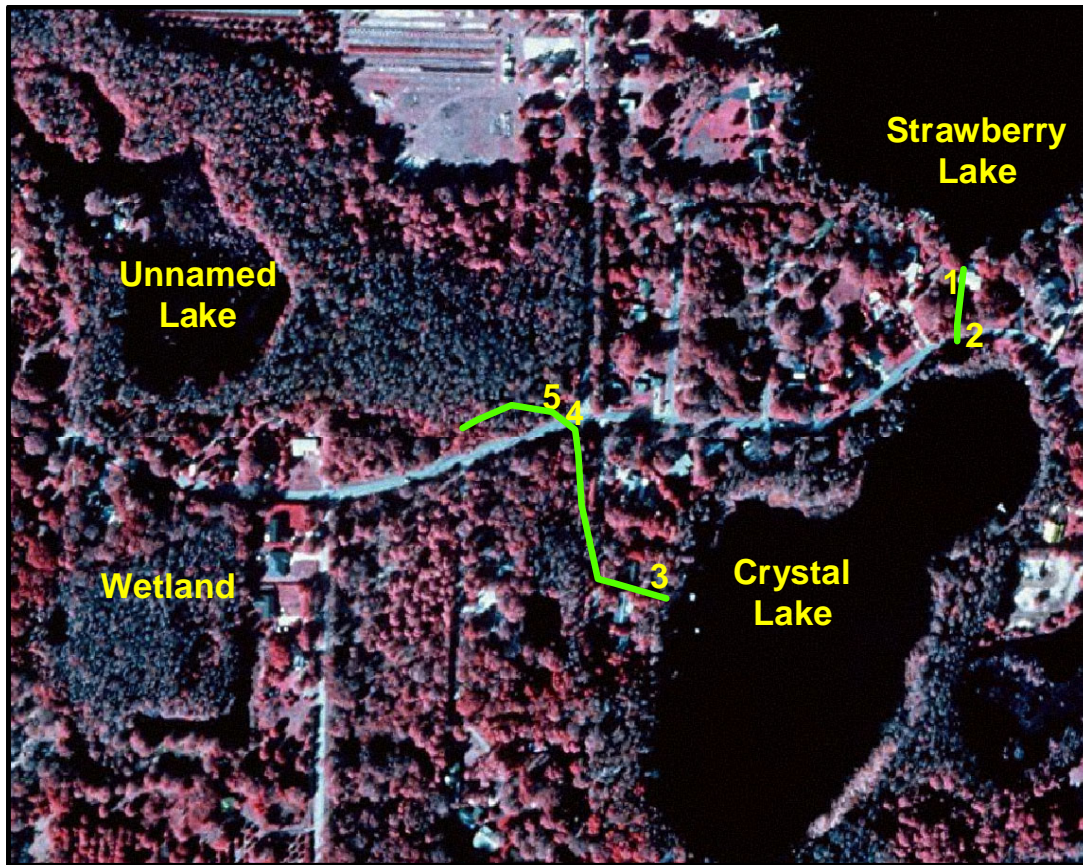
Figure 7. Outlet conveyance system for Strawberry (North Crystal) Lake in Hillsborough County, Florida. Ditched flow paths are indicated by the green line.

Map prepared September 3, 2003 using 1999 USGS digital orthophotography.

An outlet along the south shore of the lake drains Strawberry Lake under Crystal Lake Road to Crystal Lake. A dredged canal along the west shore of Crystal Lake drains the lakes to the north, back under Crystal Lake Road to a wetland adjacent to an unnamed lake. This lake/wetland system drains to the south, under Crystal Lake Road to a series of wetlands that discharge into Reinheimer Lake. There are no surface water withdrawals from Strawberry Lake currently permitted by the District. There are, however, several permitted groundwater withdrawals in the area, including major withdrawals associated with Tampa Bay Water's operation of the Section 21 Wellfield.

Site	Description	Elevation (feet above NGVD)
1	Ground elevation in center of ditch, approximately 85-ft north of Crystal Lake Road	59.2
2	North and south inverts of 38-inch X 60-inch oval reinforced concrete pipe running under Crystal Lake Road	57.61, 57.64
3	East and west inverts of 8-inch diameter PVC pipe imbedded in concrete wier. Top of wier is at 60.1 ft above NGVD; soil is eroded around wier.	58.96, 59.50
4	Southeast and northwest inverts of 38-inch X 60-inch oval reinforced concrete pipe running under Crystal Lake Road. Ground elevations in ditches south and north of the pipe are 58.6 and 58.4 ft above NGVD, respectively.	58.20, 58.22
5	Control point; ground elevation in center of ditch northwest of pipe identified as Site No. 4. Ditch drains through a wetland to an unnamed lake that drains under Crystal Lake Road to Reinheimer Lake through a series of wetlands.	59.3

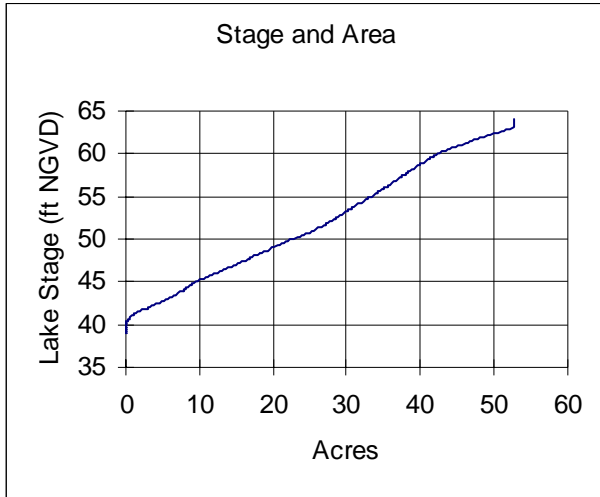
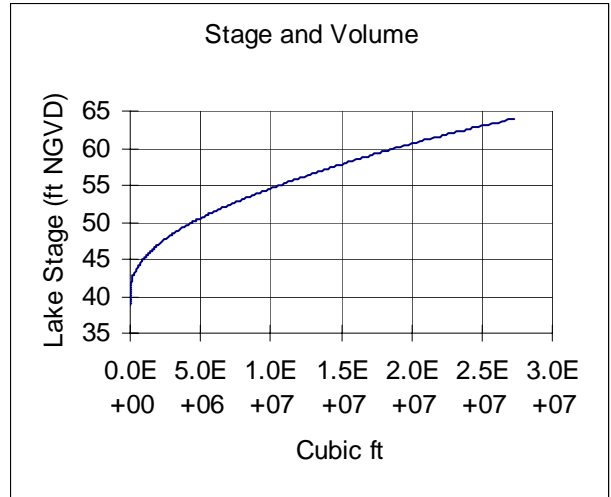
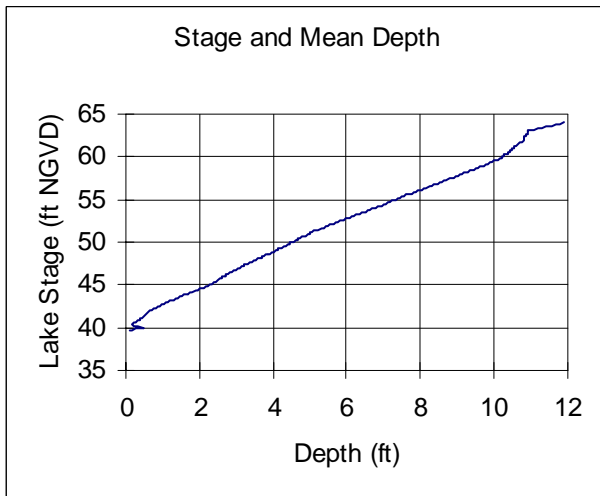
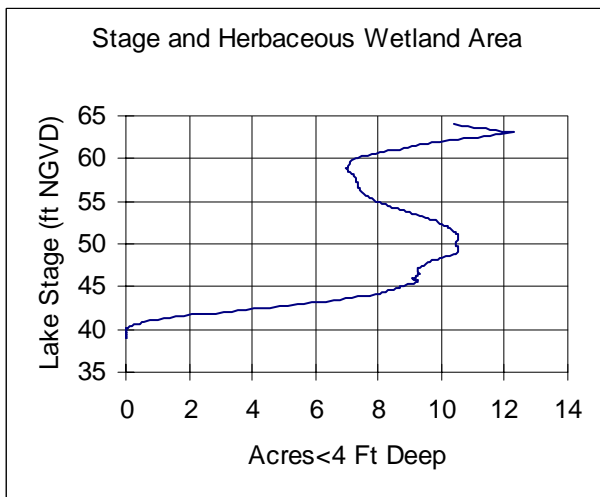
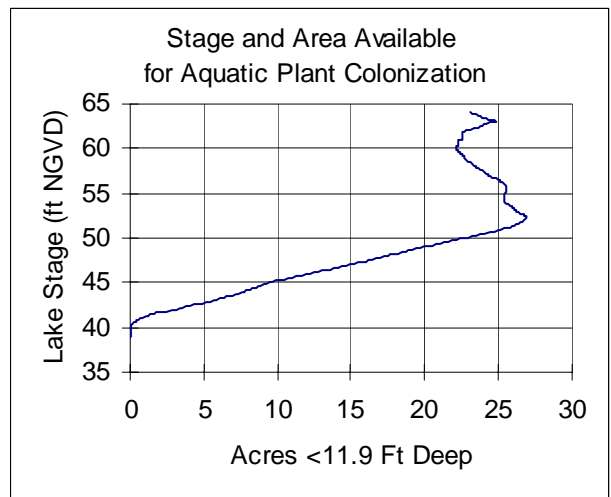
Figure 8. Surface area, volume, mean depth, dynamic ratio (basin slope), potential herbaceous wetland area, and area available for colonization by aquatic macrophytes versus lake stage for Strawberry (North Crystal) Lake in Hillsborough County, Florida.

Dock-Use, Basin Connectivity, Aesthetics, and Species Richness Standards were evaluated for minimum levels development (Table 3). The Dock-Use Standard was established at 59.3 ft above NGVD, based on the elevation of sediments at the end of 90% of the 10 docks at the lake (56.2 ft above NGVD, Table 5), a clearance value of 2 ft based on use of powerboats in the lake, and the difference between the Reference Lake Water Regime 5090 for the northern Tampa Bay area (1.1 ft). The Connectivity Standard was established at 58.1 ft above NGVD, based on the elevation that ensures connectivity among the two major sub-basins of the lake (55 ft), a two-foot clearance value for use of powerboats on the lake, and the Reference Lake Water Regime 5090 for the northern Tampa Bay area (1.1 ft). The Aesthetic-Standard for the lake was established at the Low Guidance Level elevation of 58.0 ft above NGVD. The Species Richness Standard was established at 55.6 ft above NGVD, based on limiting reduction in lake surface area to less than a 15% decrease in the area at the Historic P50 elevation. Mixing and Recreation/Ski Standards were not developed, based on the small size and morphology of the lake basin. Review of changes in potential herbaceous wetland area associated with change in lake stage, and potential change in area available for aquatic macrophyte colonization did not indicate that use of any of the identified standards would be inappropriate for minimum levels development (Figure 8).
