# Technical Memorandum

**Subject: Recommendations for Pasco Lake Minimum Lake Levels**

Pasco Lake in north-central Pasco County currently has minimum lake levels approved by the Southwest Florida Water Management District (District or SWFWMD) in November 2006. This document summarizes information available for Pasco Lake and develops recommendations related to its minimum lake levels.

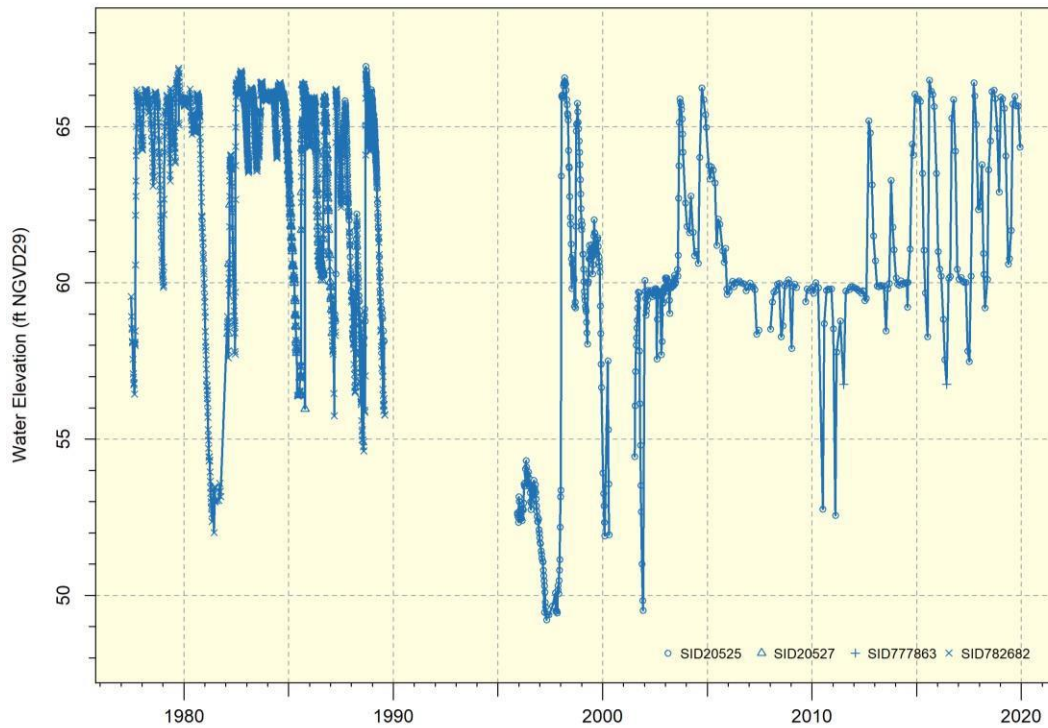
Figure 3. Pasco Lake water levels from June 1977 to December 2019 (dry readings between 1990 and 1995 not shown).

The District currently maintains water level gauging stations in the southern portion of Pasco Lake (Figure 2). The U.S. Geological Survey (USGS) historically maintained a series of water level gauges at sites near the lake outlet. The combined stage record for Pasco Lake spans 1977 to present, with dry readings from 1990 to 1995 (Figure 3).

In one of the earliest written analyses of Pasco Lake, Lee, Jones, and Nguyen (1981) hypothesized that based on “a general study of the geology and history of the Cross Bar Wellfield and Pasco Lake... [i]t was found that Pasco Lake differs from most lakes in the area in that it is not a natural or sinkhole lake but is the result of the dredging and damming of Jumping Gully. As such, Pasco Lake has a very sandy bottom with no near surface confining layer which subjects it to more rapid water loss than surrounding lakes during periods of dry weather.” The report also noted that based on “photographic evidence...the drying up of [Pasco Lake] is not a unique event [even before wellfield operations],” a finding corroborated by review of the limited water level and flow data available, respectively, for Pasco Lake and Jumping Gully prior to 1980 (Figure 3).
