**Re: Review of 4th Quarter Water Quality Sampling Results and
Summary of Four Quarters of Sampling,
March 2016 Sampling Event, Sawgrass Lake Site Restoration Project
Southwest Florida Water Management District
3200 Gandy Boulevard, St. Petersburg, FL 33702
FDEP Facility ID # COM_301769**

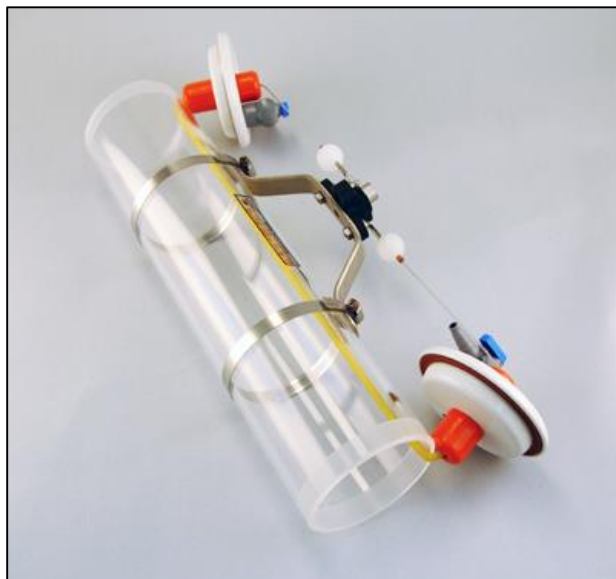
Typical Kemmerer water sampling device.

Four sampling locations were selected based on compliance with the RAP and water depths within the lake. The first sample location was in the upland cut canal to the south and the remaining three samples were taken from the southwest area of the lake. The samples were named using a naming convention that consisted of Sawgrass Lake (SL) and the surface water location identification number (for example, SW-1) and the depth (in feet) at which the sample was collected (for example, -2). The process consisted of collecting four water samples at the canal sampling location and four samples at the other three locations within the lake. Samples were collected based on water depth, including a surface, one-foot, mid-depth and bottom sample. Samples were collected using a Kemmerer water sampler (see photo below). The device is lowered into the water column to the desired depth, then a weight is dropped down the main line activating two latches which close the outside doors and seal the sample inside the tube without being contaminated by other water.
