Crystal River/Kings Bay Shoreline Mapping

Madison Trowbridge, Ph.D. Springs Scientist Surface Water Improvement & Management Section

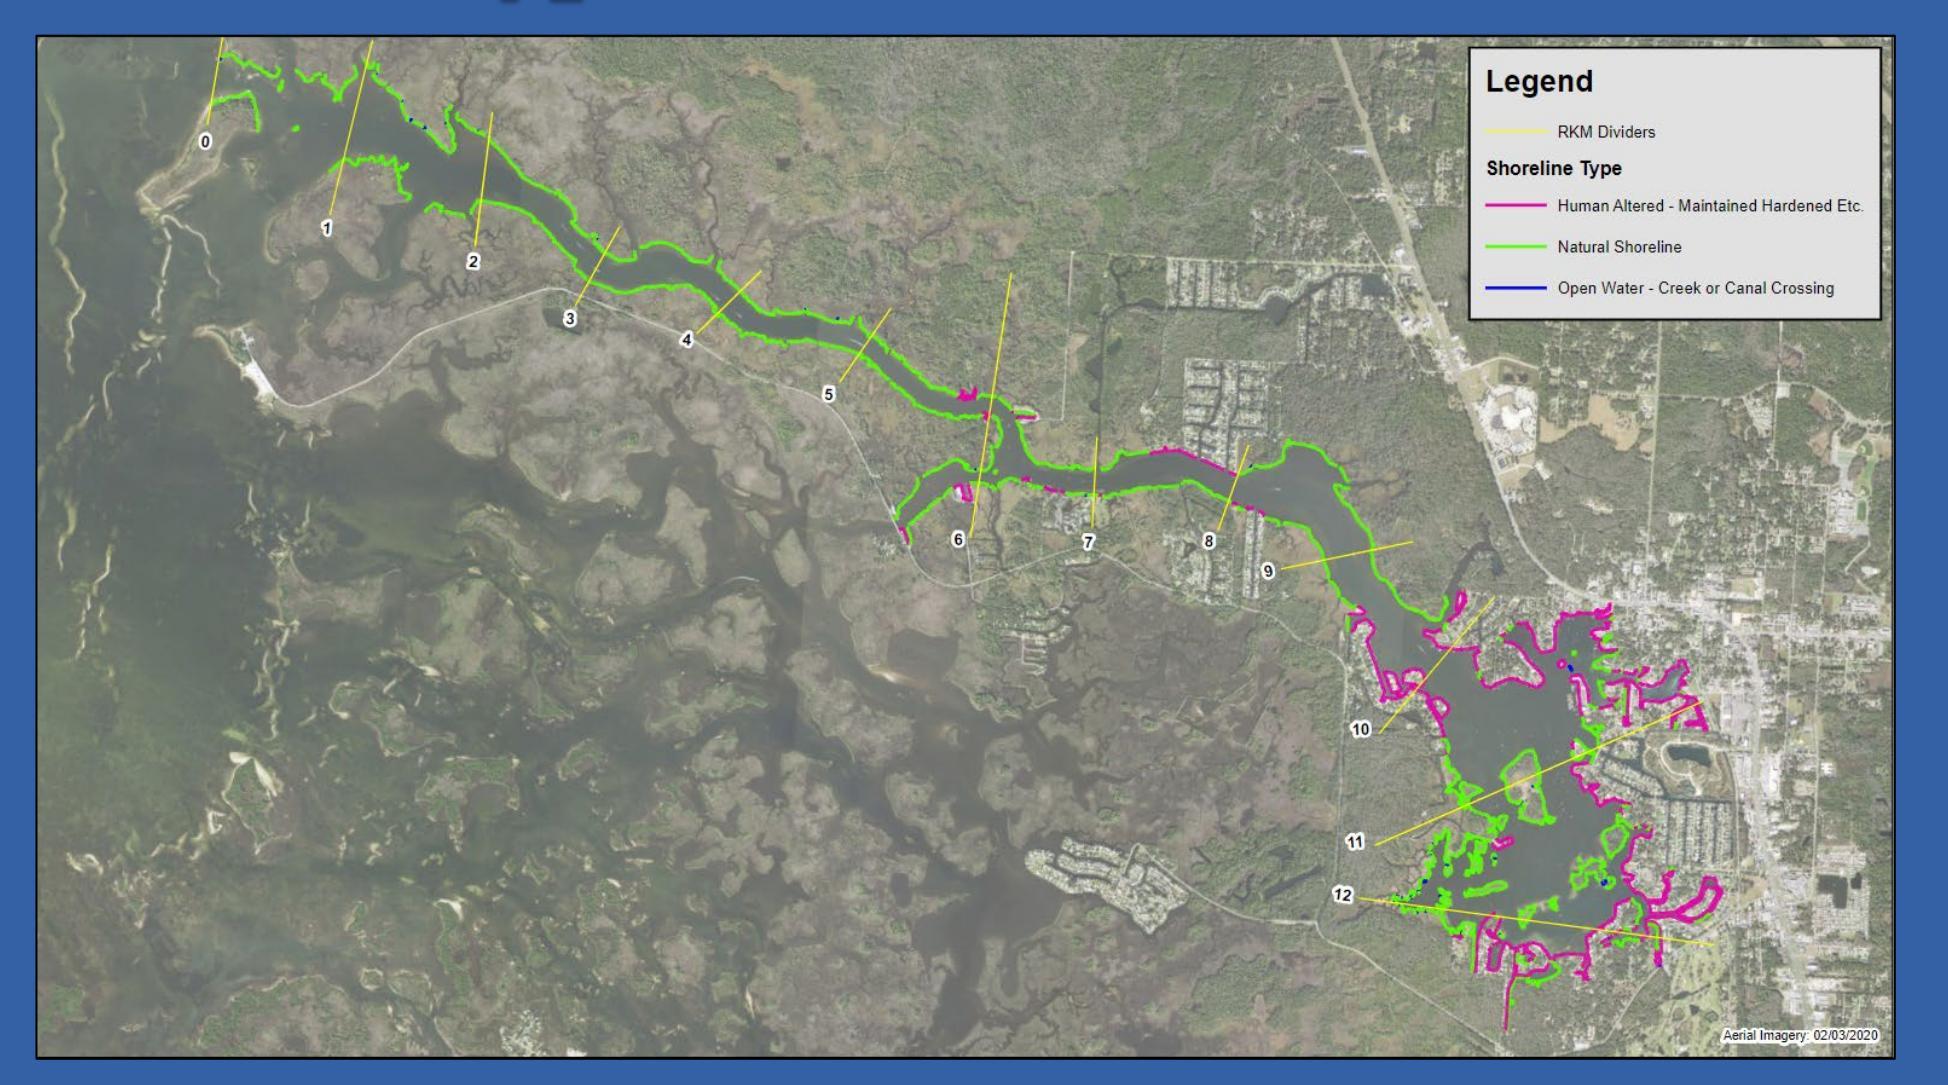
Shoreline Types - 2021

- Shoreline types (2021)
 - Crystal River: 81% is natural
 - Kings Bay: 48% is seawall
- Increase in human altered shoreline
- Climate change present in Crystal River/Kings Bay
 - Red mangroves & black needle rush
- Manatee grazing impacts shoreline
