LEAK DETECTION PROGRAM

SUMMARY REPORT

July 8, 2009

**Prepared for:
Southwest Florida Water Management District
2379 Broad Street
Brooksville, Florida 34604-6899**

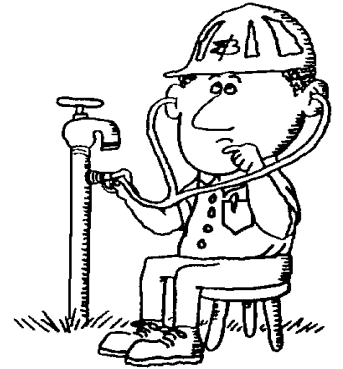
Since current leak detection techniques rely on vibrations that travel from molecule to molecule along the wall of the pipe, the most important factor affecting leak detection is the pipe material itself. The more dense the wall of the pipe, the greater the distance leak sounds will travel. Density is a function of molecular proximity. Cast iron, ductile iron, galvanized steel, and copper pipes are all extremely dense and exhibit excellent transmission qualities. Asbestos-concrete pipe (AC), or transite as it is often called, is not as dense and dampens vibrations much quicker than metallic pipes. Due to their lack of density, PVC and poly-pipe absorb, or attenuate, vibrations rather quickly. As a result, leaks sounds do not travel great distances on these plastics.
