**MEMORANDUM**

**SUBJECT: Proposed minimum and guidance levels for Hancock Lake in  
Pasco and Hernando Counties, Florida**

## **Hancock Lake**

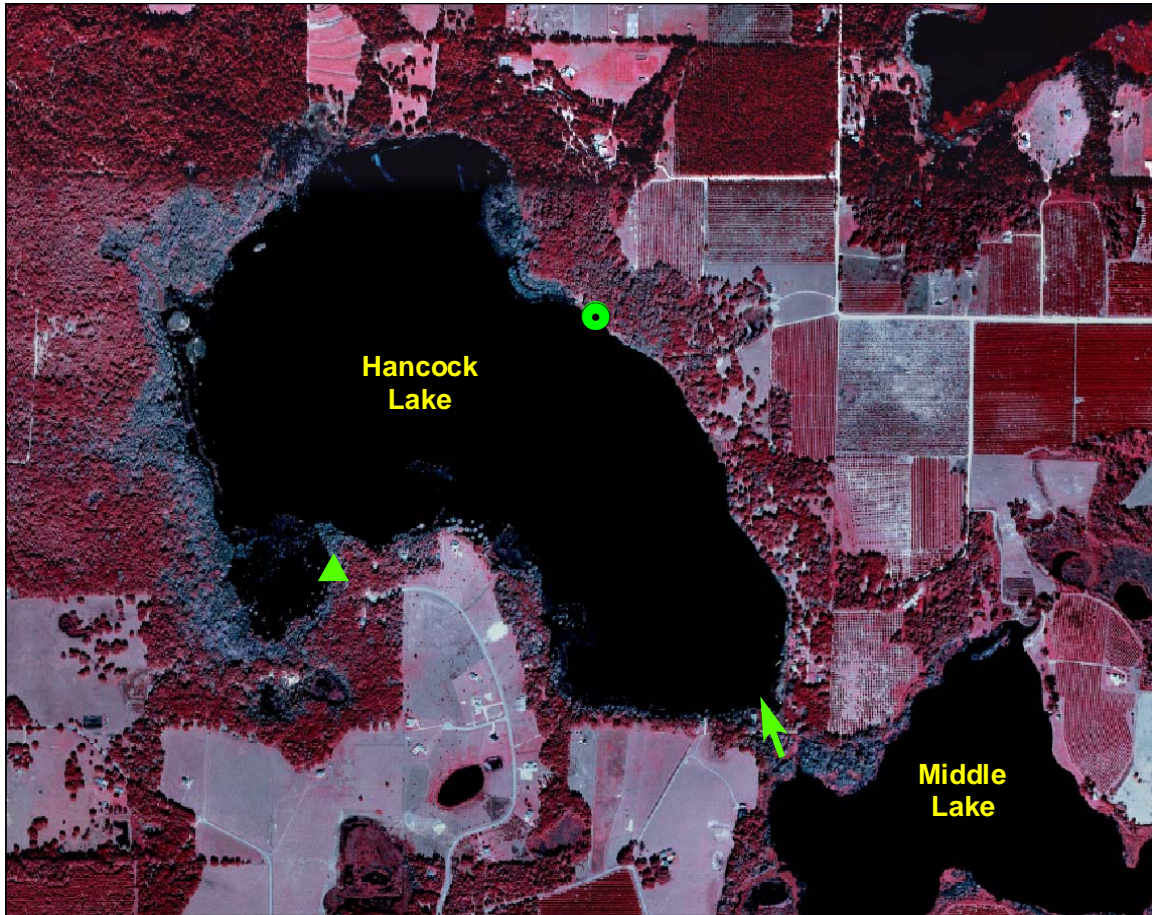
**Figure 2. Location of District lake-level gauge, inlet and area of active sinkhole activity at Hancock Lake in Pasco and Hernando Counties, Florida.**

Lake gauge

Inlet

Sinkholes

The lake basin has been highly modified, with upland areas primarily used for livestock grazing, citrus production and residential development (Figure 2). Despite these modifications, natural vegetation remains intact along much of the lake shoreline. Public access to the Hancock Lake is not available.

Hancock Lake is located in the Crews Lake Outlet drainage basin, and has a drainage area of 3.3 square miles (SWFWMD 1996). An inlet along the southeastern lakeshore conveys water from Middle Lake to Hancock Lake when Middle Lake is staged above 99.5 ft above the National Geodetic Vertical Datum of 1929 (NGVD). Hancock Lake does not have a surface water outlet, but may drain to underlying aquifers through active sinkholes located along the southwestern lakeshore. To curtail this internal drainage, a dyke was constructed across a portion of the lake basin in the 1970s. Based on observations by District staff, the dyke does not completely limit drainage to

Hydrologic data are available for Hancock Lake (District Universal ID Number STA 121 121) from May 1978, from April 1980 through August 1982, and from January 1983 to the present date (Figure 5; see Figure 2 for current location of the SWFWMD lake-level gauge). Monthly mean water surface elevations, along with proposed guidance and minimum levels are shown in Figure 6. For the entire period of record, the hydrologic data are classified as Historic data. Historic data collected through January 2003 were used to calculate the Historic P10, P50, and P90 (Table 3).

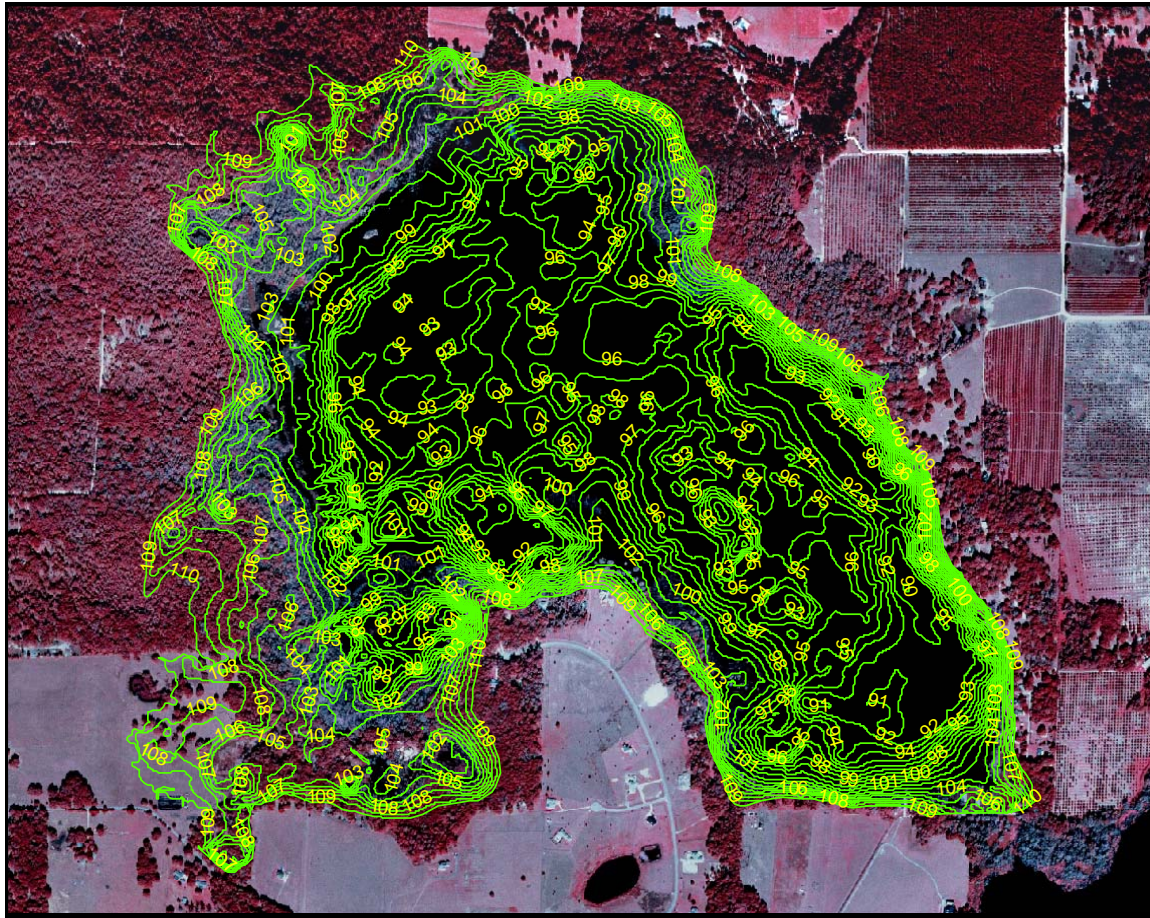
**Figure 3. One-foot contours within the Hancock Lake basin in Pasco and Hernando Counties, Florida. Values shown are elevations, in feet above the National Geodetic Vertical Datum of 1929.**

Map prepared July 17, 2003 using 1999 USGS digital orthophotography, elevation data from 1987 SWFWMD aerial photography with contours maps (Sheet Nos 05-24-20, 06-24-20, 31-23-20 and 32-23-20), and elevation data collected on March 13 and 18, 2003 by SWFWMD Staff.

The 1954 (photorevised 1988) United States Geological Survey 1:24,000 Spring Lake, Fla. quadrangle map shows a surface elevation of 106 ft above NGVD for Lake Hancock. The "Gazetteer of Florida Lakes" (Florida Board of Conservation 1969, Shafer *et al.* 1986) lists the lake area as 519 acres at a surface elevation of 106 ft above NGVD. Based on a topographic map of the basin generated in support of minimum levels development (Figure 3), the lake covers an area of 601 acres when the surface level is at 106 ft above NGVD. Data used for production of the topographic map were obtained from field surveys conducted in March 2003 and 1:200 aerial photography maps containing one-foot contour lines prepared using photogrammetric methods.

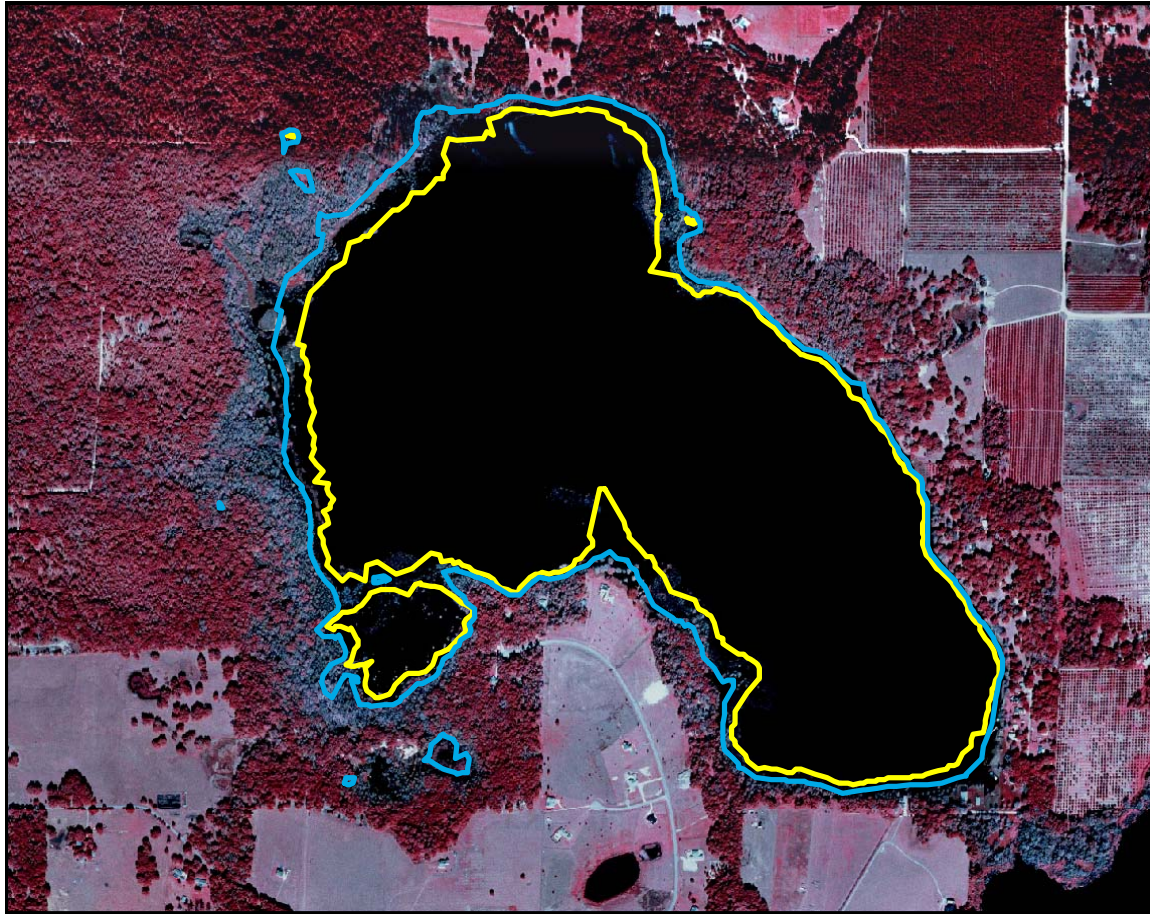
**Figure 4. Approximate location of the proposed Minimum Lake Level (yellow) and proposed High Minimum Lake Level (blue) for Hancock Lake in Pasco and Hernando Counties, Florida. Contour elevations are expressed as feet above the National Geodetic Vertical Datum of 1929.**

Map prepared September 30, 2003 using 1999 USGS digital orthophotography, elevation data from 1987 SWFWMD aerial photography with contours maps (Sheet Nos 05-24-20, 06-24-20, 31-23-20 and 32-23-20), and elevation data collected on March 13 and 18, 2003 by SWFWMD Staff.

- 100.2 ft above NGVD
- 102.5 ft above NGVD

Proposed Minimum and Guidance Levels were developed for Hancock Lake using the methodology for Category 3 Lakes described in Leeper *et al.* (2001), in accordance with modifications outlined by Dierberg and Wagner (2001). Proposed levels, along with lake surface area values for each level are listed in Table 2. Contour lines corresponding the proposed minimum level elevations are shown within the basin in Figure 4.

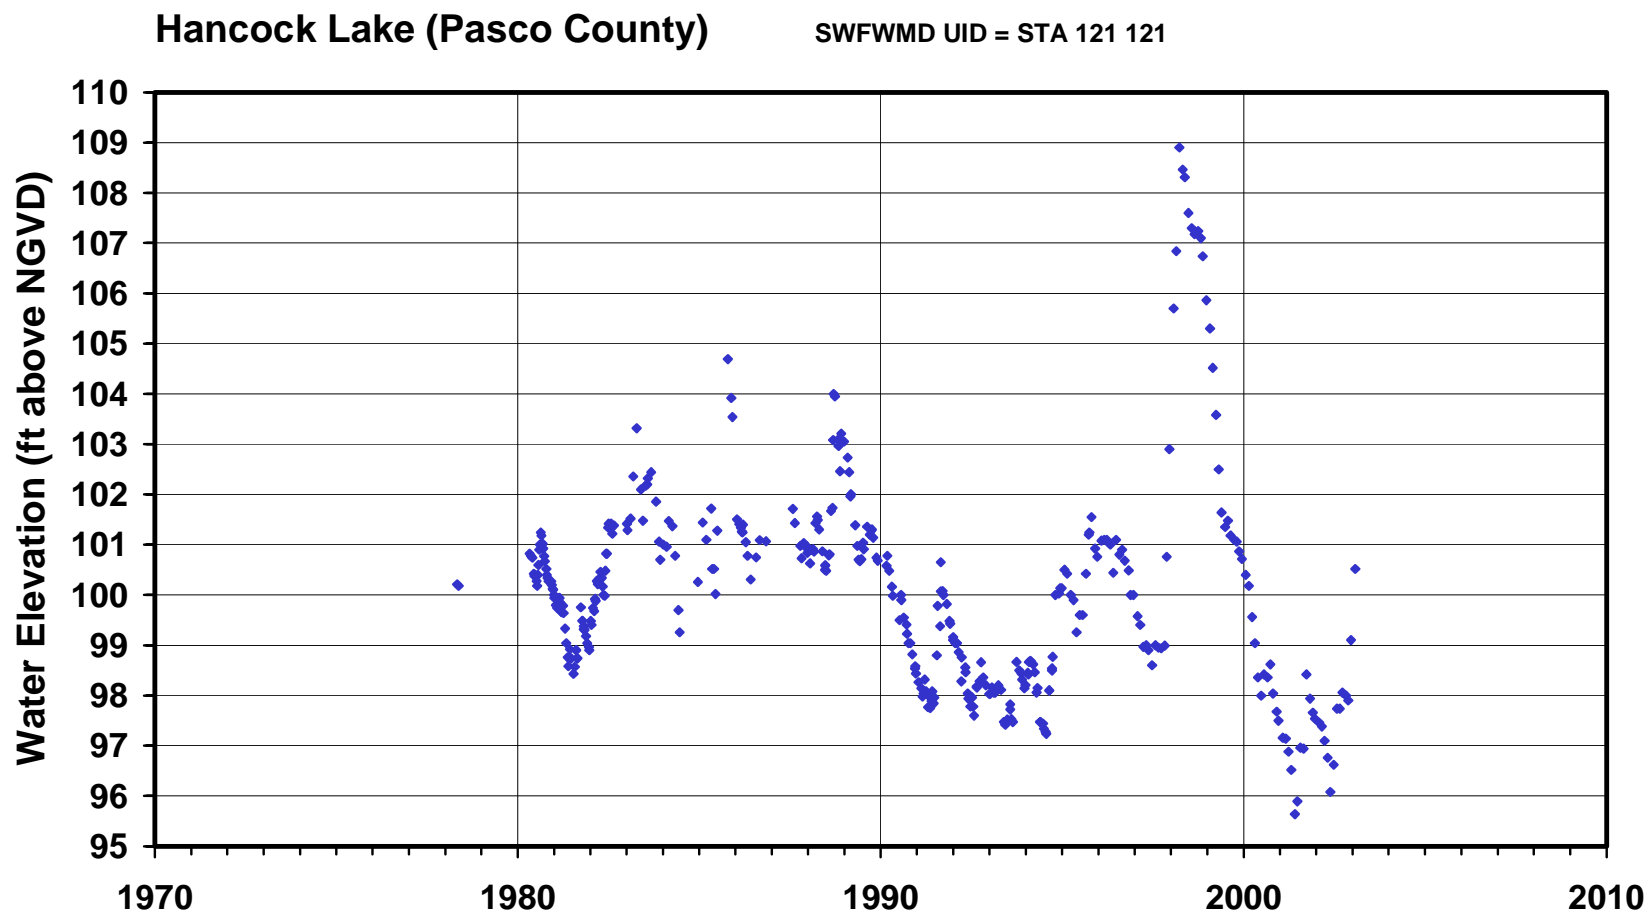
Figure 5. Surface water elevation at Hancock Lake in Pasco and Hernando Counties, Florida. Data through January 2003 are shown.

Based on available stage data, the Ten Year Flood Guidance Level was last exceeded during the late 1990s (see Figure 5). The highest surface elevation for Hancock Lake included in the District Water Management Database, 108.9 ft above NGVD, occurred on March 26, 1998. The low of record, 95.64 ft above NGVD, occurred on March 31, 2001.

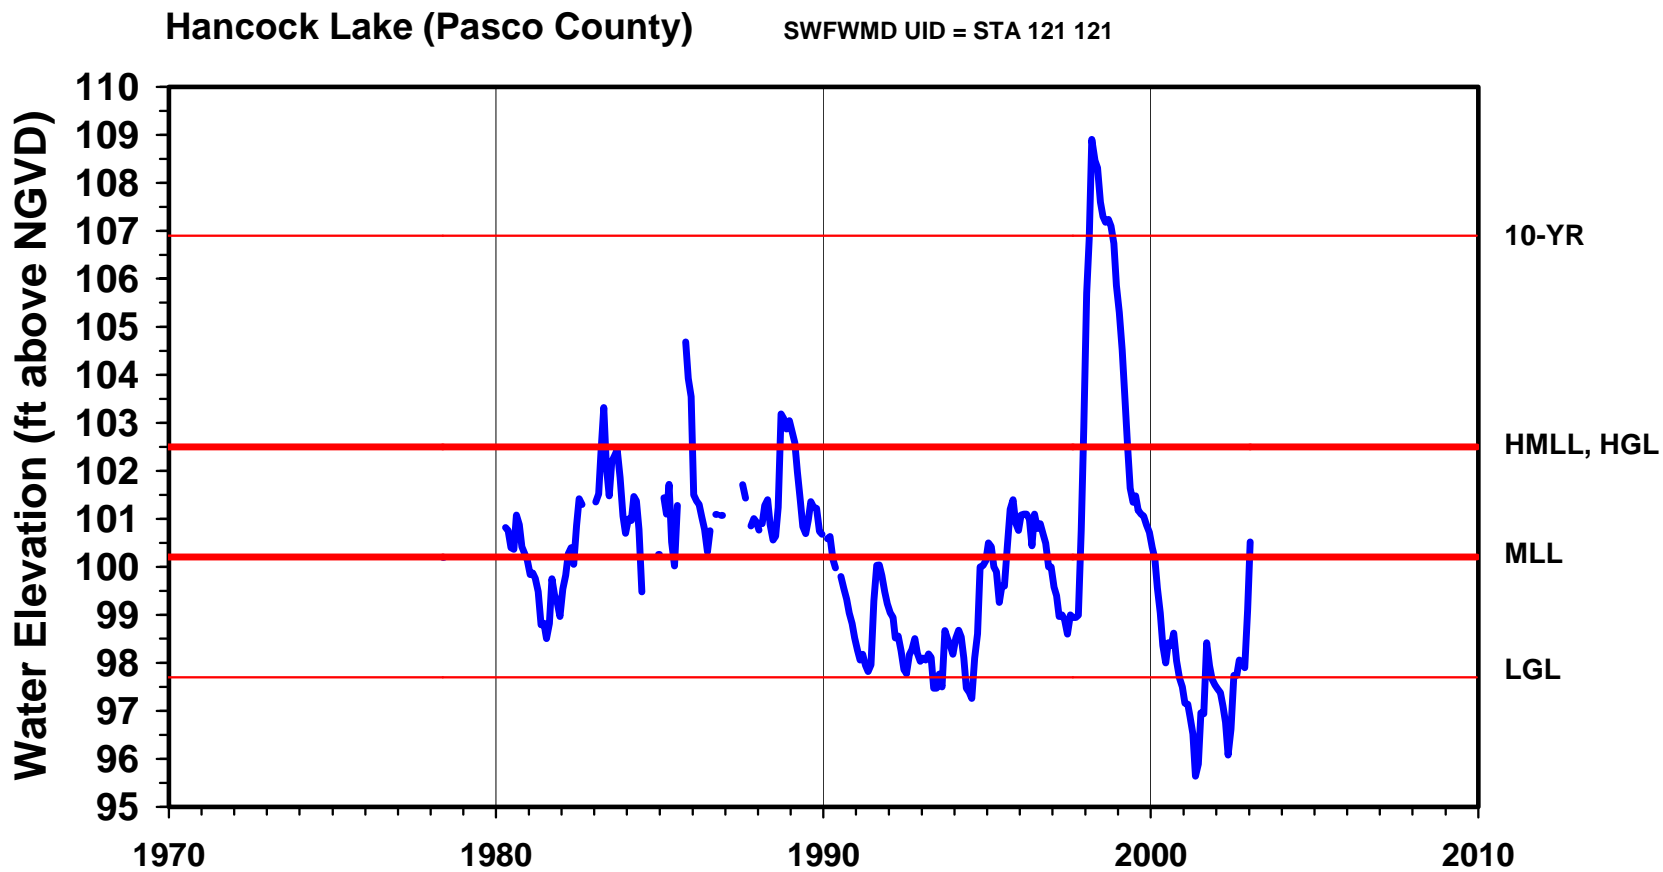
Figure 6. Mean monthly surface water elevation through January 2003, and proposed guidance and minimum levels for Hancock Lake in Pasco and Hernando Counties, Florida. Proposed levels include the Ten Year Flood Guidance Level (10-YR), High Guidance Level (HGL), Low Guidance Level (LGL), High Minimum Lake Level (HMLL), and Minimum Lake Level (MLL).

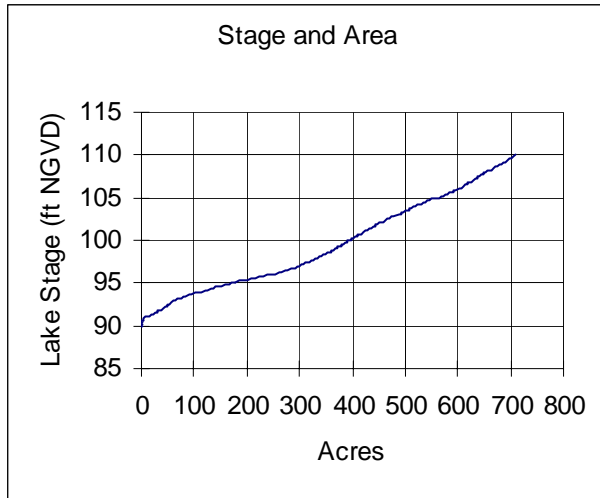
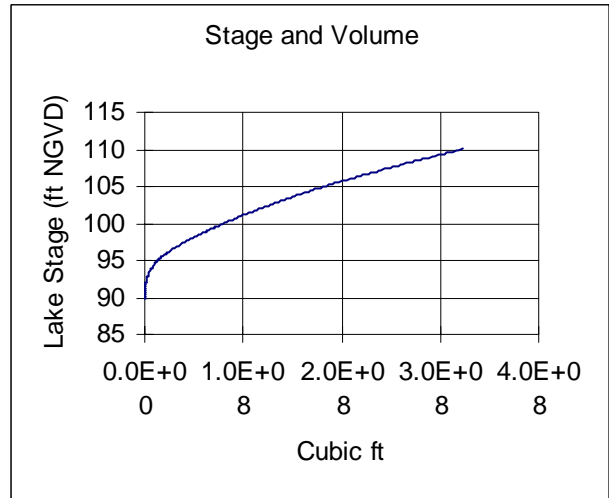
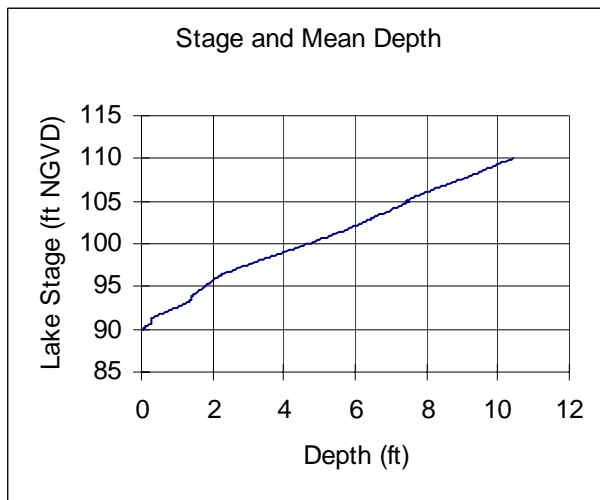
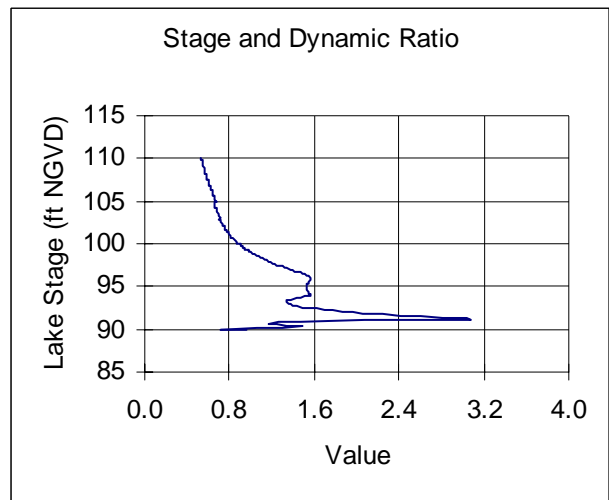
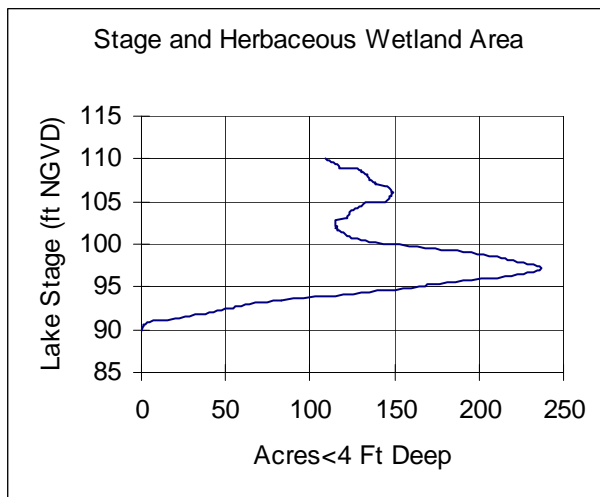
**Figure 7. Surface area, volume, mean depth, dynamic ratio, and potential herbaceous wetland area versus lake stage for Hancock Lake in Pasco and Hernando Counties, Florida.**

Dock-Use, Basin Connectivity, Recreation/Ski, Species Richness, Aesthetics and Mixing Standards were evaluated for minimum levels development (Table 3). The Dock-Use Standard was established at 102.3 ft above NGVD, based on the elevation of sediments at the end of ninety percent of the 10 docks at the lake (97.9 ft above NGVD, Table 4), a clearance value of 2 ft based on use of powerboats in the lake, and the difference between the Historic P50 and Historic P90 elevations (2.4 ft). The Basin Connectivity Standard was established at 100.9 ft above NGVD, based on the elevation that ensures connectivity among the major lake sub-basins (96.5 ft above NGVD), a clearance value of 2 ft for use of power boats on the lake and the difference between the Historic P50 and Historic P90 elevations (2.4 ft). The Basin Connectivity Standard was developed to ensure connectivity among the major lake sub-basins, but not between the major lake sub-basins and the southwestern sub-basin, which is the site of active sinkhole activity. The Recreation/Ski Standard was established at 100.4 ft above NGVD, based on the elevation at which the lake could contain a safe skiing area with a depth of five-feet (98 ft above NGVD) and the difference between the Historic P50 and Historic P90 (2.4 ft). The Species Richness Standard was established at 98.2 ft above NGVD, based on limiting change in lake surface area to less than a 15% reduction from the area at the Historic P50 elevation. The Aesthetic-Standard for the lake was established at the Low Guidance Level elevation of 97.7 ft above NGVD. Based on review of dynamic ratio values for lake stages up to the Historic P50 elevation (see Figure 7), a Mixing Standard was not established for the lake. Review of changes in potential herbaceous wetland area associated with change in lake stage, and potential change in area available for aquatic macrophyte colonization did not indicate that use of any of the identified standards would be inappropriate for minimum levels development (Figure 7).
