An Evaluation of the need for future Ewanowski Spring Pool Stage Data (SWFWMD 2022)

Technical Memorandum

April 25, 2022

Subject: An Evaluation of the need for future Ewanowski Spring Pool Stage Data

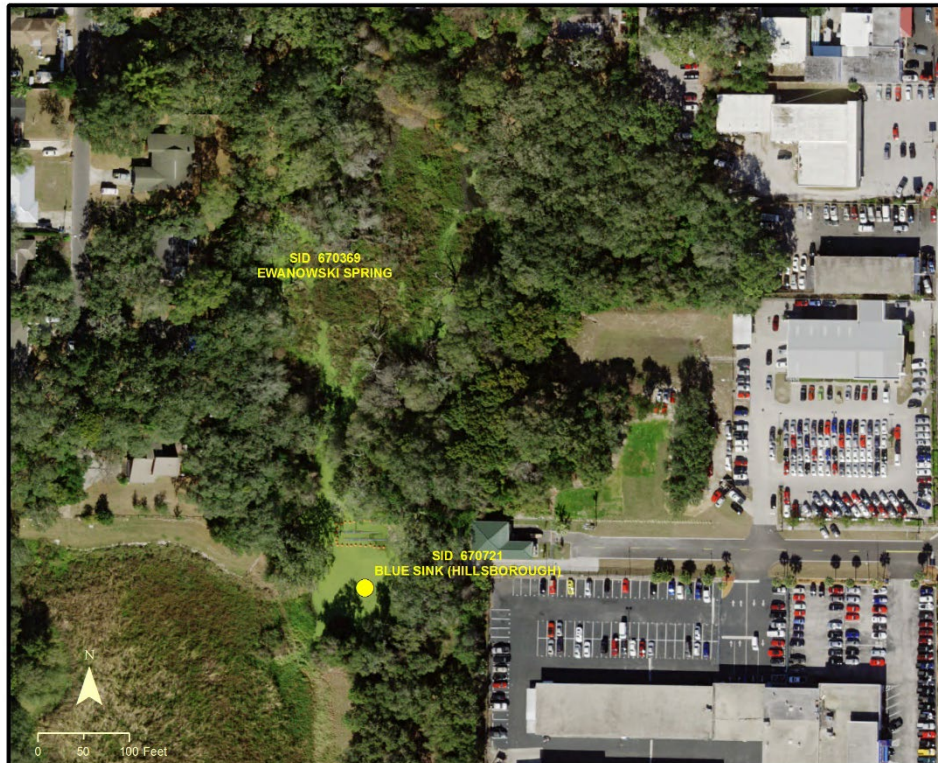
Figure 1. Location of Ewanowski Spring and Blue Sink.

In April 2022, the District was notified by the current owner of Ewanowski Spring that staff would no longer be granted access to spring pool stage measurements. Ewanowski spring is located in the backyard of a housing residence within the City of Tampa, and it's named for the current owner, Mrs. Ewanowski. The spring is located about 200 yards north-northwest of Blue Sink, one of several sinks located within the Sulphur Springs complex (Figure 1).

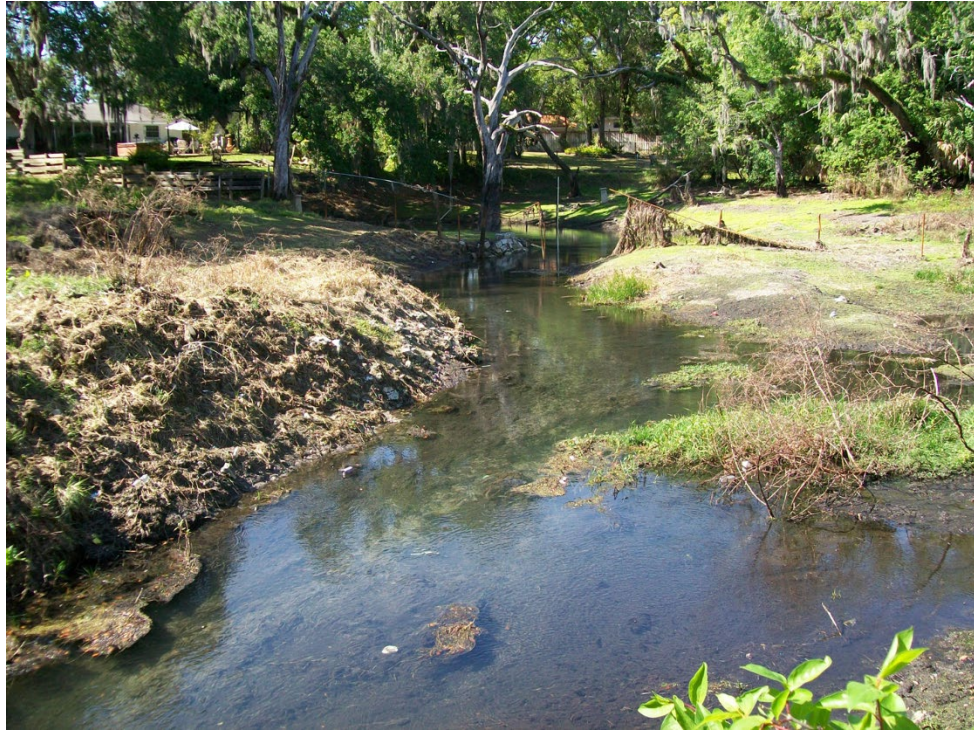
Figure 3. Location of stream channel exiting Ewanowski Spring pool.

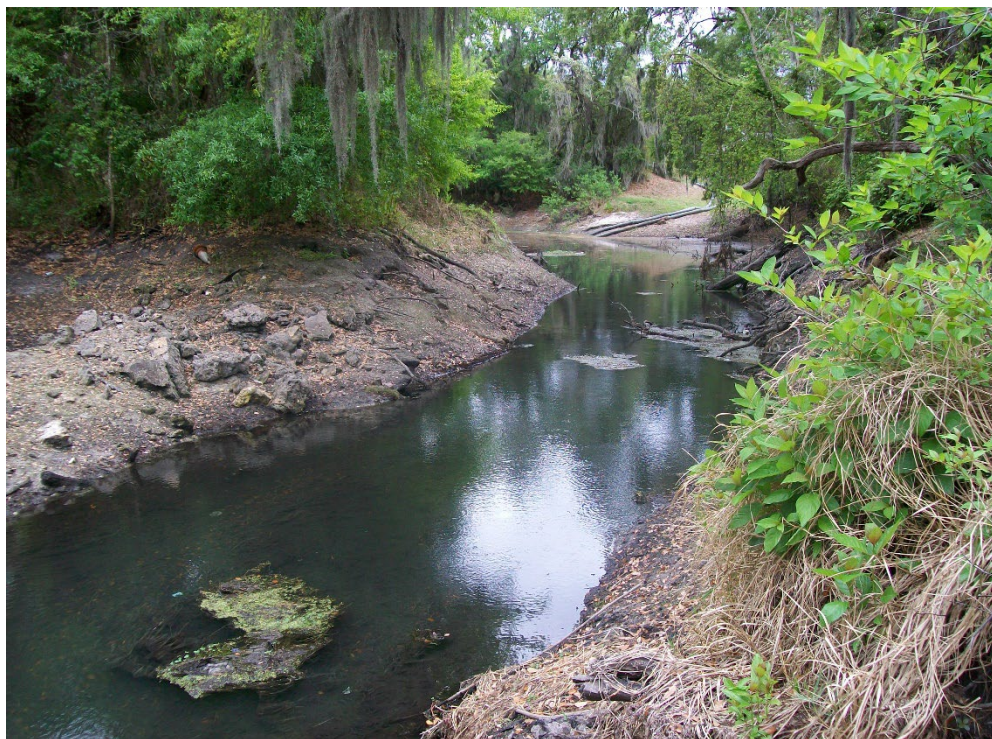
Figure 4. Location of stream channel entering Blue Sink from Ewanowski Spring.

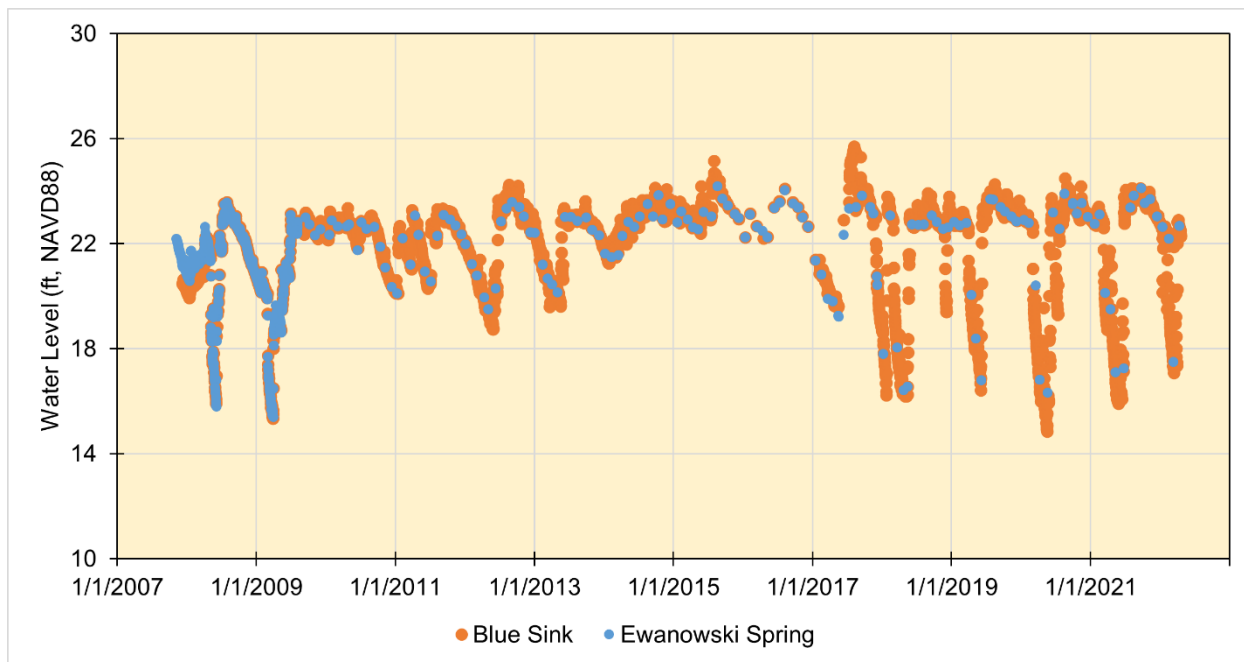
Figure 3. Stage history at Blue Sink and nearby Ewanowski Spring Pool.

Stage monitoring was initiated by the District for both Blue Sink and Ewanowski Spring in late 2007 prior to the first SWFWMD 30-day pumping test. Continuous measurements have occurred at both sites since that time. The third five-year assessment for the Lower Hillsborough Recovery Strategy is due in 2023. There should be ample data to evaluate the Blue Sink pumping and lower Hillsborough River augmentation project based on these two stage histories. In addition to these two sites, there are numerous lakes and monitor wells in the vicinity of Blue Sink and Ewanowski Spring that include five (5) lakes and eight (8) UFA monitor wells where continuous water level data has been recorded since mid-to-late 2007 (https://www.swfwmd.state.fl.us/sites/default/files/documents-and-reports/reports/Final_Blue_Sink_2_Report.pdf).

As of April 2022, District staff are no longer granted access to Ewanowski Spring pool to collect stage observations. The previous 30-day pumping tests conducted by the District showed almost a one-to-one relation between changes in Blue Sink stage and Ewanowski Pool Stage since they are hydraulically connected by a short conveyance ditch. To confirm this understanding, water levels were plotted for both Ewanowski Spring and Blue Sink for their period of record since late 2007 (Figure 5). Upon inspection, both systems are fluctuating almost identically. A linear regression of Ewanowski Spring pool stage versus Blue Sink stage indicates very high correlation with an R^2 value of 0.98 (Figure 6). Therefore, Blue Sink observations should serve as a surrogate stage for Ewanowski Spring Pool in the future. Flow measurements conducted by the USGS in the Ewanowski Spring outlet will also continue to monitor the flow from the Spring to Blue Sink into the foreseeable future.

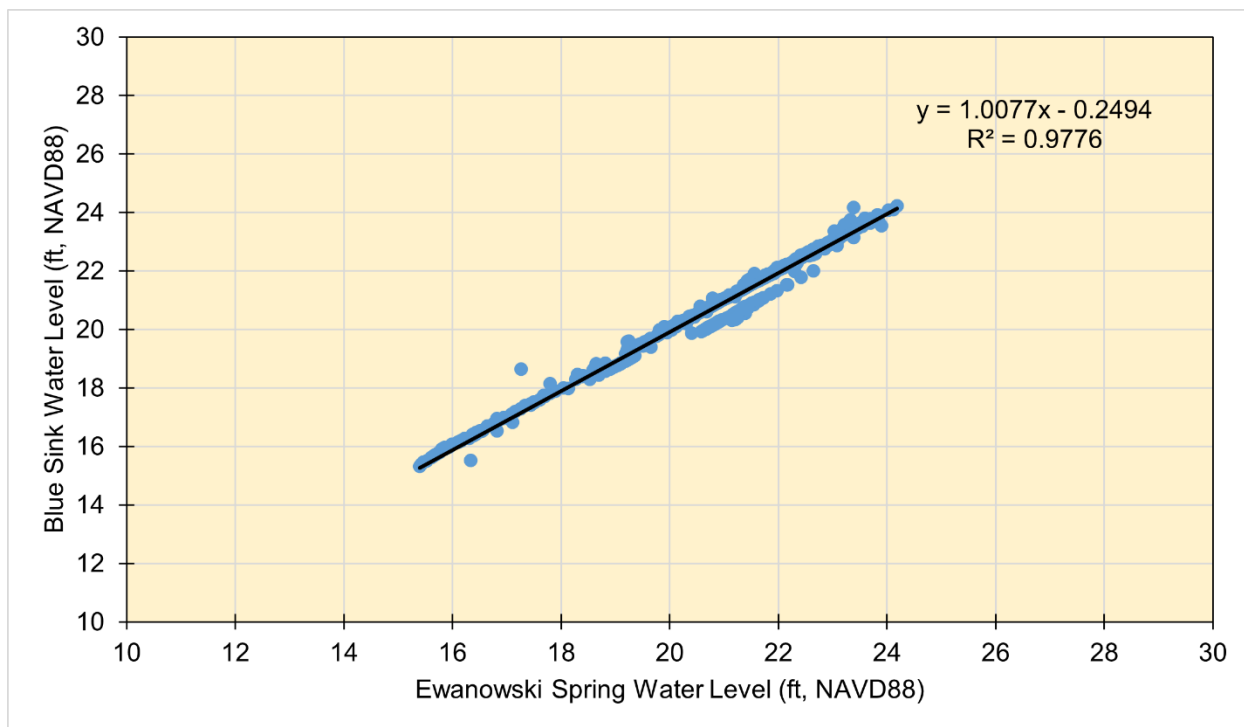
Figure 4. Linear regression of Blue Sink stage with Ewanowski Spring Pool Stage.
