**Results of Morris Bridge Sink Pumping  
Test (SWFWMD 2010)**

**Results of Morris Bridge Sink Pumping Test  
Hillsborough County, Florida**

**Final Report**

**Hydrologic Evaluation Section  
Southwest Florida Water Management District**

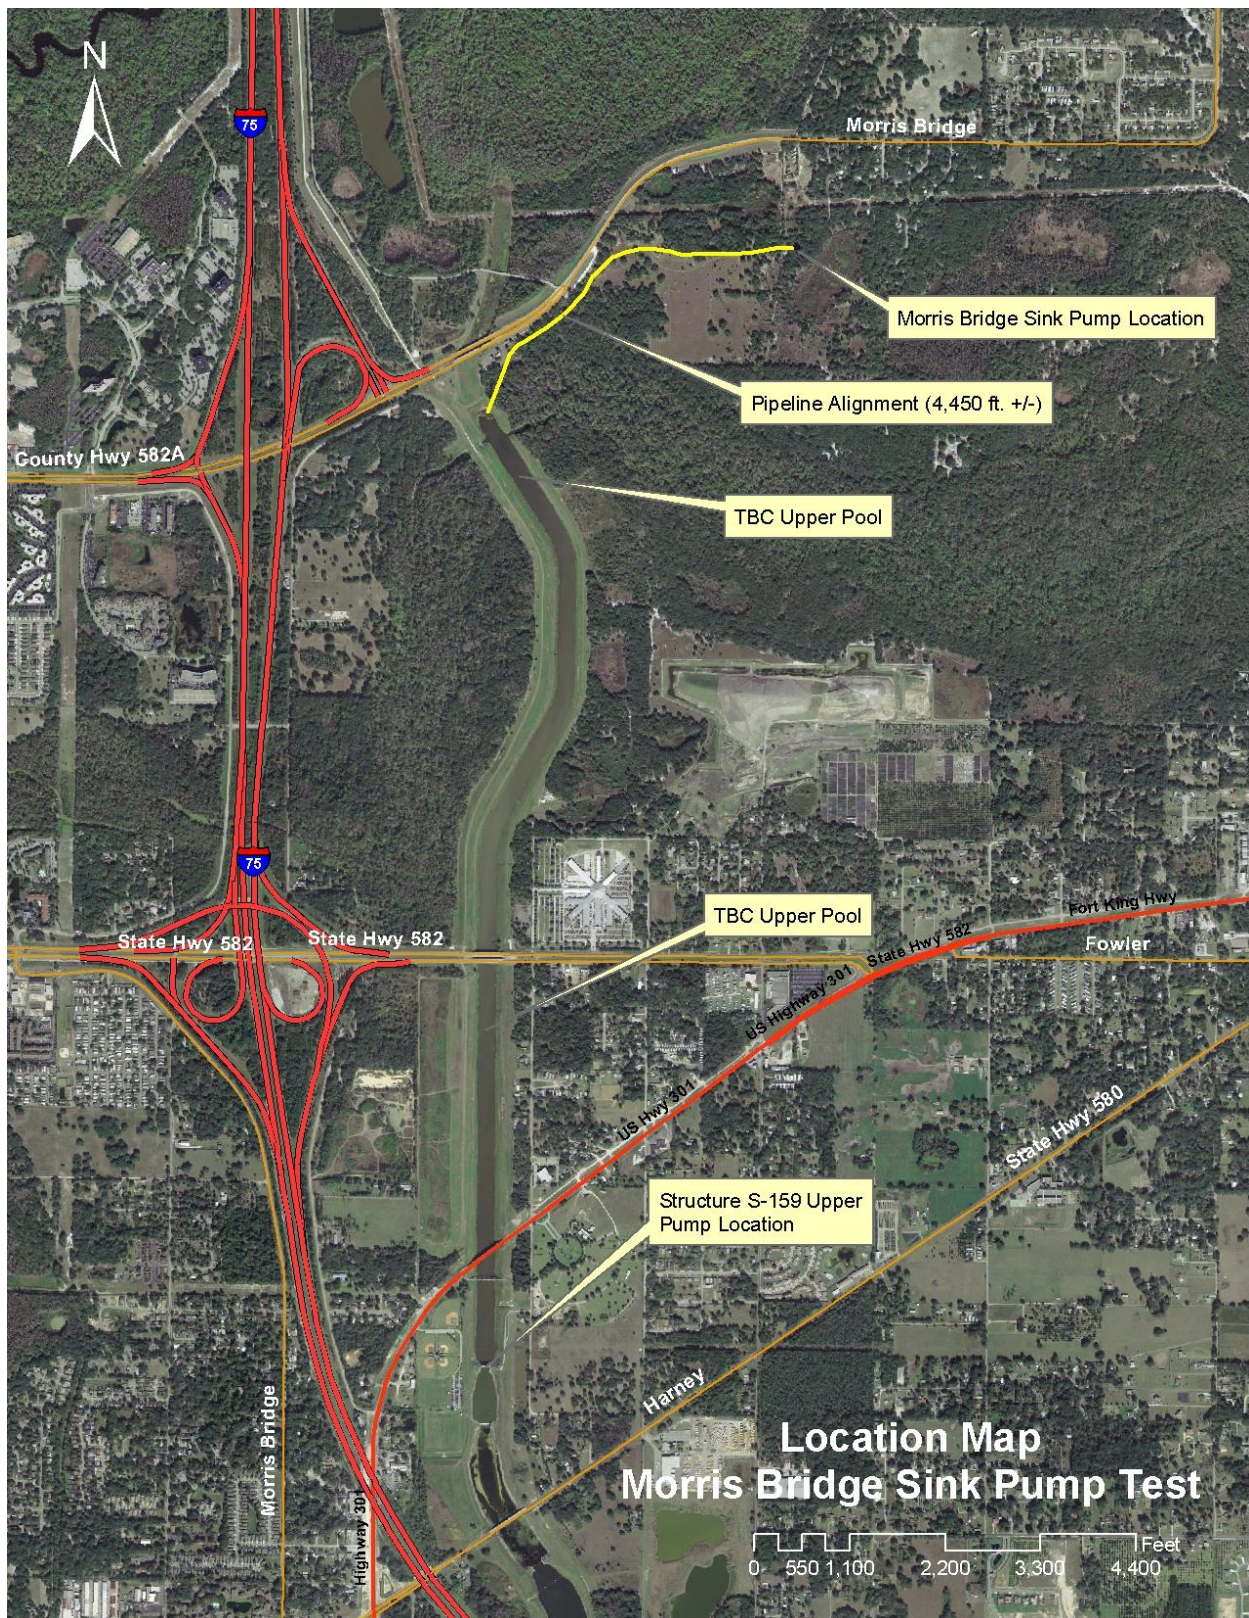
Figure 2. Location of the pipeline used to discharge water from Morris Bridge Sink to the TBC Upper Pool.

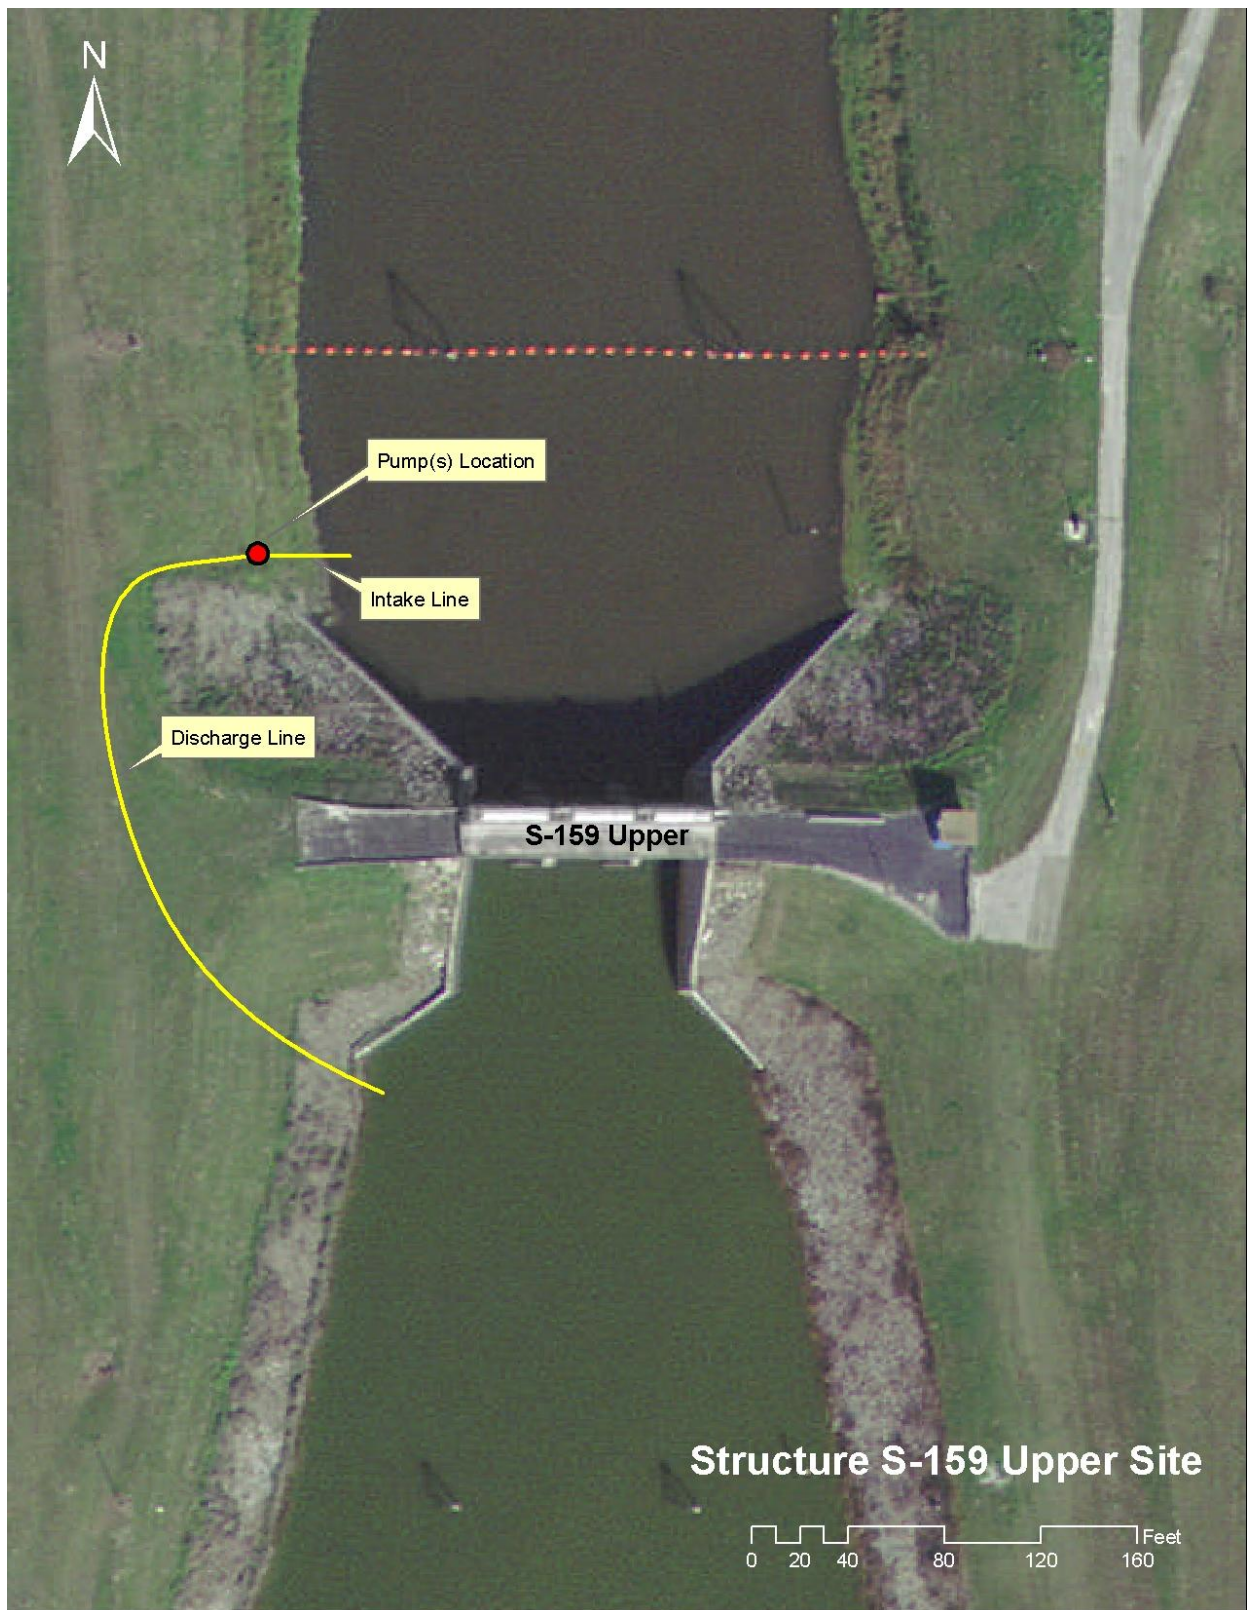
Figure 3. Location of pipeline to move water between the TBC Upper Pool to Middle Pool.

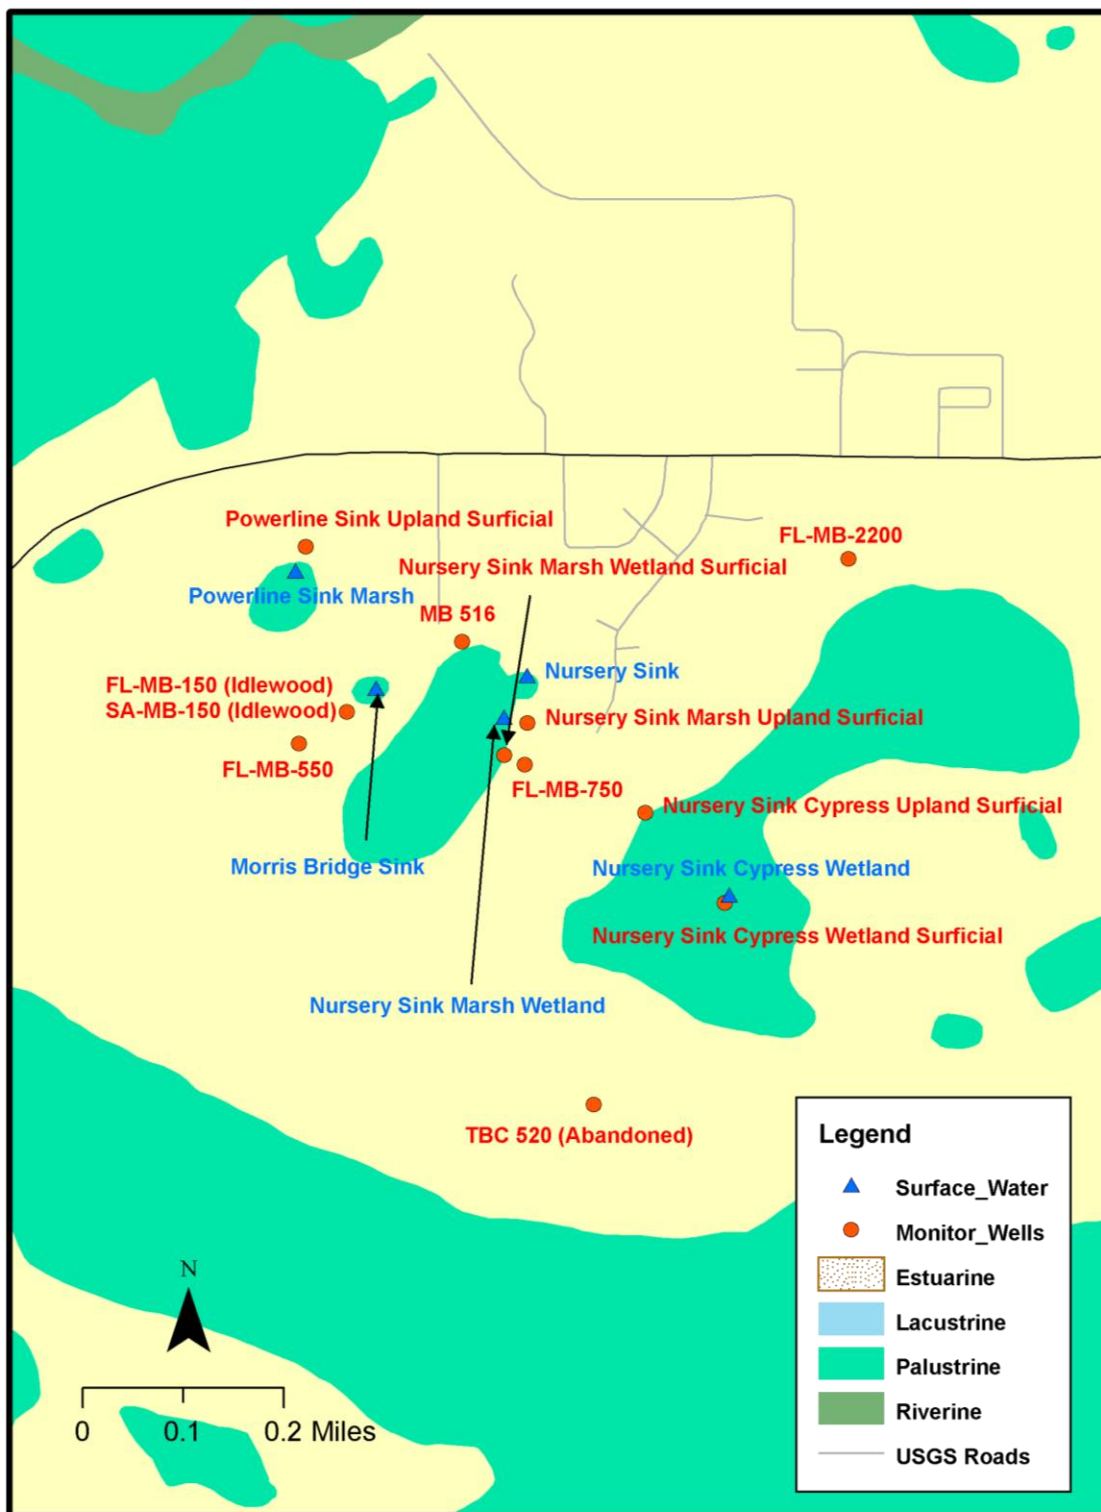
Figure 4. Location of Monitor Wells and Surface Water Stage Recorders used in the Morris Bridge Sink Pumping Test.

Continuous water-level data was collected at 15-minute intervals by the District at seven (7) surficial aquifer monitor wells: Powerline Sink Upland, Nursery Sink Marsh Upland, Nursery Sink Marsh Wetland, Nursery Sink Cypress Upland, Nursery Sink Cypress Wetland, Idlewood, and TBW 516-S. Continuous water-level data was also collected at 15-minute intervals by the District at five Upper Floridan aquifer monitor wells: Idlewood, TBW 516-D, FL-MB-550, FL-MB-750, and FL-MB-2200 (Figure 4).

Continuous water-level data was collected from stage recorders located at three wetlands in the Morris Bridge Sink area including Powerline Sink Marsh, Morris Bridge Nursery Marsh, and Morris Bridge Nursery Cypress Wetland (Figure 4). All of the wetlands are clustered within one-half mile of the Sink. Stage data was collected at 15-minute intervals. However, due to the prolonged drought conditions experienced over the last three years, all three wetland locations were dry during the 30-day pumping test.

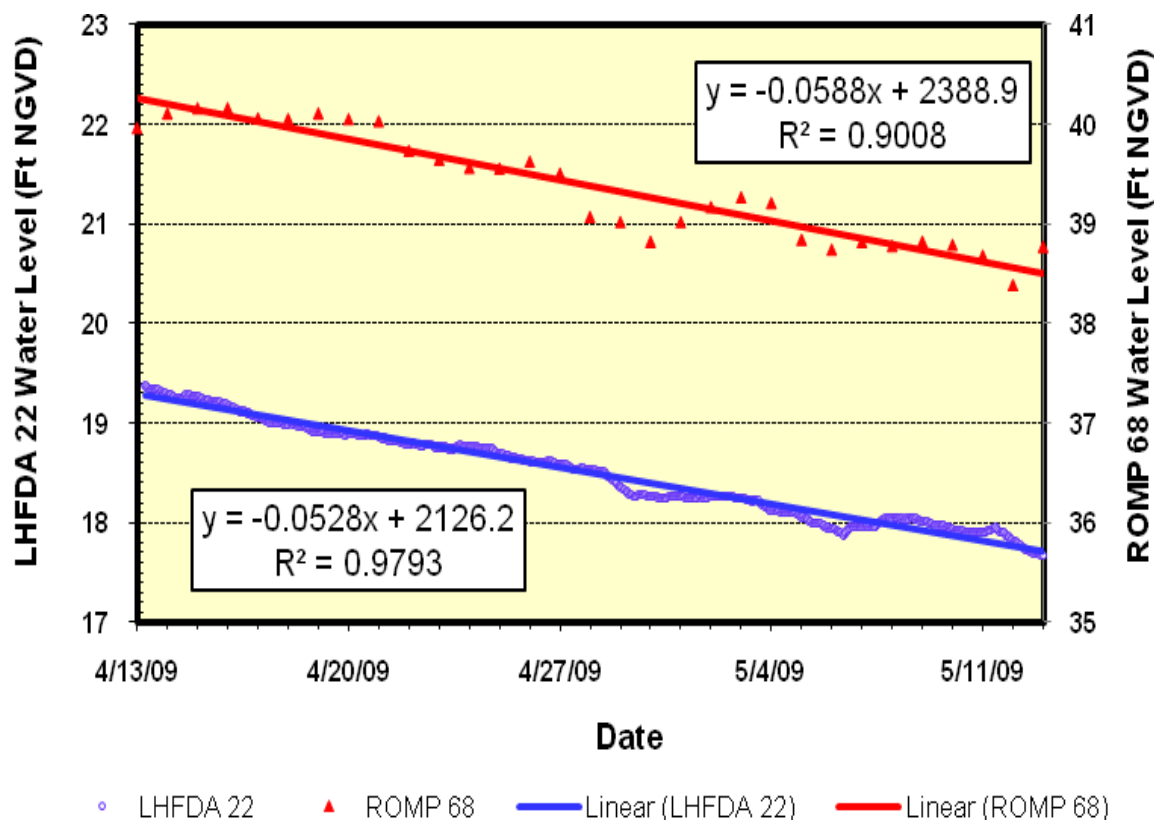
Figure 6. Linear regression of background water level trends at the LHFDA22 and Romp 68 UFA wells.

Several wells were examined to obtain background water levels to compare with monitor well data collected within the zone-of-influence of the pumping test. The LHFDA 22 Upper Floridan aquifer monitor well, located approximately 2.5 miles east of the Sink, was utilized to establish the background trend in the aquifer (Figure 5). For comparison purposes, water level data was also reviewed from the ROMP 68 Tampa-Suwannee well, located about 5.5 miles east of the Sink. Linear regression of water levels at both wells for the 30-day pumping period from April 13 to May 13, 2009 indicated a slope or regional trend of -0.0528 ft/day for LHFDA 22 UFA well and -0.0588 ft/day at the Romp 68 Tampa-Suwannee well (Figure 6). While both wells showed similar trends, water levels from the LHFDA 22 well were used as background conditions to calculate drawdown in the UFA based on a slightly better r-squared value and closer proximity to the Sink.

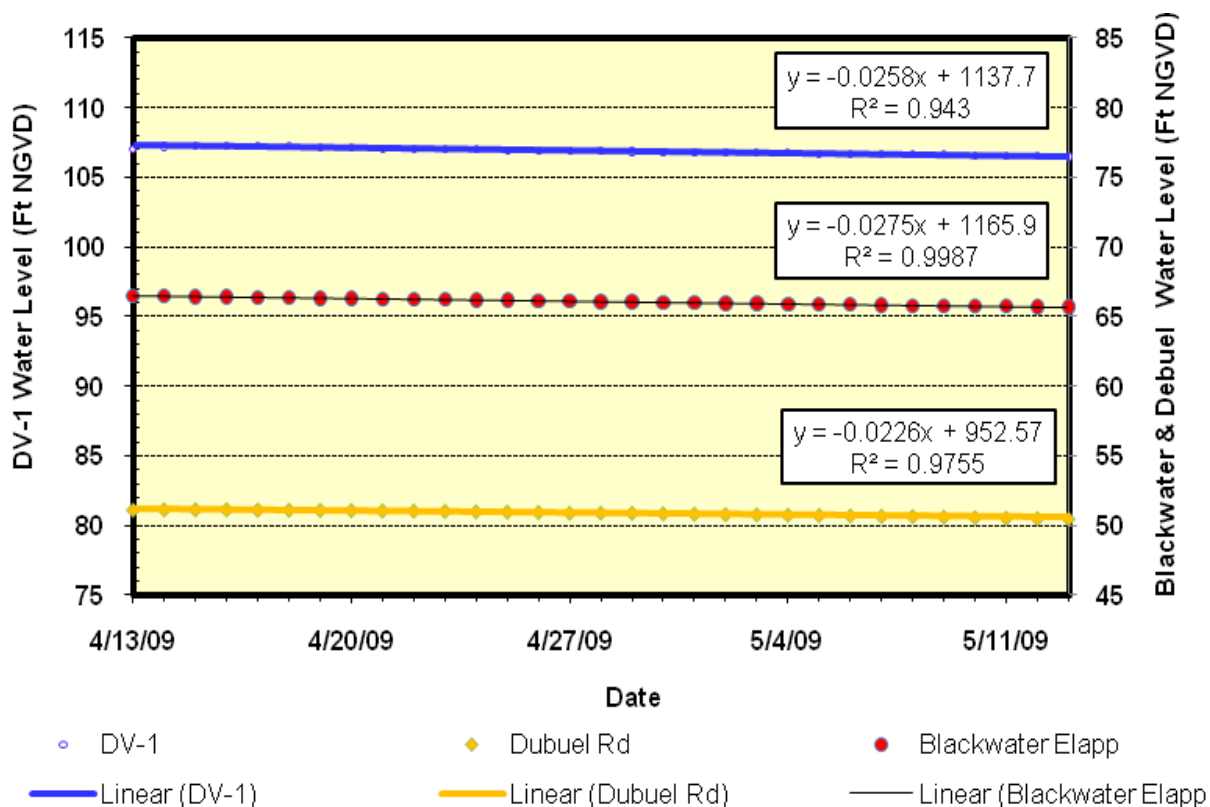
Figure 8. Linear regression of background water level trend at Romp DV-1, Blackwater Creek Elapp, and Debuel Road surficial aquifer wells.

In the surficial aquifer, water levels were analyzed for the background trend from three wells: Romp DV-1, Blackwater Creek Elapp, and Debuel Road. All three wells are located from eight to ten miles from the Sink (Figure 7). Linear regression of water levels at all three wells for the 30-day pumping period from April 13 to May 13, 2009 indicated a regional trend of -0.0258 ft/day for Romp DV-1 well, -0.0275 ft/day for the Blackwater Creek Elapp well, and -0.0226 ft/day at the Debuel Road well (Figure 8). The background trend selected for the surficial aquifer was -0.0253 ft/day based on the average from all three wells since their trends were all very similar.

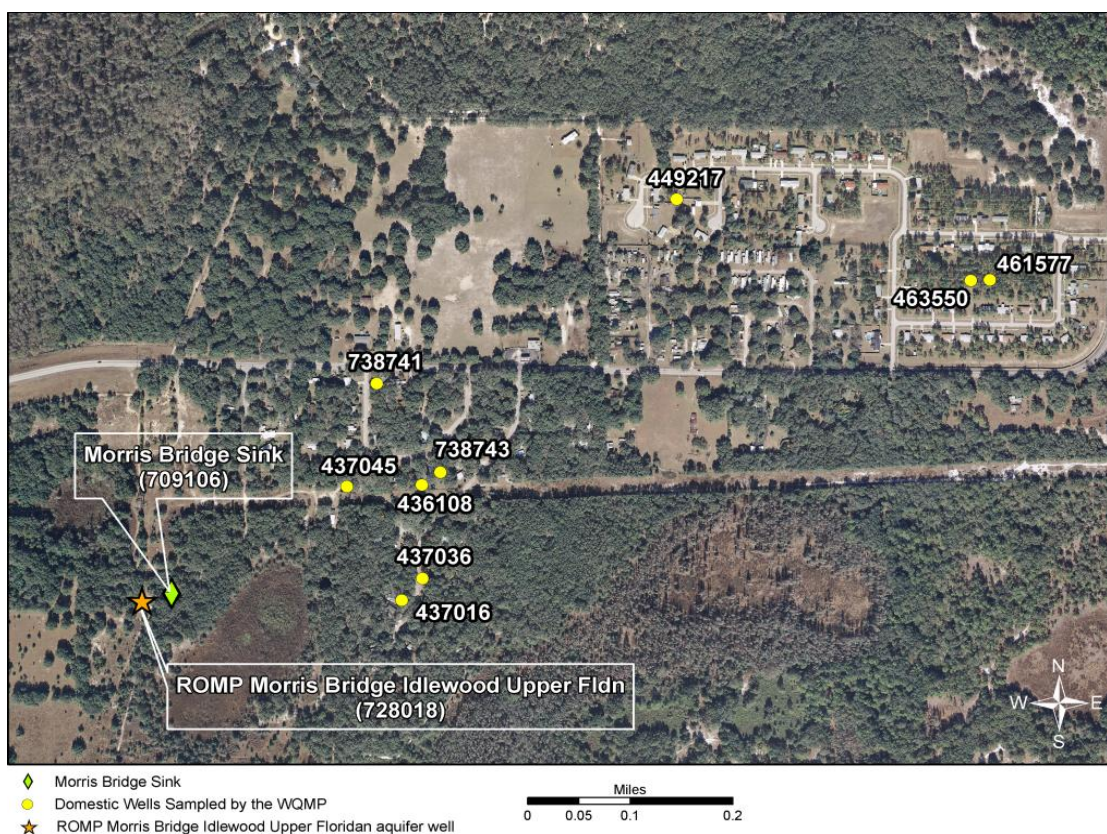
Figure 10. Groundwater quality sampling sites for the Morris Bridge Sink pumping test.

Domestic well water quality sampling sites were selected based upon their proximity to Morris Bridge Sink and well owner participation. A public meeting was held in February 2009, to present the Morris Bridge Sink Pumping Test Project Plan and request well owner participation for water quality sampling. The owners whose domestic wells met the water quality sampling plan criteria were then contacted to set up subsequent sampling. The domestic wells selected for sampling were assumed to be open to the Upper Floridan aquifer based on well specifications on record at, or provided to, the District. The District provided the domestic well owners with the water quality sampling results immediately following their availability after each water quality sampling. The locations of the domestic wells monitored as part of the pumping test are depicted in Figure 10.

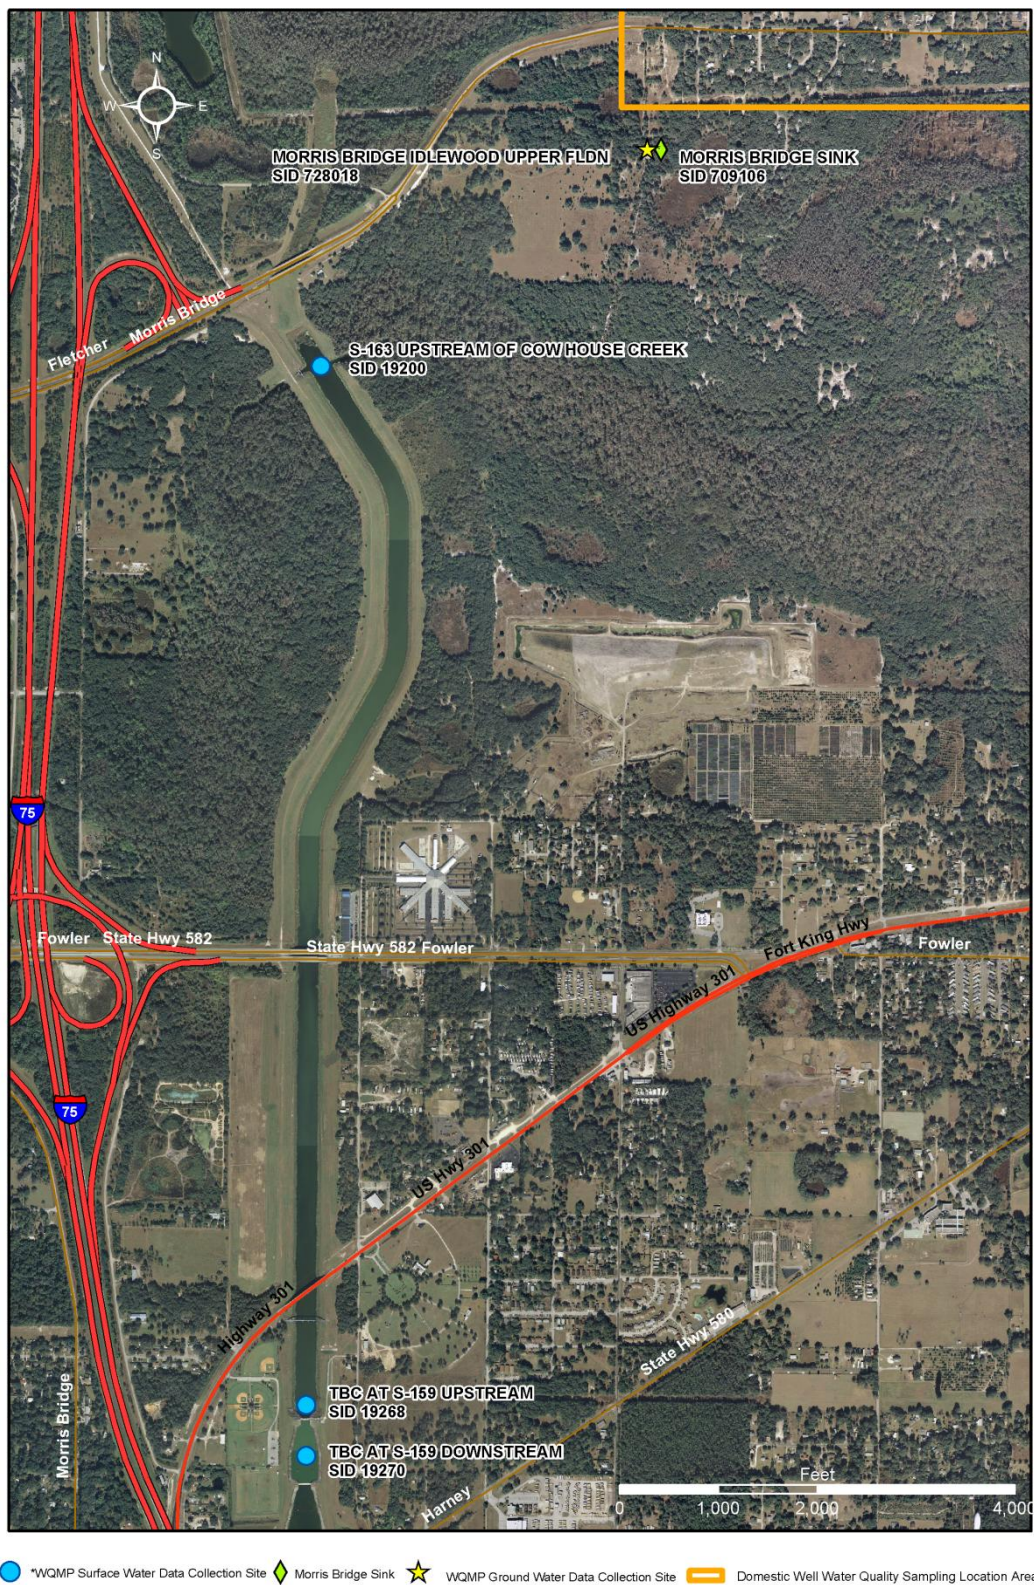
Figure 11. Surface water quality sampling sites during the Morris Bridge Sink pumping test.

Surface water quality samples were obtained from three sites along the upper portion of the Tampa Bypass Canal to monitor any potential water chemistry changes that may have resulted from the pumping discharge (Figure 11). The pumping discharge occurred upstream of the convergence of Cow House Creek and the Tampa Bypass Canal. As a result, a surface water sampling site was located immediately downstream of the discharge, but upstream of the convergence of Cow House Creek and the Tampa Bypass Canal and Structure 163. The other two stations are located adjacent to Structure 159; one is located upstream and the other downstream.

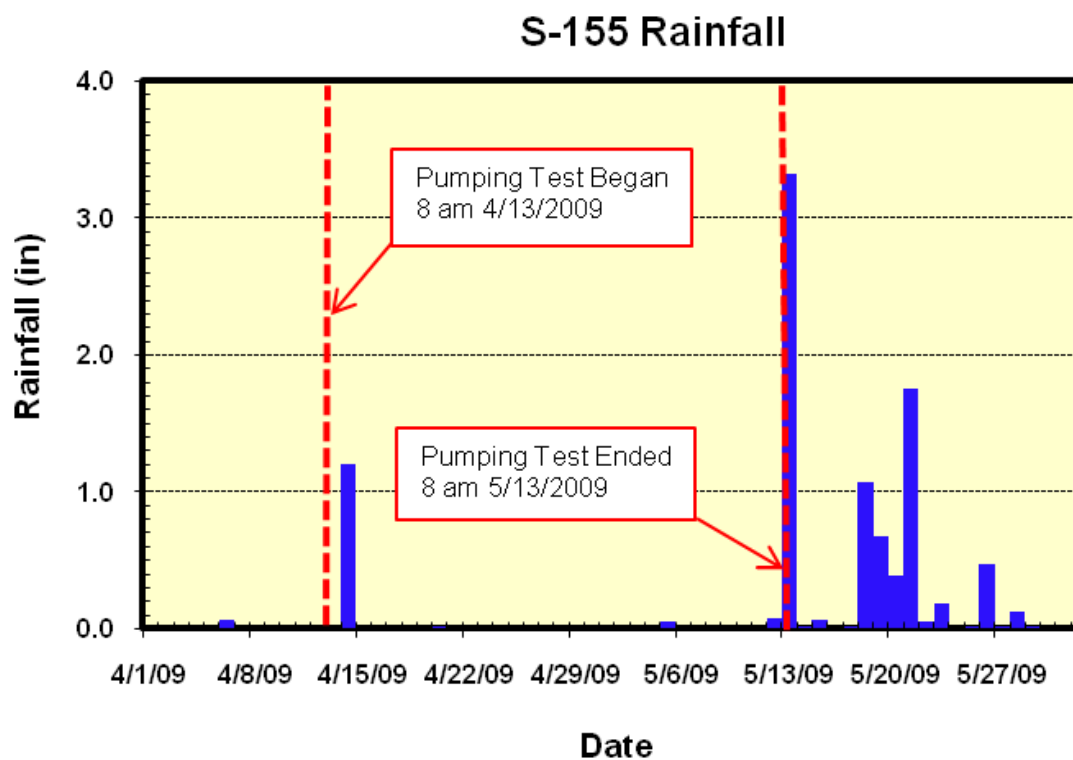
Figure 12. Rainfall history at the S-155 station from April 1 to June 1, 2009.

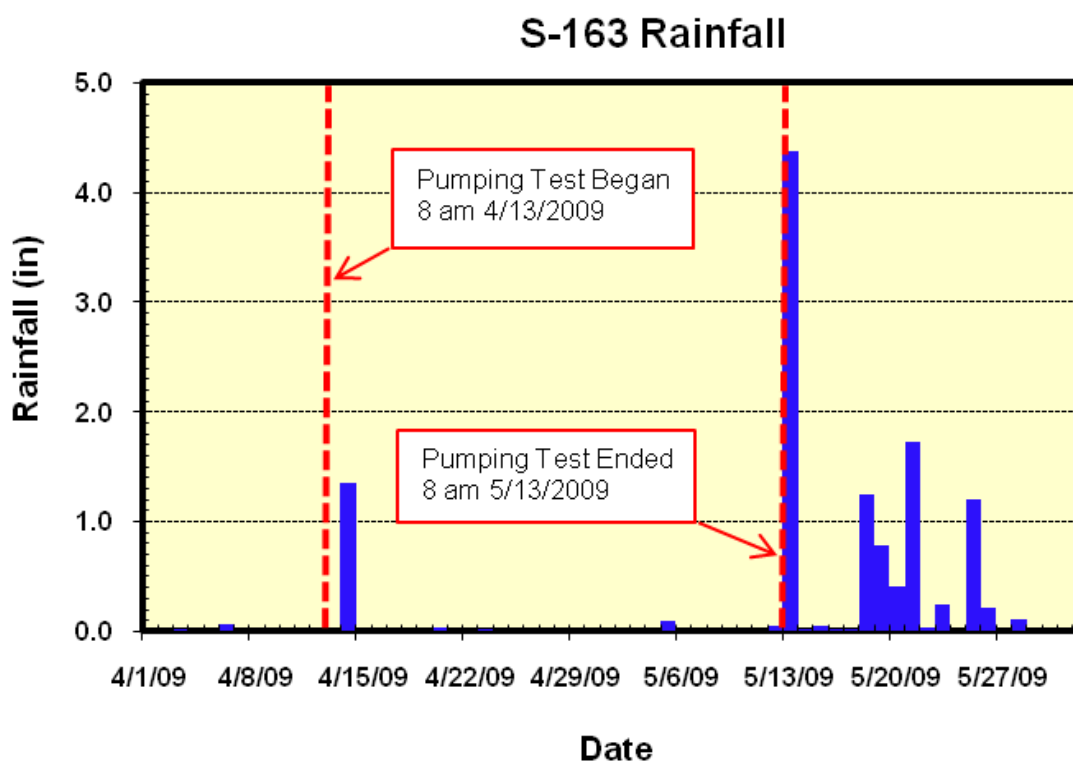
Figure 13. Rainfall history at the S-163 station from April 1 to June 1, 2009.

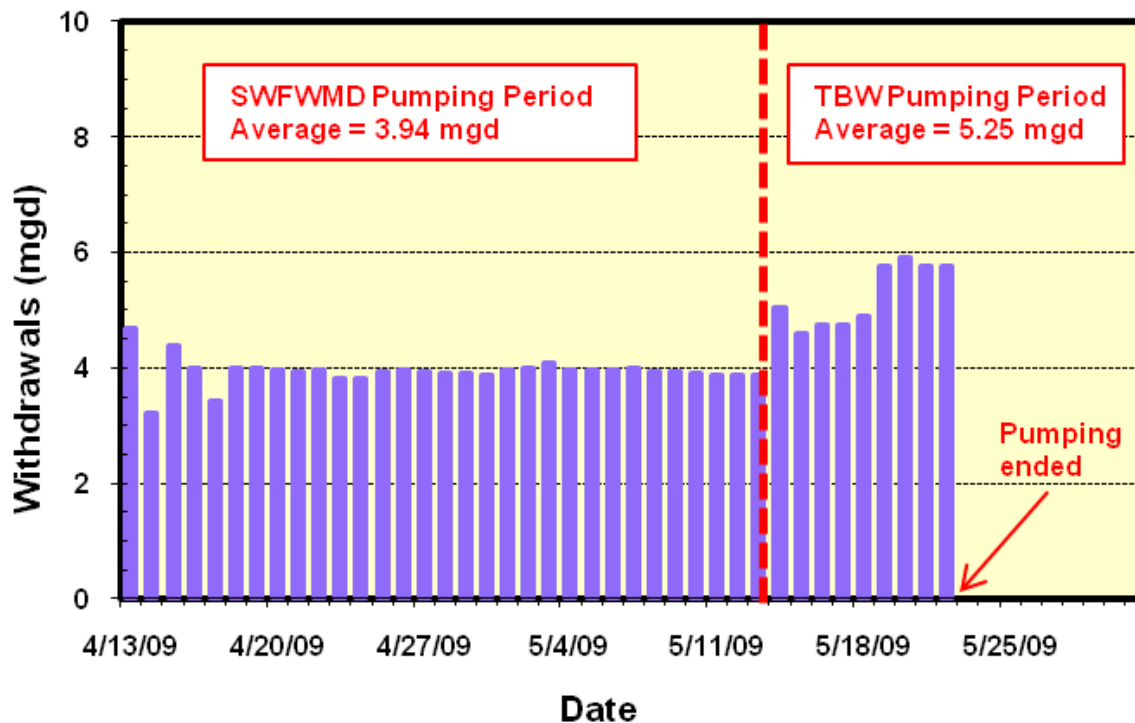
Figure 14. Morris Bridge Sink withdrawals during the SWFWMD 30-Day Test and TBW's emergency order period.

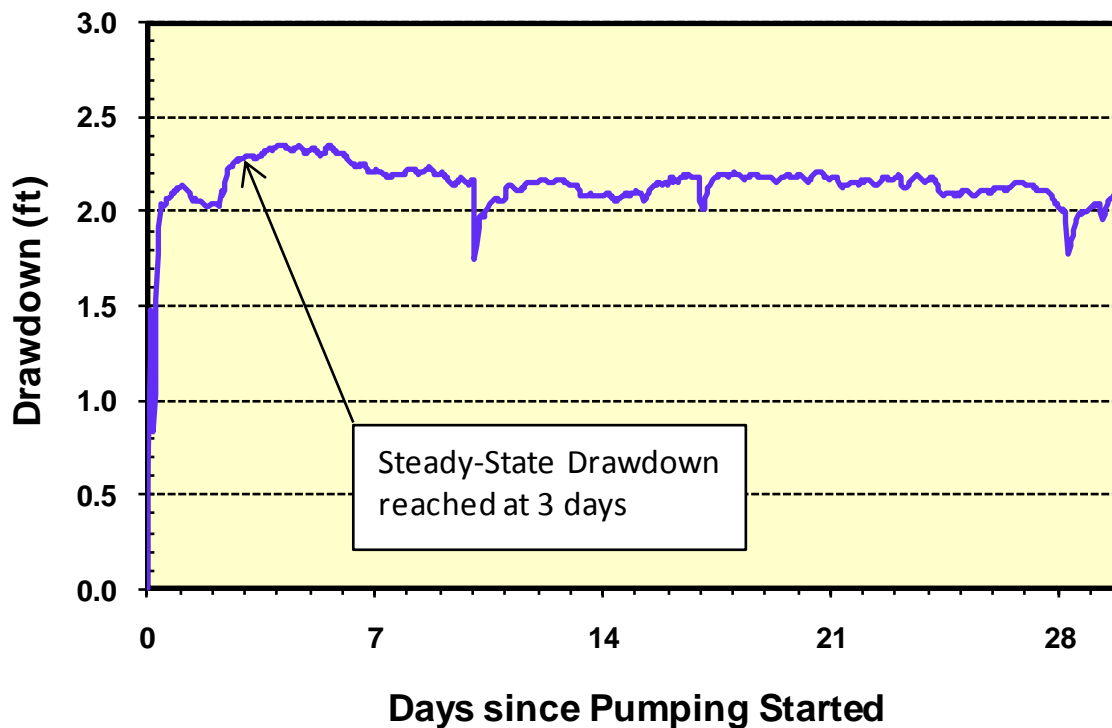
Figure 15. Drawdown in Morris Bridge Sink stage during the duration of the 30-day test.

Over the 27-day period, drawdown in Morris Bridge Sink was approximately 2.16 ft (Table 6). In Nursery Sink, located approximately 780 ft northeast of Morris Bridge Sink, calculated drawdown was 0.3 ft. Morris Bridge Sink drawdown approached a quasi steady-state condition after about three days of withdrawals as it remained relatively steady around 2.2 ft (Figure 15). This condition was also reflected in Nursery Sink stage and UFA monitor wells surrounding the sink (Appendix E). The minor oscillations in drawdown depicted after three days of pumping were mainly due to small alterations in the withdrawal rate.

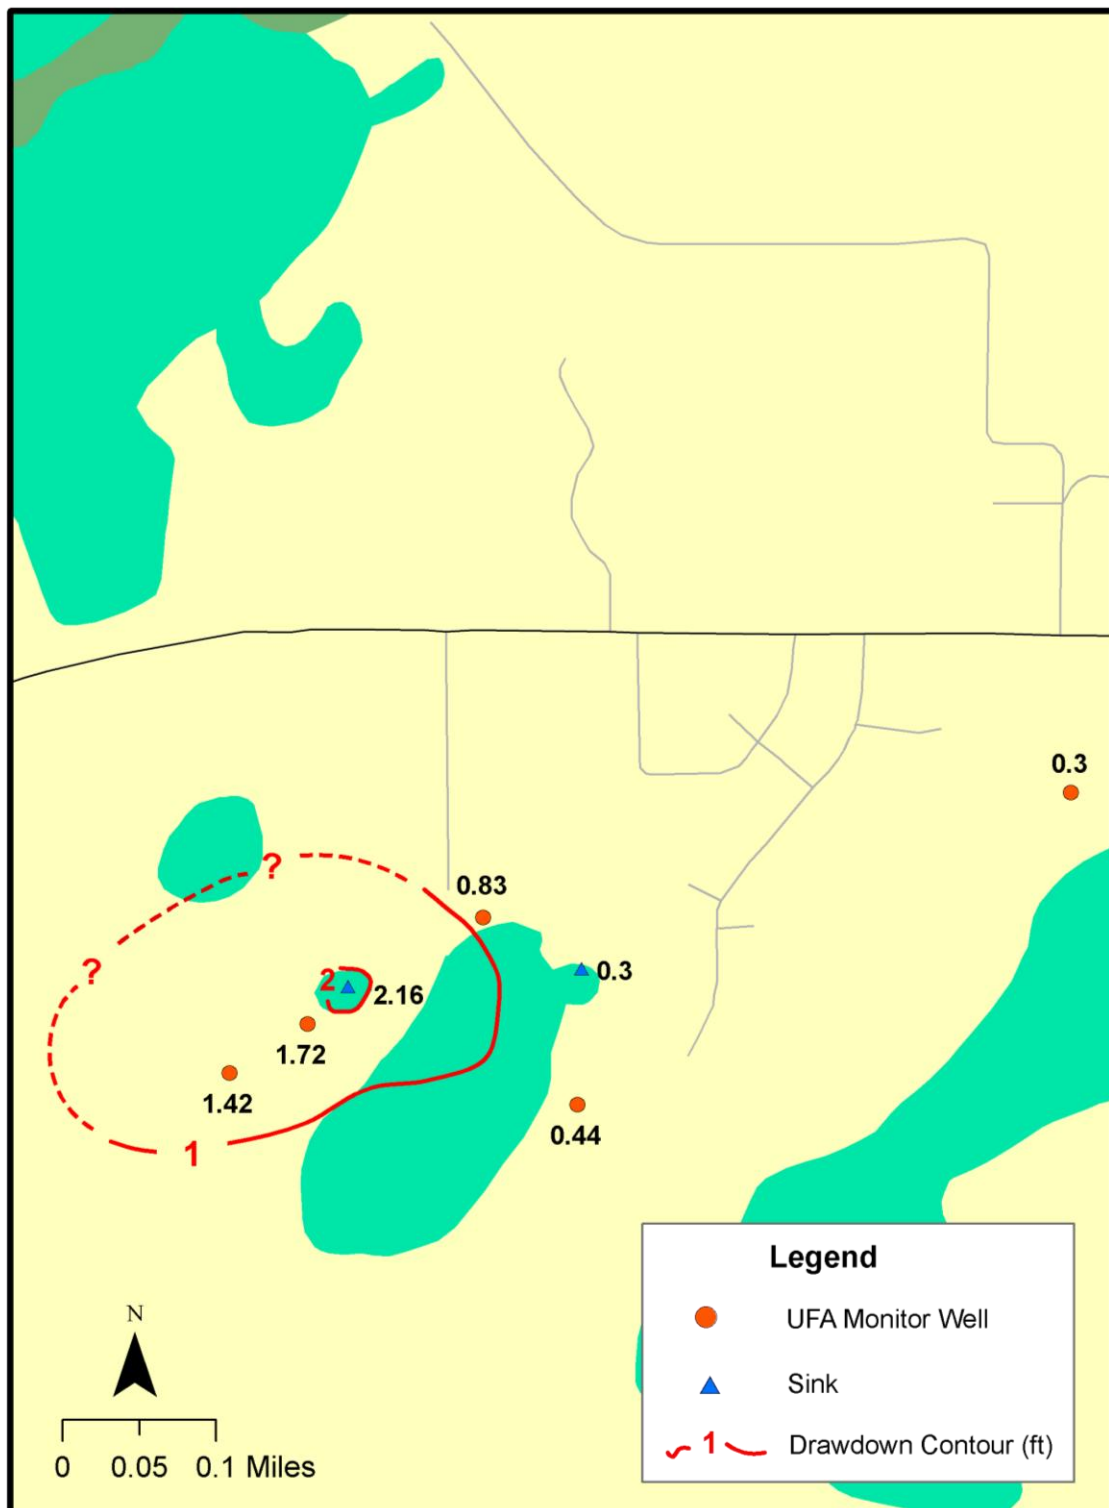
Figure 16. Drawdown in the Upper Floridan aquifer from the Morris Bridge Sink pumping test.

The distance to one foot of drawdown ranges from about 400 ft toward the east and northeast of the sink to more than 600 ft to the southwest. A contour map of Upper Floridan aquifer drawdown is presented in Figure 16.

Continuous water-level data was also collected at five Upper Floridan aquifer monitor wells: Idlewood, TBW 516-D, FL-MB-550, FL-MB-750, and FL-MB-2200. Upper Floridan aquifer drawdown to the southwest of the sink ranged from 1.7 ft at 160 ft to 1.4 ft at 550 ft (Figure 16). To the east and northeast of the sink, drawdown was less with 0.8 ft recorded at 516 ft, 0.4 ft at 750 ft, and 0.3 ft at 2,200 ft. The drawdown results indicate anisotropic flow conditions in the UFA with permeability much greater to the east and northeast of Morris Bridge Sink.

Calculated drawdown ranged from 1.72 ft at a distance of 160 ft southwest of the Sink to 1.41 ft at a distance of 550 ft southwest of the Sink. To the east and northeast of the Sink, drawdown was noticeably less with 0.82 ft observed at 516 ft, 0.44 ft at 750 ft, and 0.30 ft at 2,200 ft.

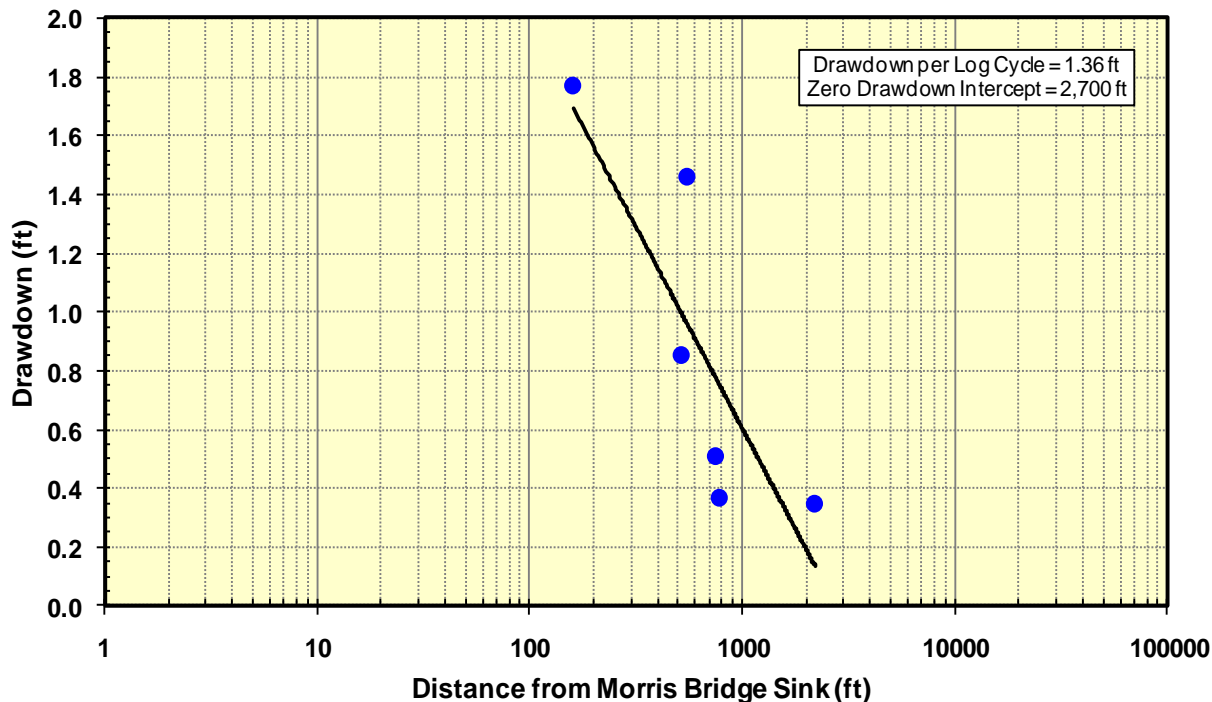
Figure 17. Distance-drawdown plot of all UFA monitor wells and Nursery Sink at 7 days.

The transmissivity of 142,000 ft<sup>2</sup>/d is consistent with transmissivity results of 130,000 to 200,000 ft<sup>2</sup>/d determined from aquifer tests performed at the site in 1972 (Stewart, 1977). This transmissivity value is very close to 146,000 ft<sup>2</sup>/d determined in the year 2000 test of Morris Bridge Sink (LBG, 2001).

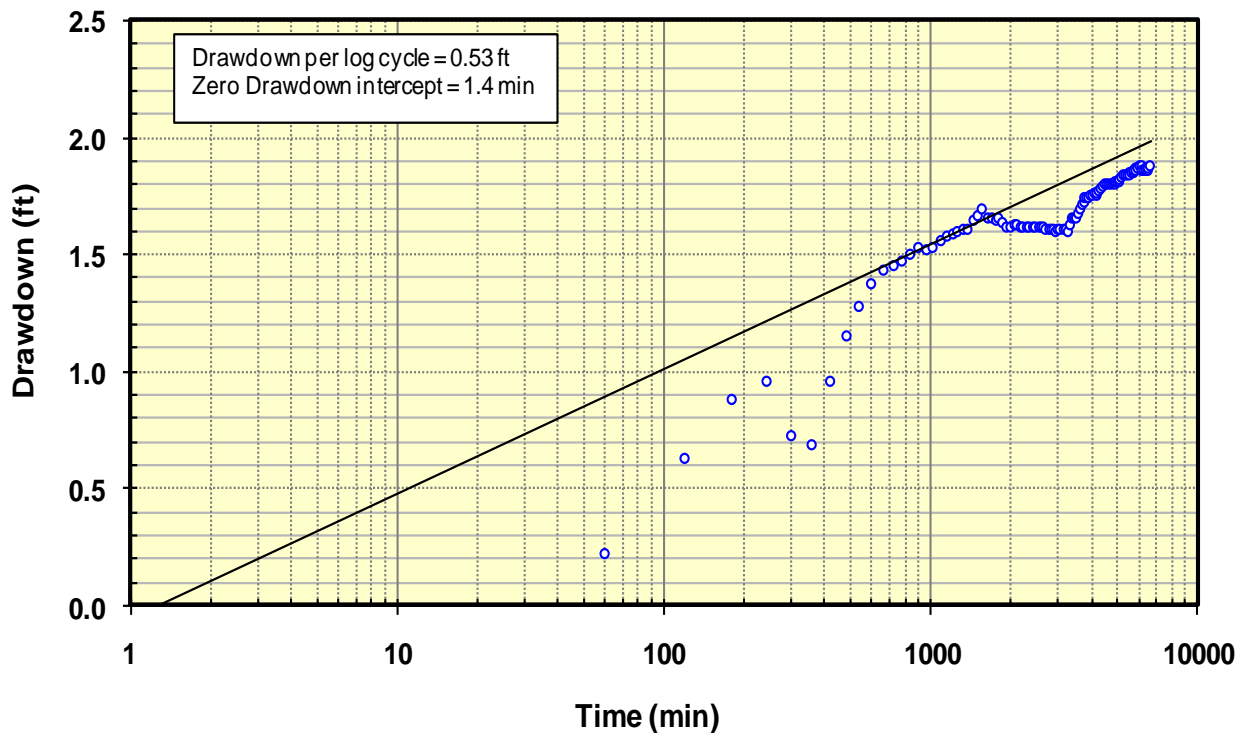
Figure 18. Drawdown versus time analysis using the Cooper-Jacob method for the Idlewood well.

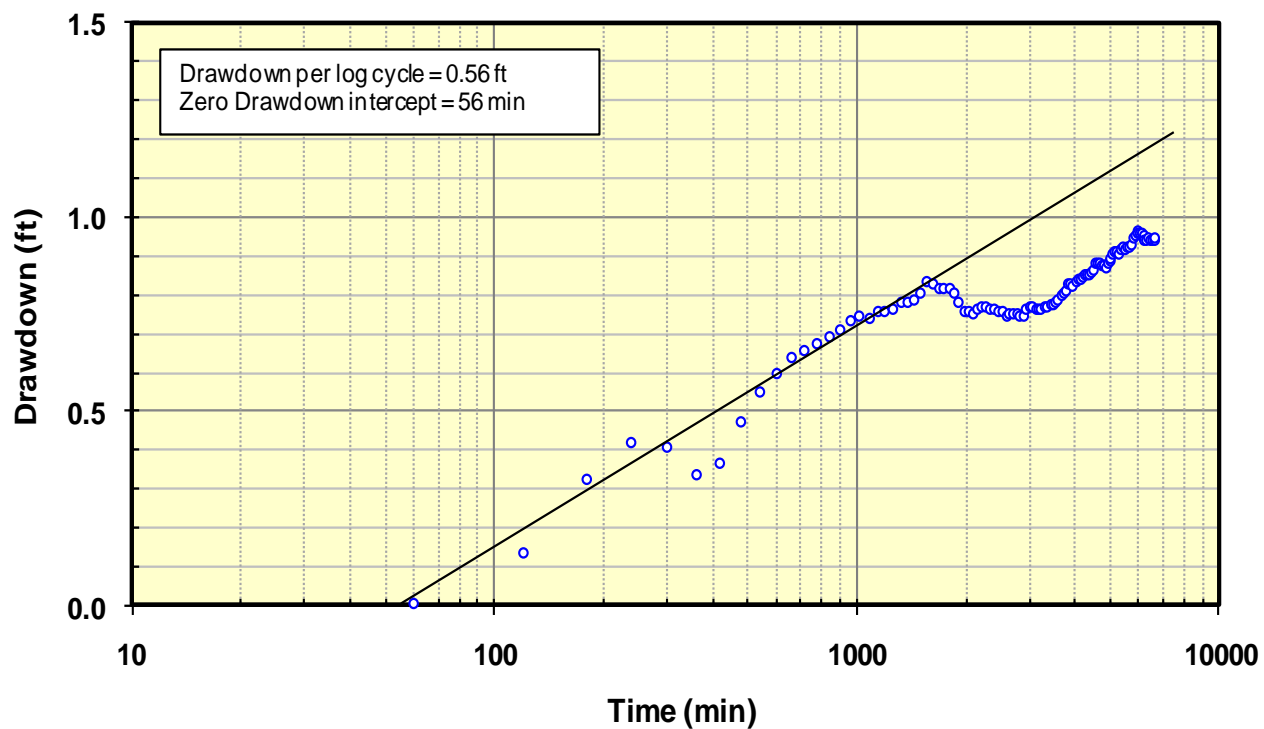
Figure 19. Drawdown versus time analysis using the Cooper-Jacob method for the TBW 516 well.

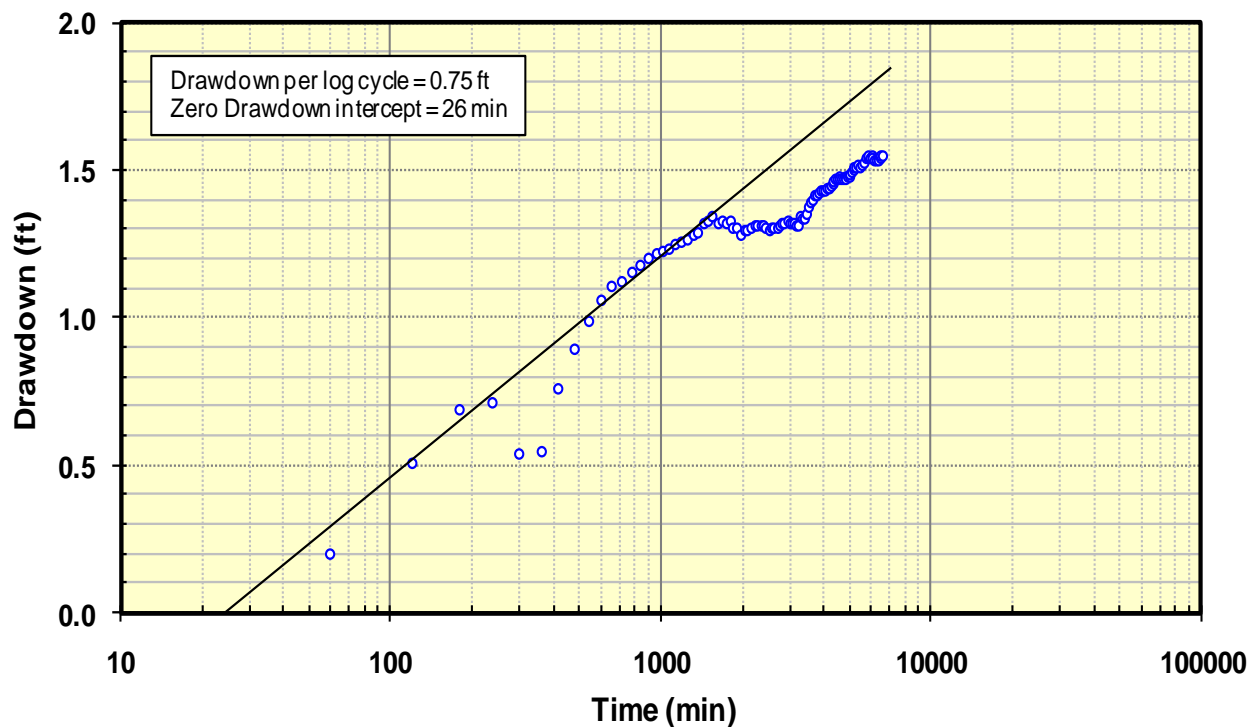
Figure 20. Drawdown versus time analysis using the Cooper-Jacob method for the FL-MB-550 well.

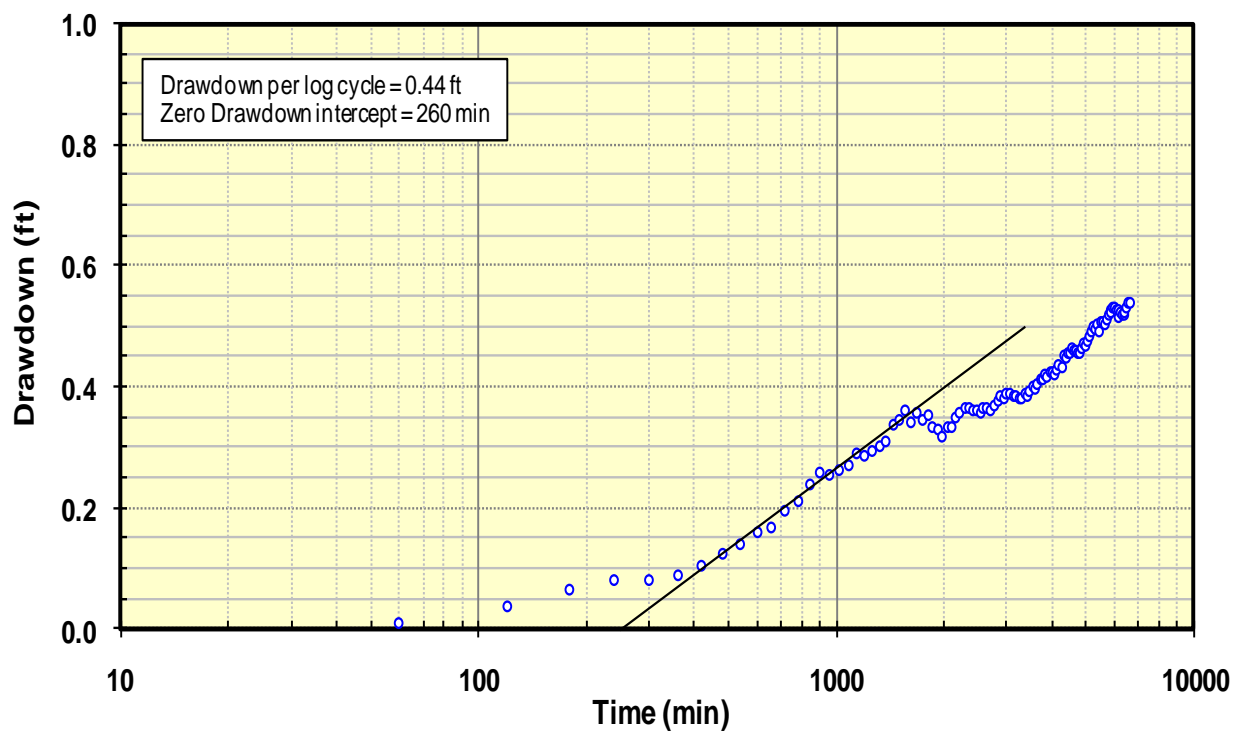
Figure 21. Drawdown versus time analysis using the Cooper-Jacob method for the FL-MB-750 well.

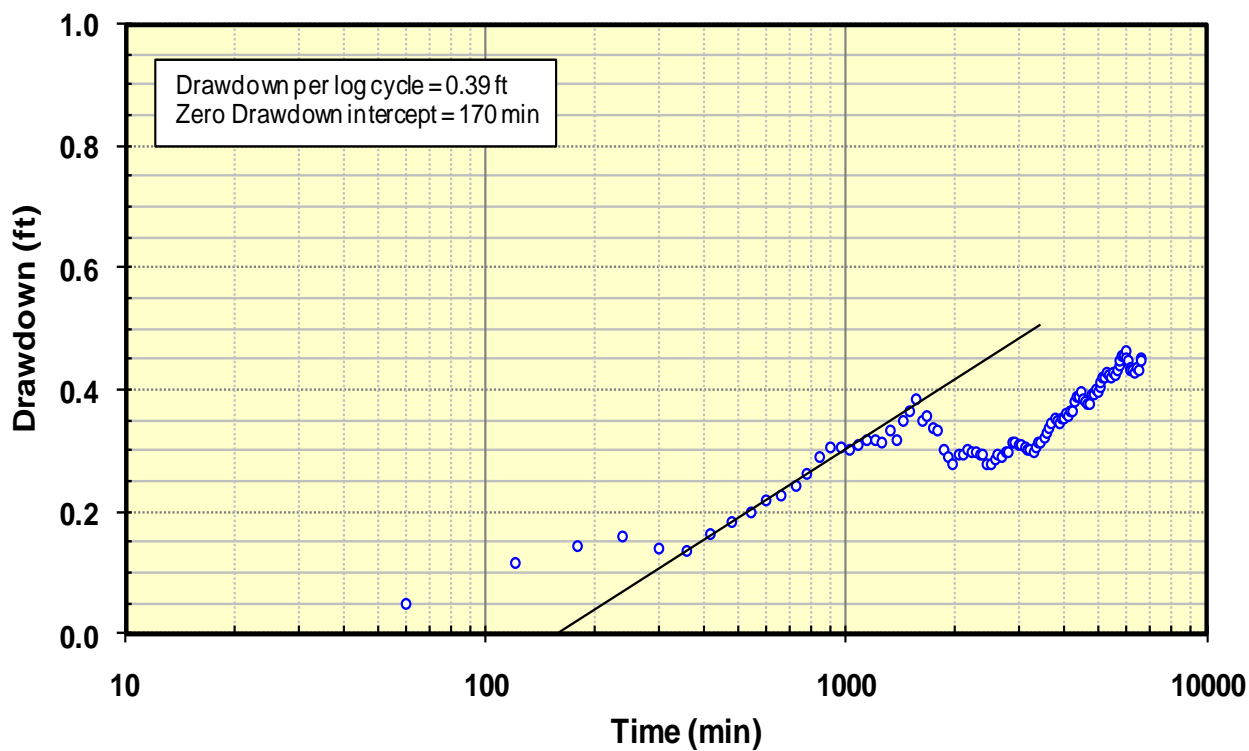
Figure 22. Drawdown versus time analysis using the Cooper-Jacob method for Nursery Sink.
