**Results of Morris Bridge Sink Pumping  
Test (SWFWMD 2010)**

**Results of Morris Bridge Sink Pumping Test  
Hillsborough County, Florida**

**Final Report**

**Hydrologic Evaluation Section  
Southwest Florida Water Management District**

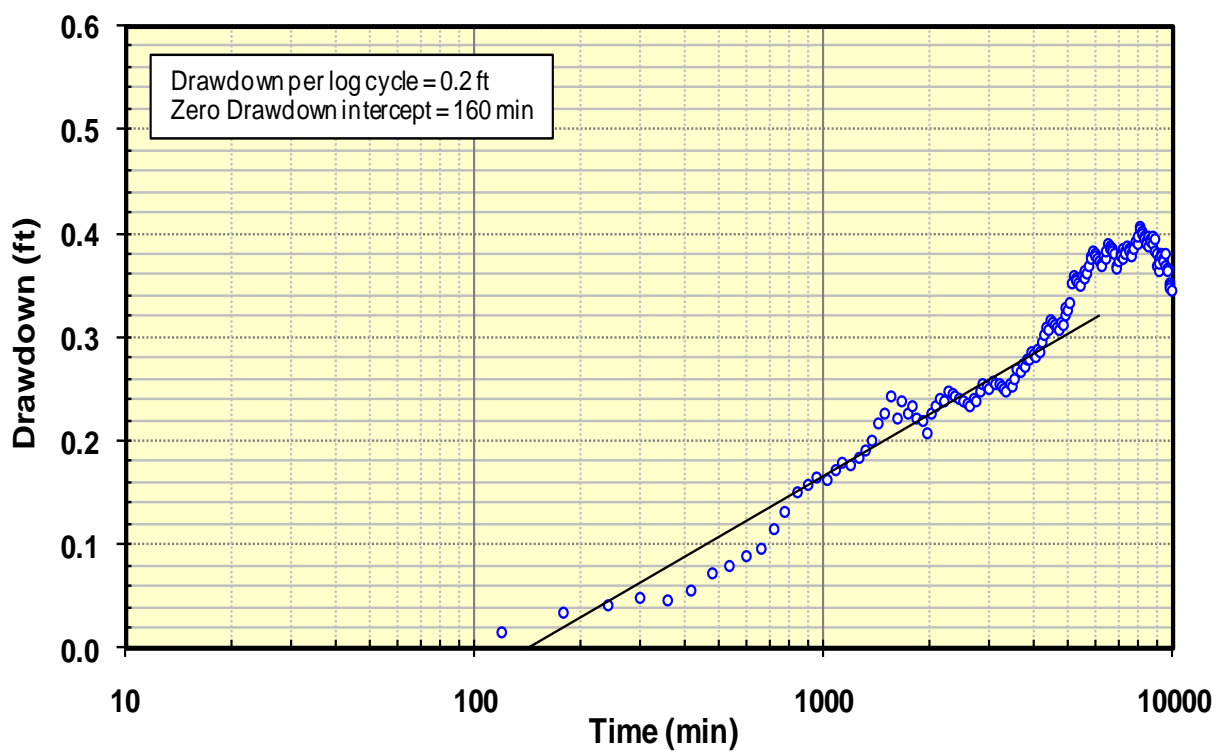
Figure 23. Drawdown versus time analysis using the Cooper-Jacob method for the FL-MB-2200 well.

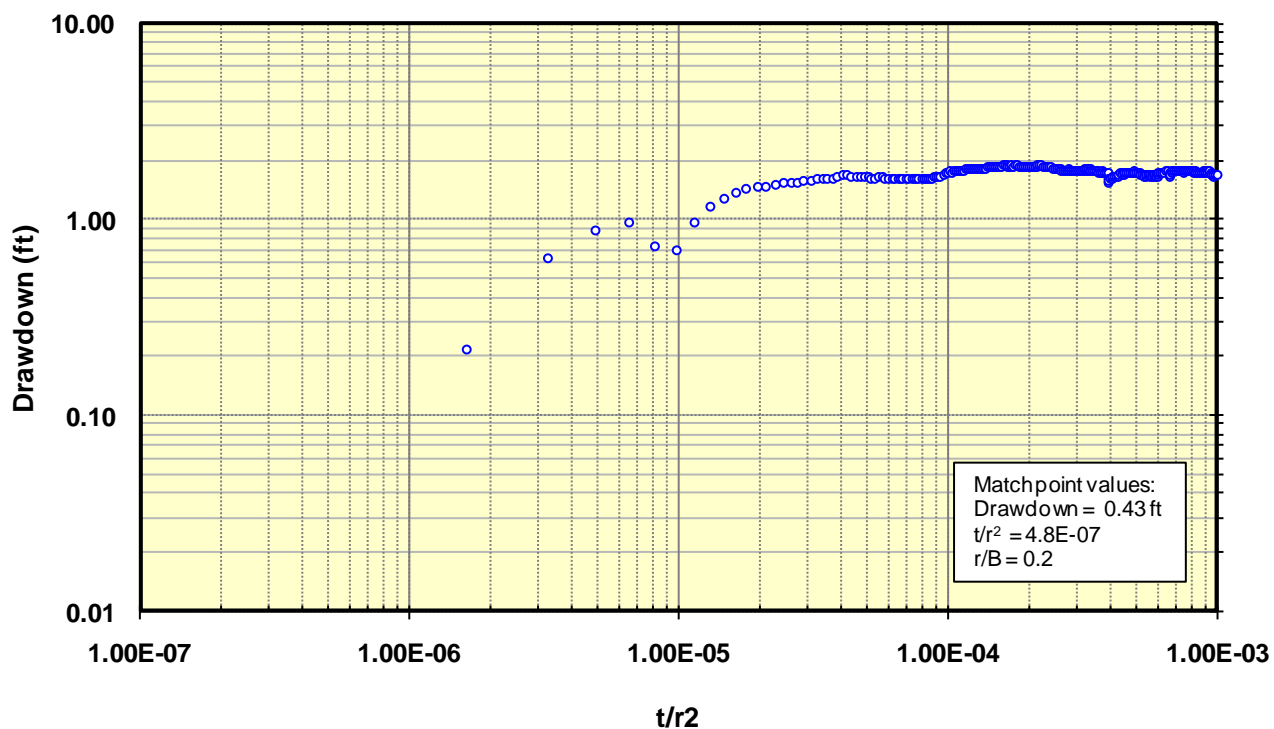
Figure 24. Drawdown versus time analysis using the Hantush-Jacob method for the Idlewood well.

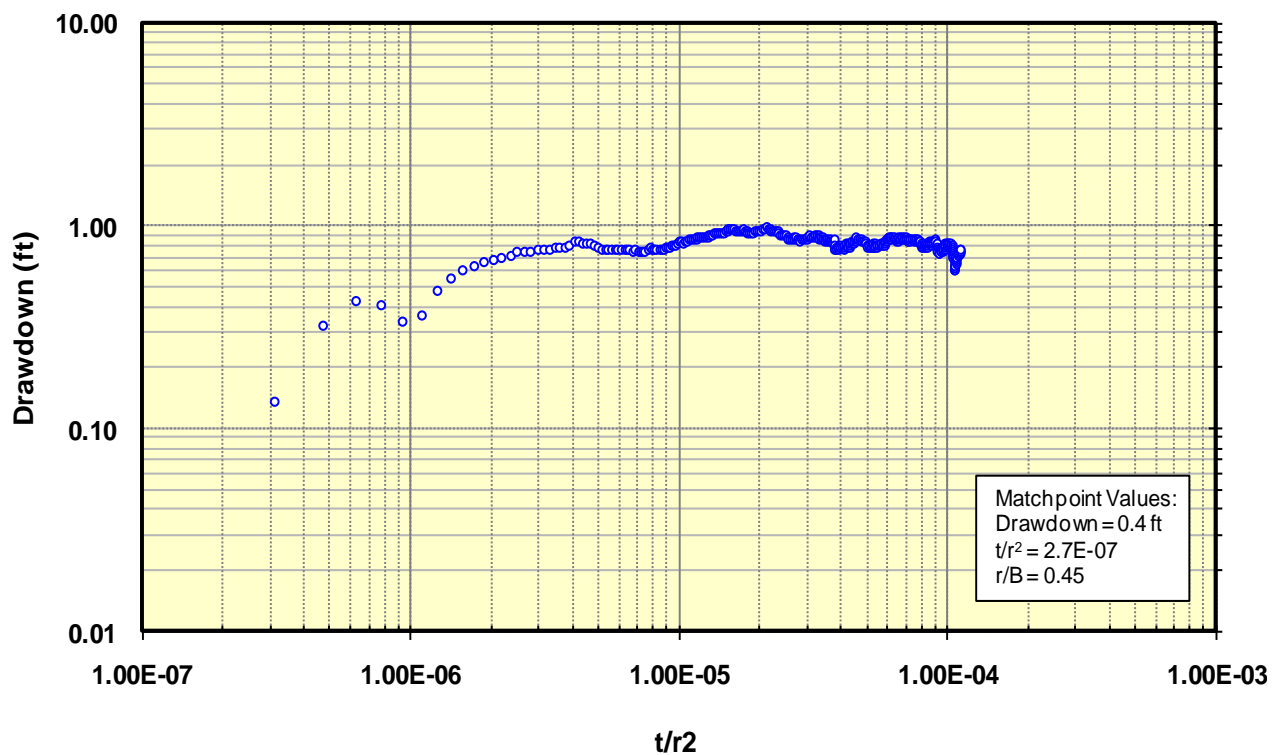
Figure 25. Drawdown versus time analysis using the Hantush-Jacob method for the TBW 516 well.

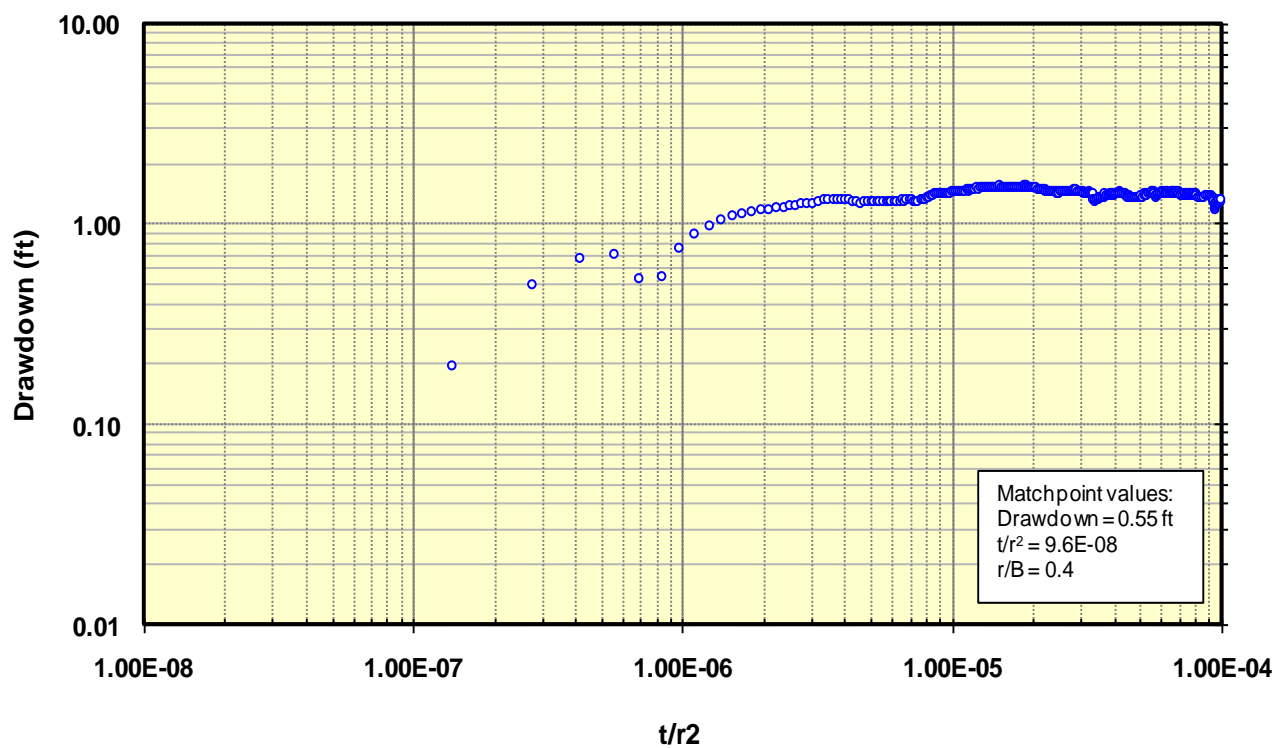
Figure 26. Drawdown versus time analysis using the Hantush-Jacob method for the FL-MB-550 well.

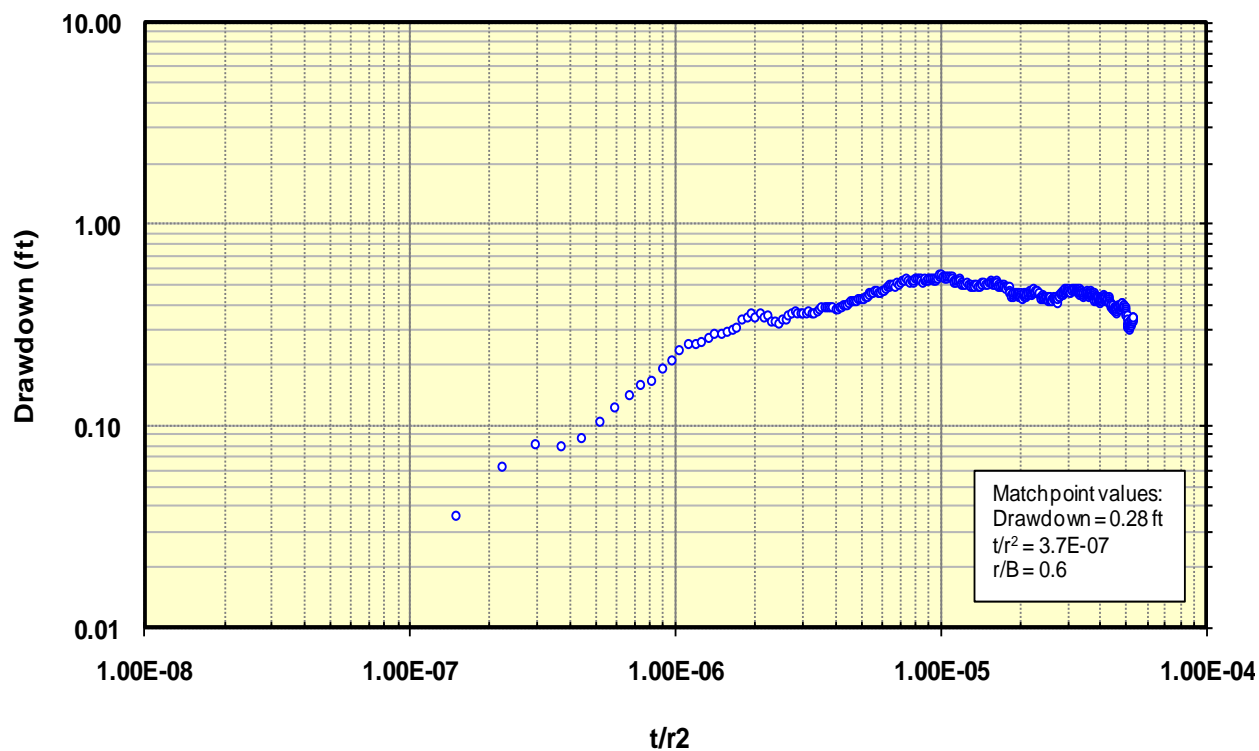
Figure 27. Drawdown versus time analysis using the Hantush-Jacob method for the FL-MB-750 well.

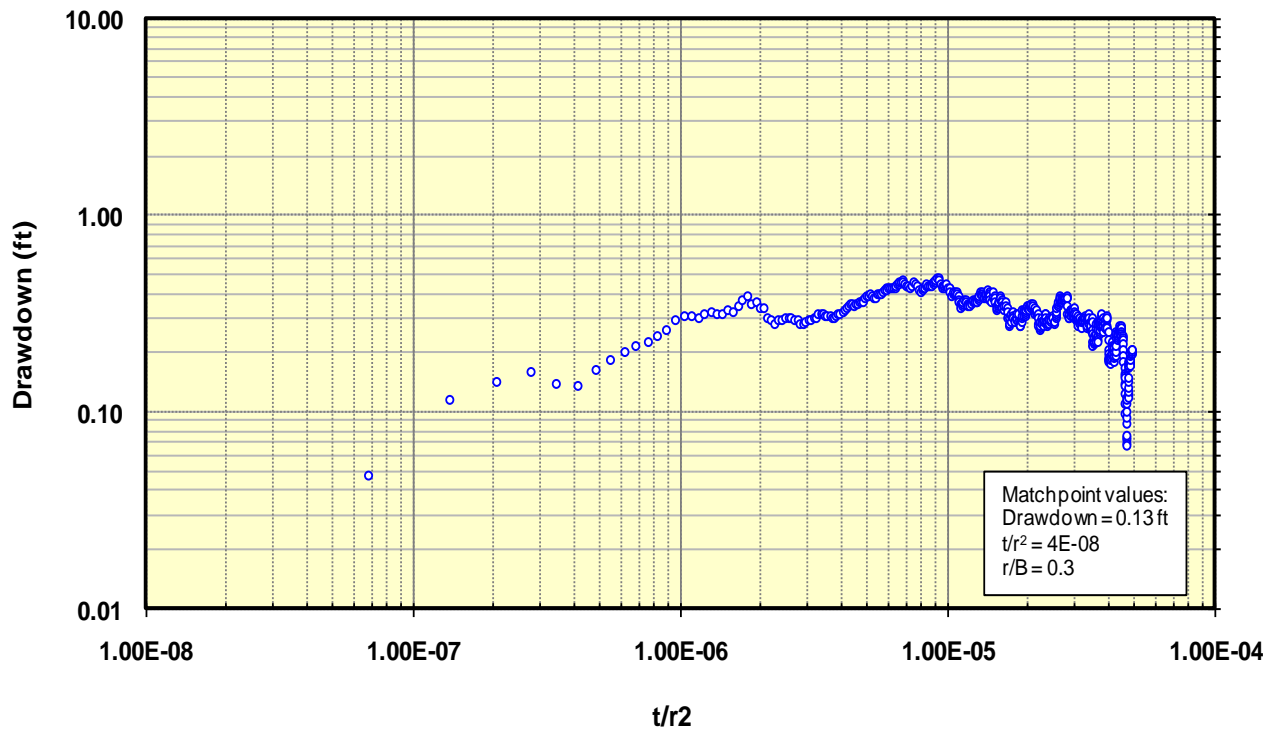
Figure 28. Drawdown versus time analysis using the Hantush-Jacob method for Nursery Sink.

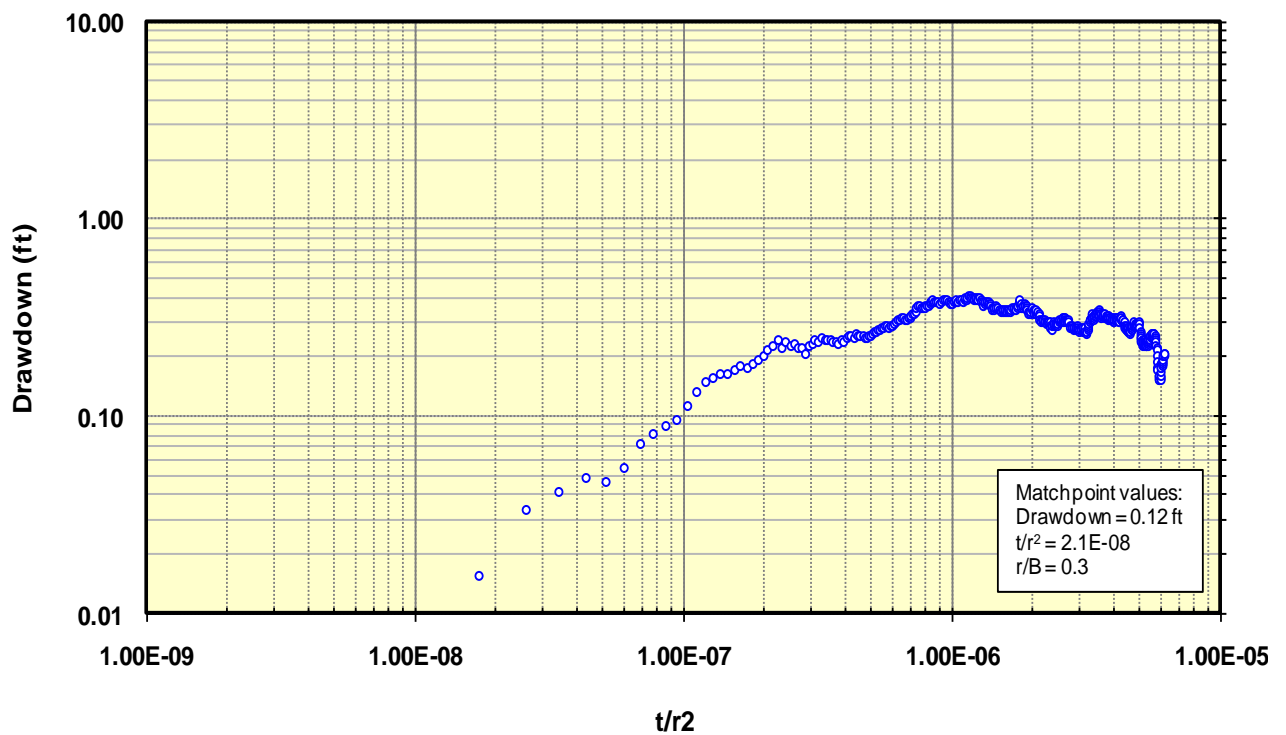
Figure 29. Drawdown versus time analysis using the Hantush-Jacob method for the FL-MB-2200 well.

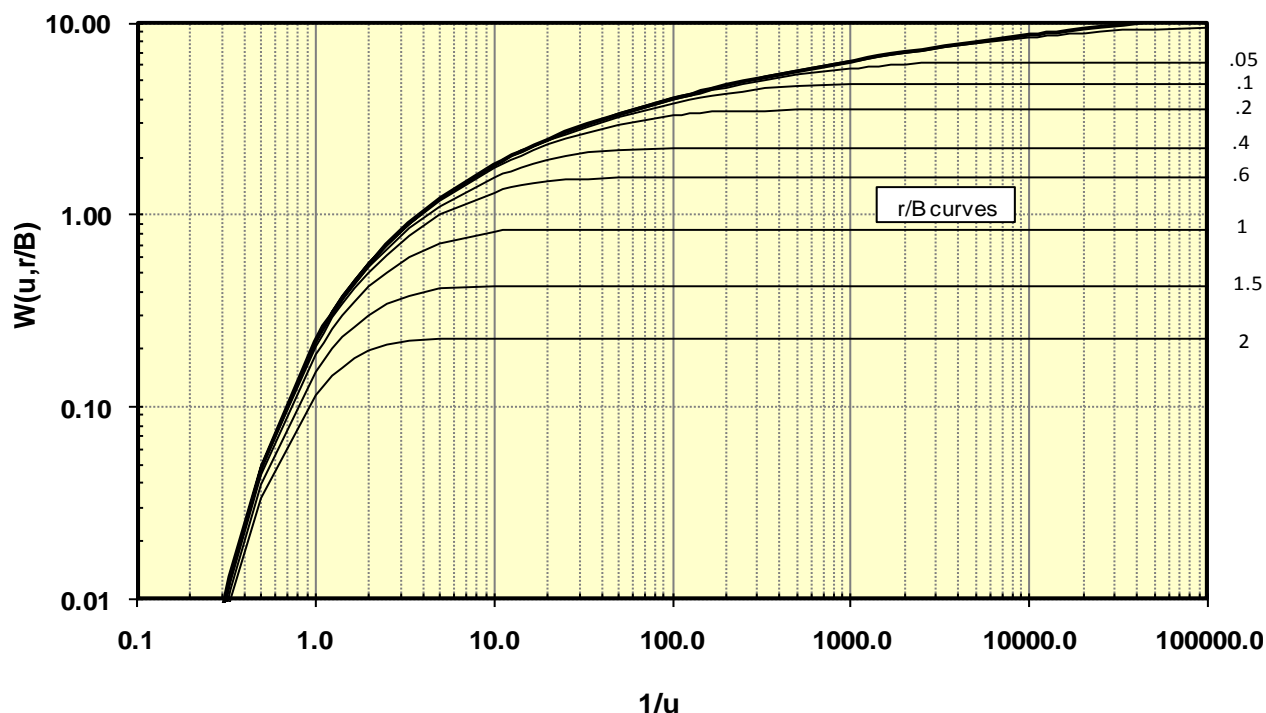
Figure 30. Hantush-Jacob leaky aquifer method type curves.

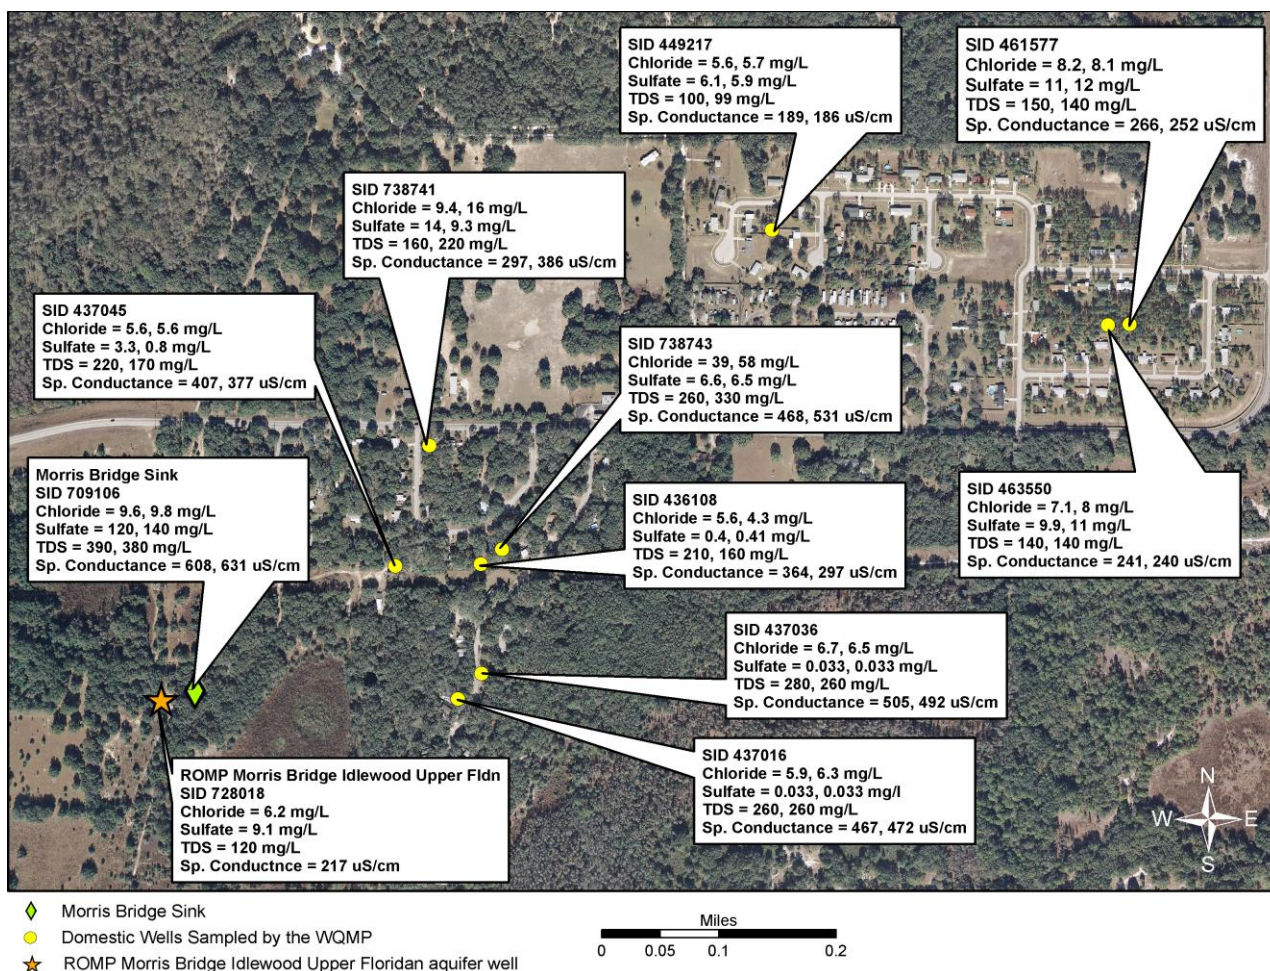
Figure 31. Select water quality parameters collected from Morris Bridge domestic wells, ROMP Morris Bridge Idlewood UFA, and Morris Bridge Sink, during the baseline and final sampling events.

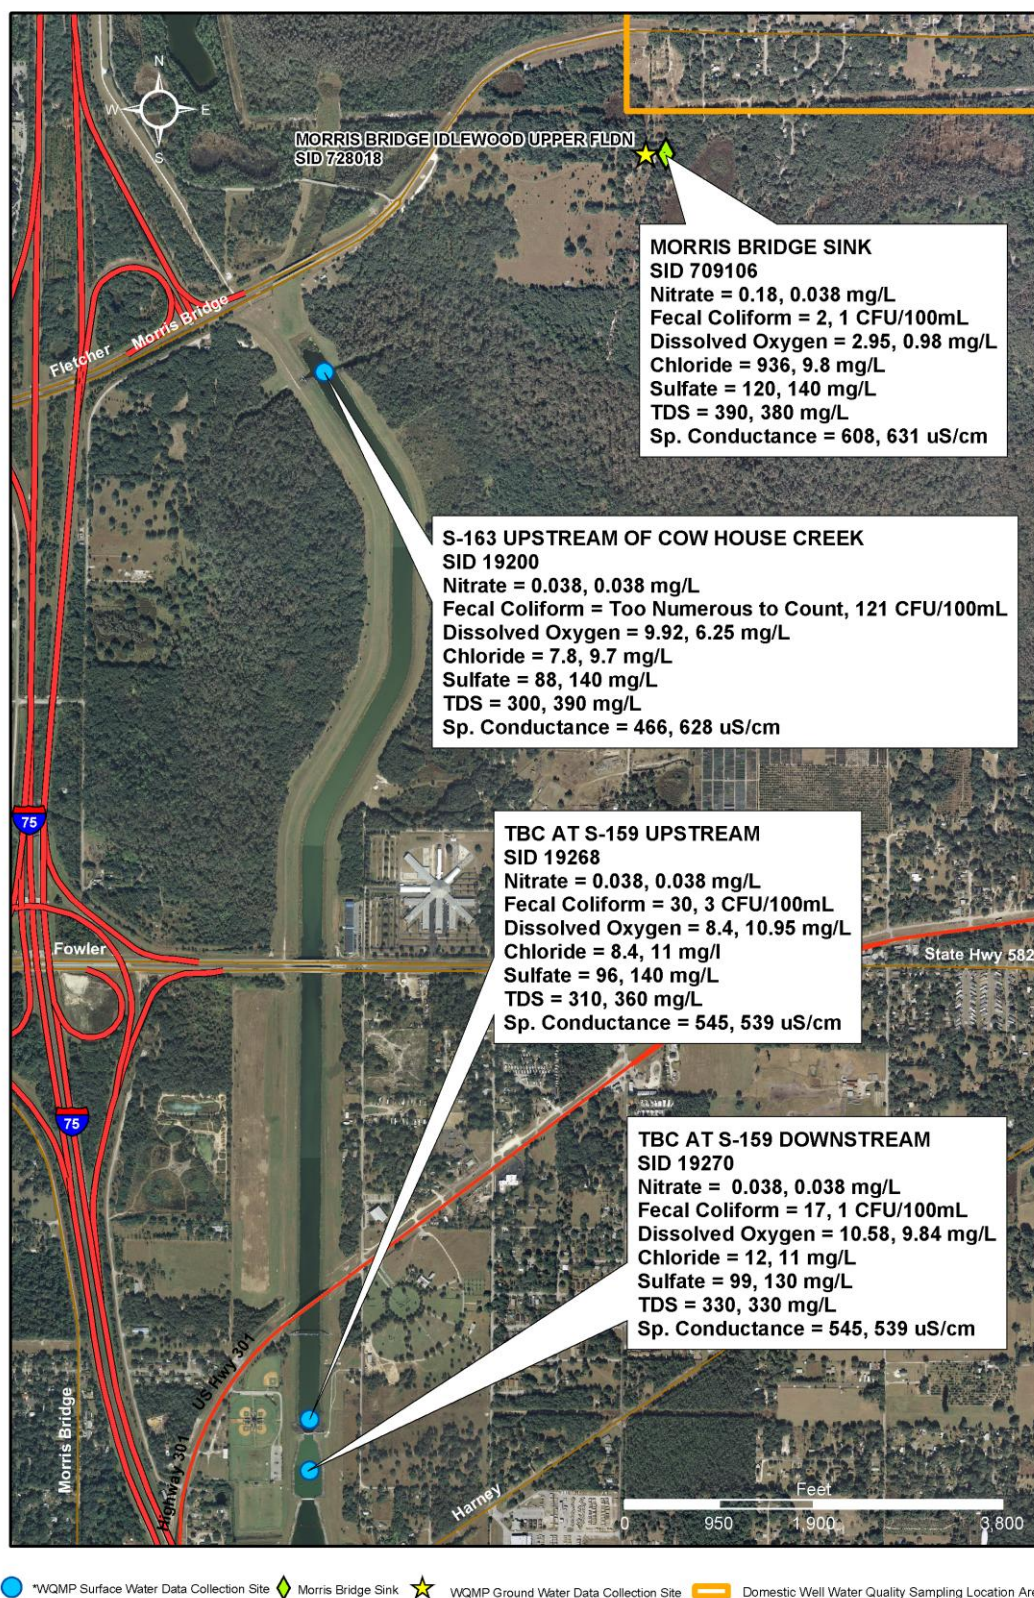
Figure 32. Select water quality parameters collected from Morris Bridge Sink pumping test during the baseline and final sampling events.

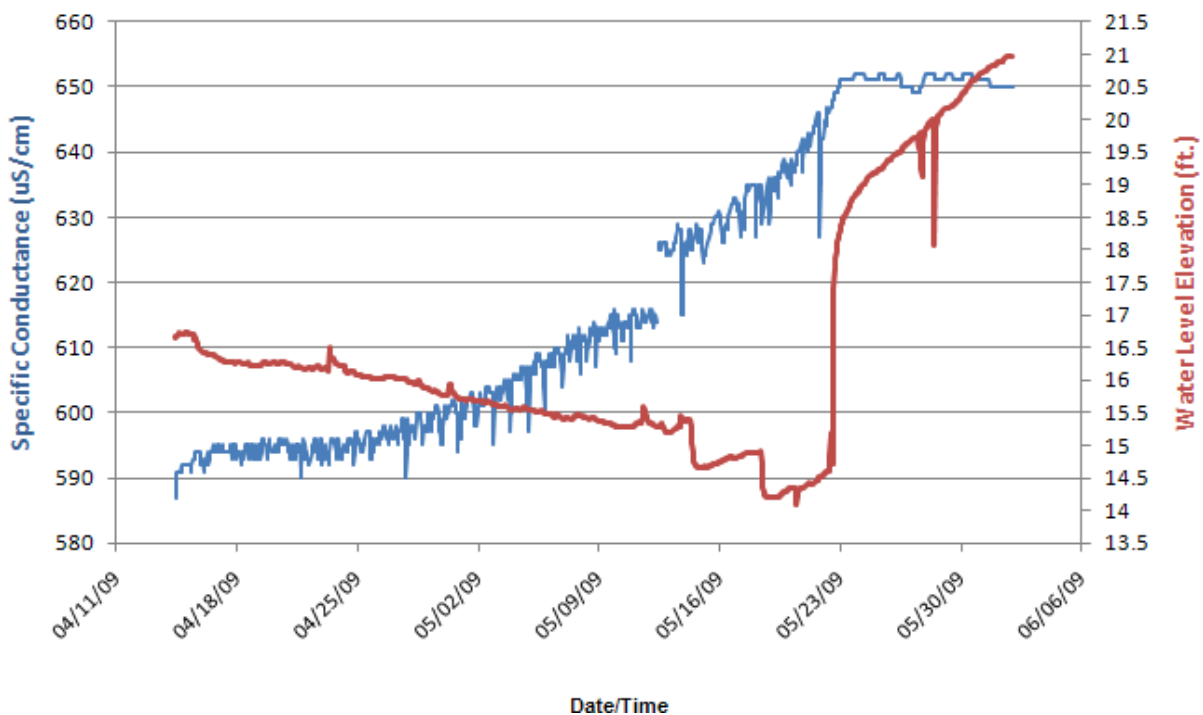
Figure 33. Morris Bridge Sink data-sonde results.

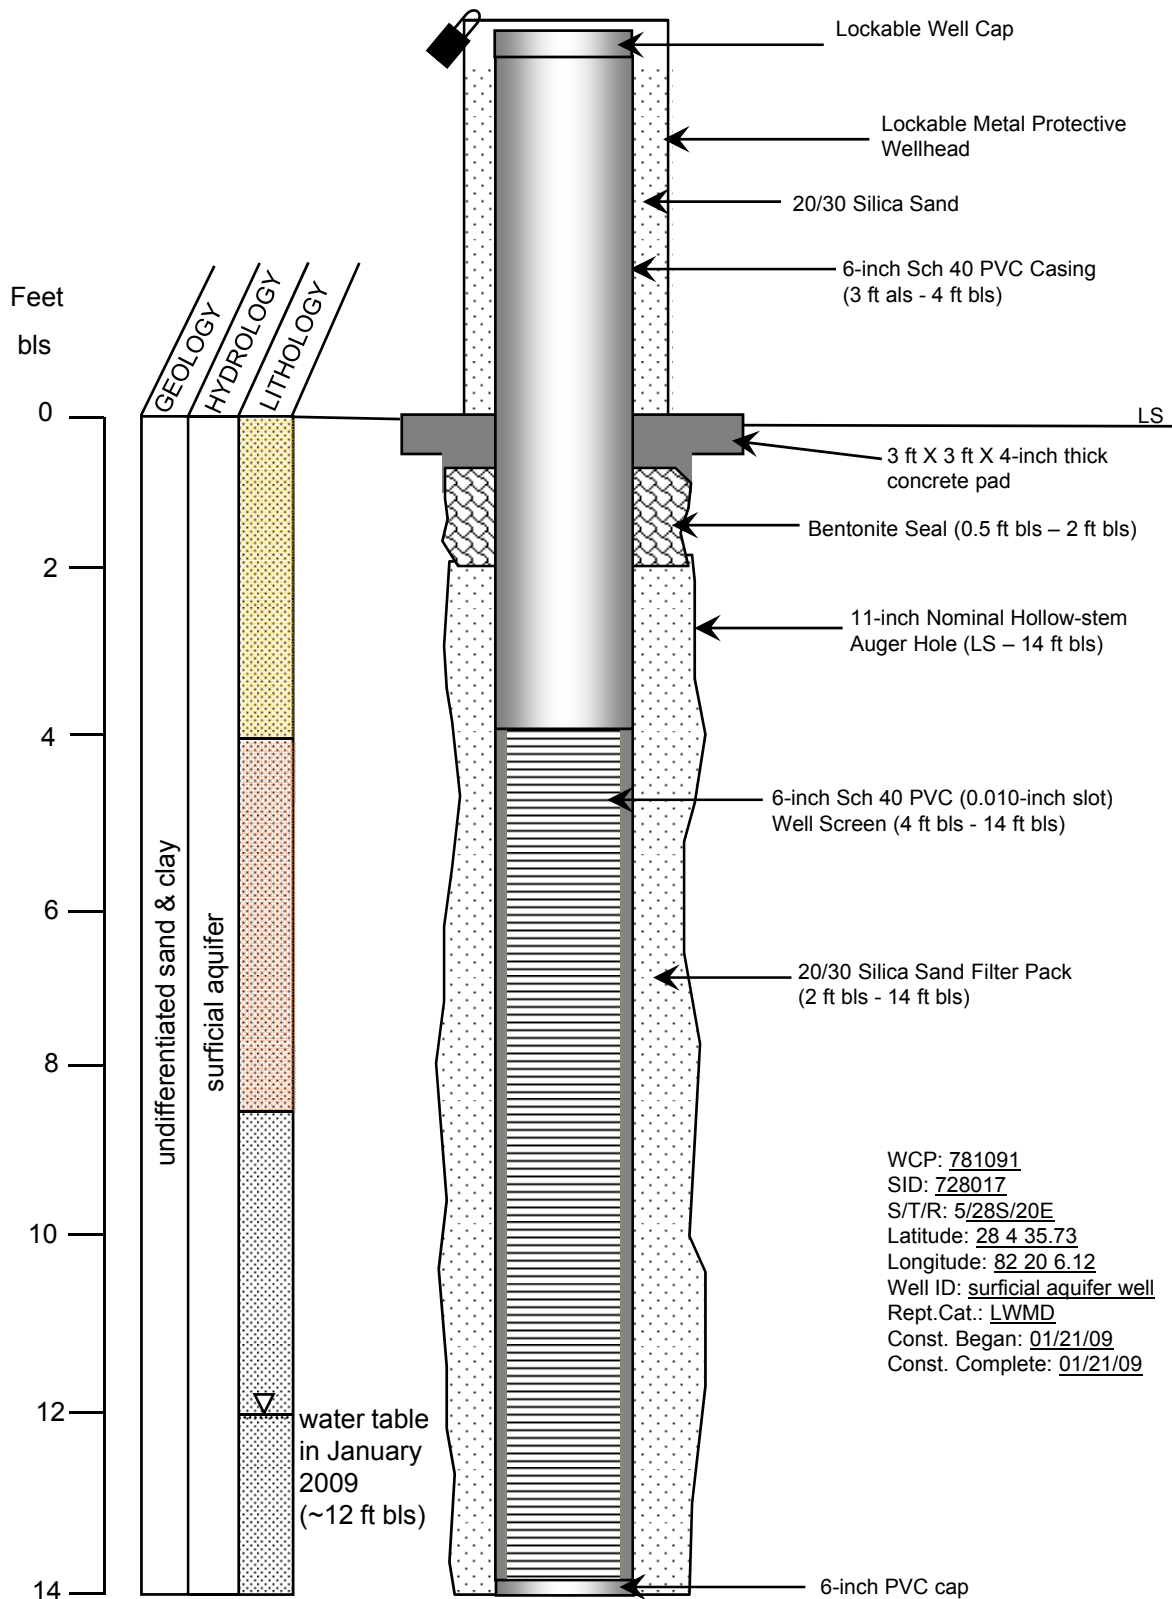
## As-Built for Morris Bridge Idlewood surficial aquifer well

Note: Not to scale

Total Depth is 14 feet bls

The Regional Observation and Monitor-well Program (ROMP) of the Geohydrologic Data Section was tasked to install two monitor-wells for the Morris Bridge Sink pump test. An Upper Floridan aquifer well and a surficial aquifer well were constructed approximately 160 feet southwest of the sink. Huss Drilling Co. installed the Upper Floridan aquifer well from January 19, 2009 to January 21, 2009, using a Failing rotary rig and installed the surficial aquifer well using a CME 75 drilling rig and hollow-stem augers on January 21, 2009.

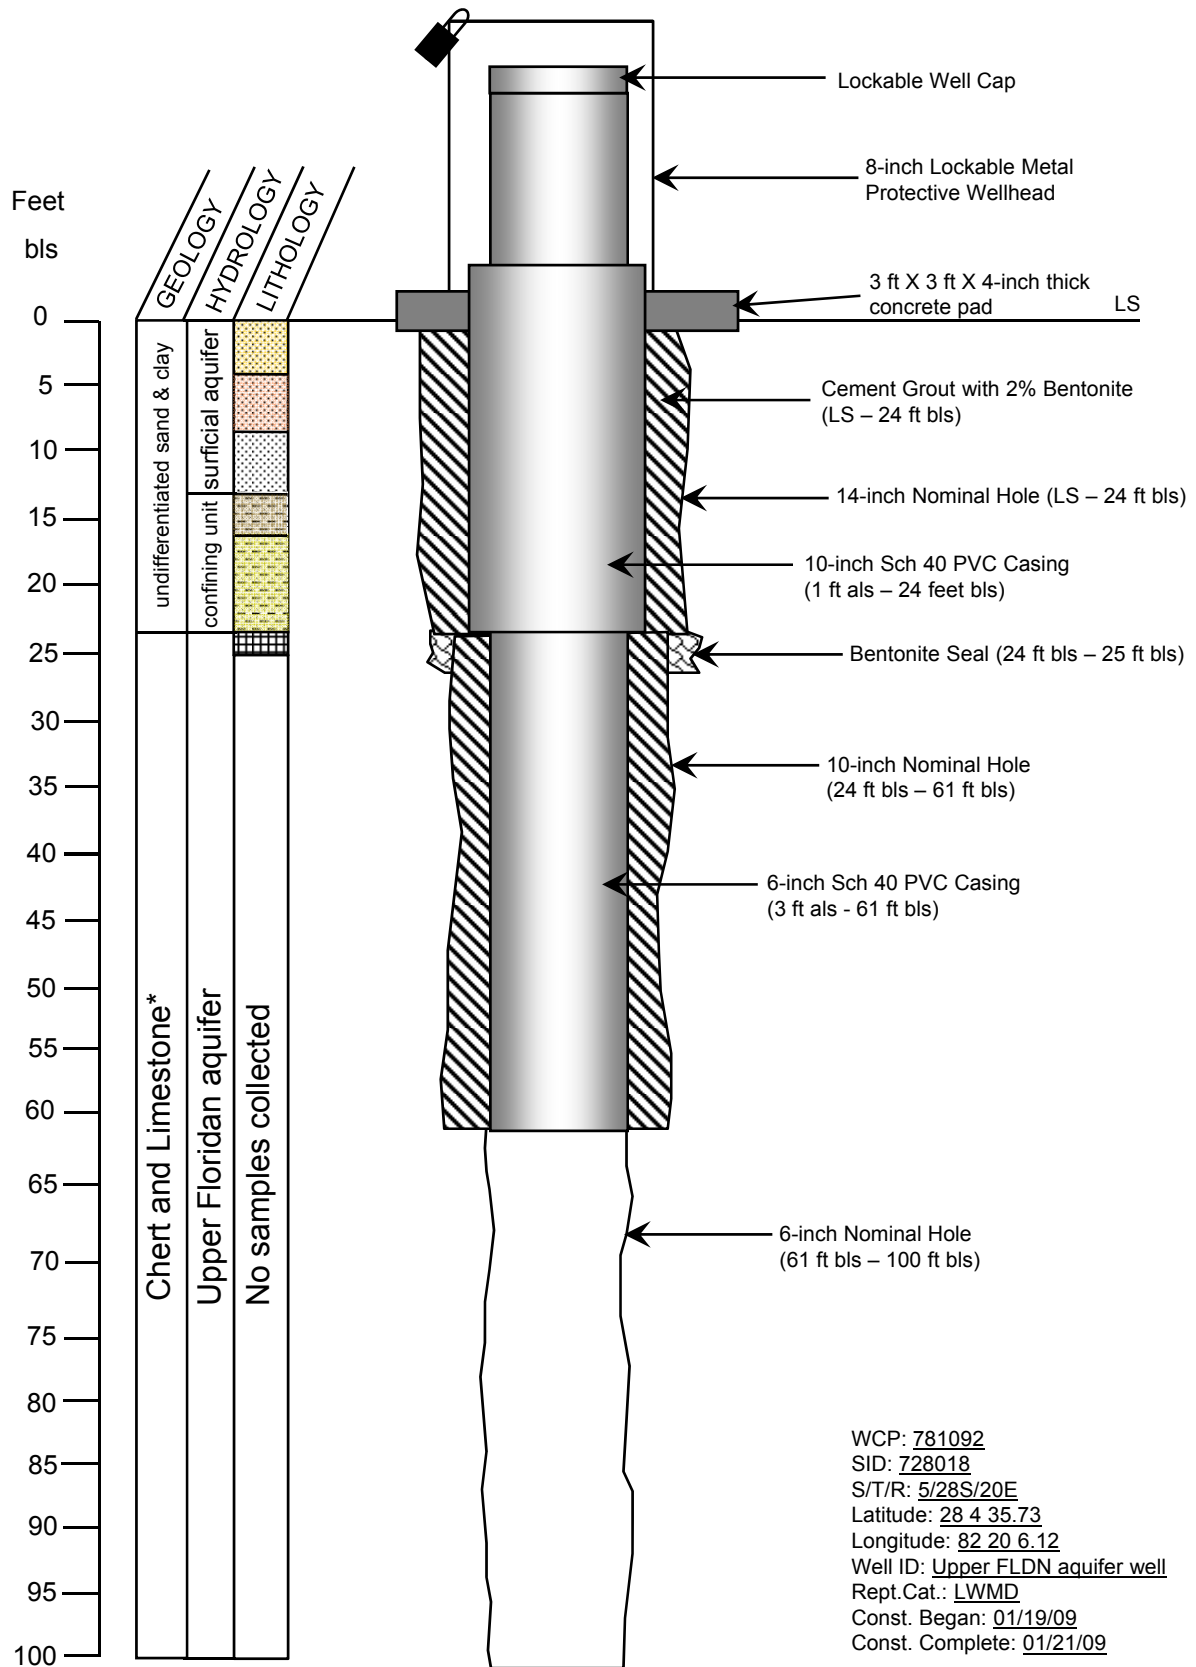
# As-Built for Morris Bridge Idlewood Upper Floridan Well

Note: Not to scale

Total Depth is 100 feet bls

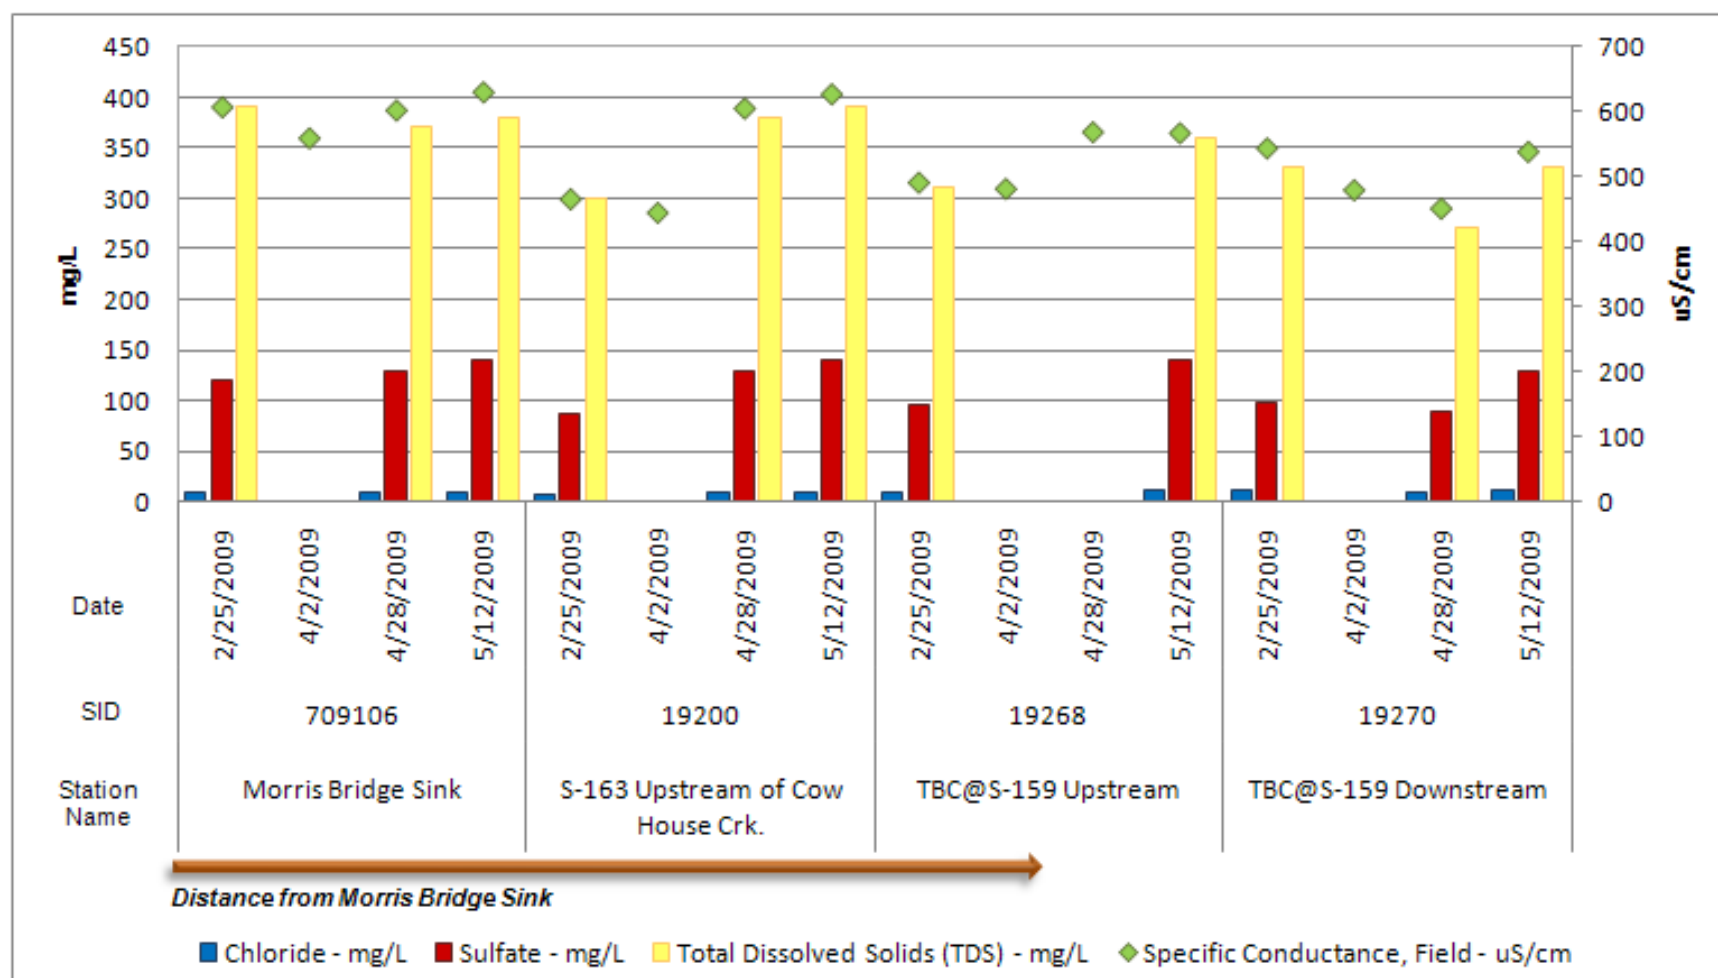
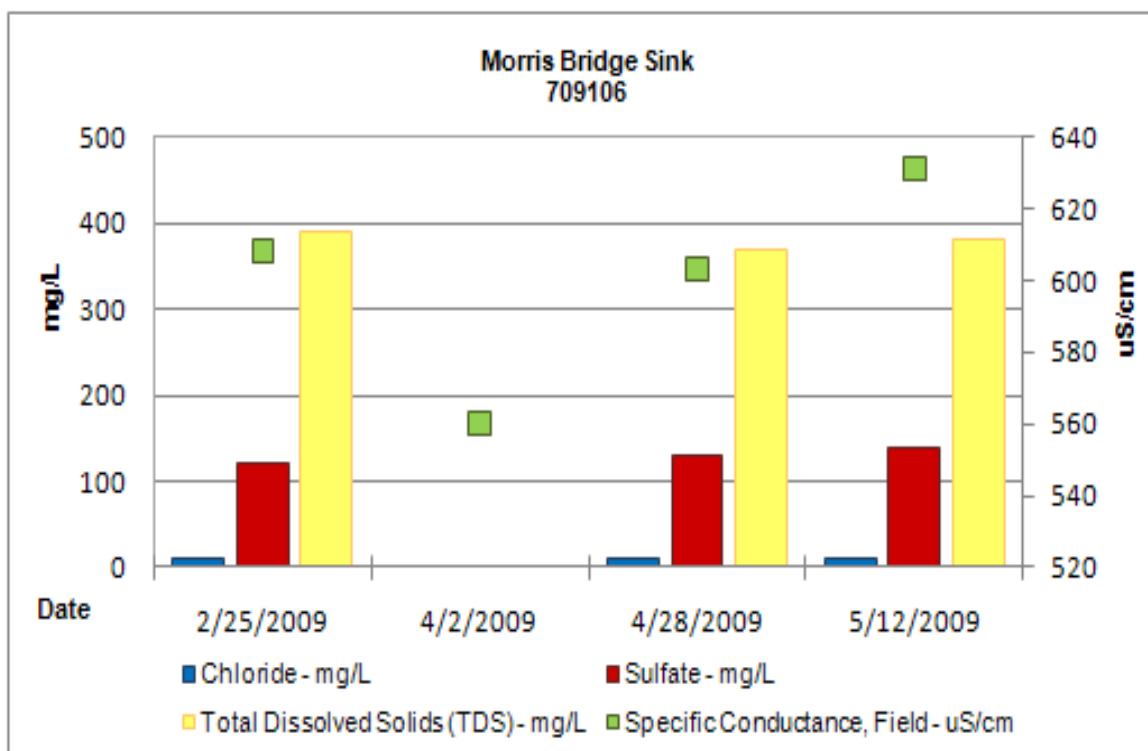
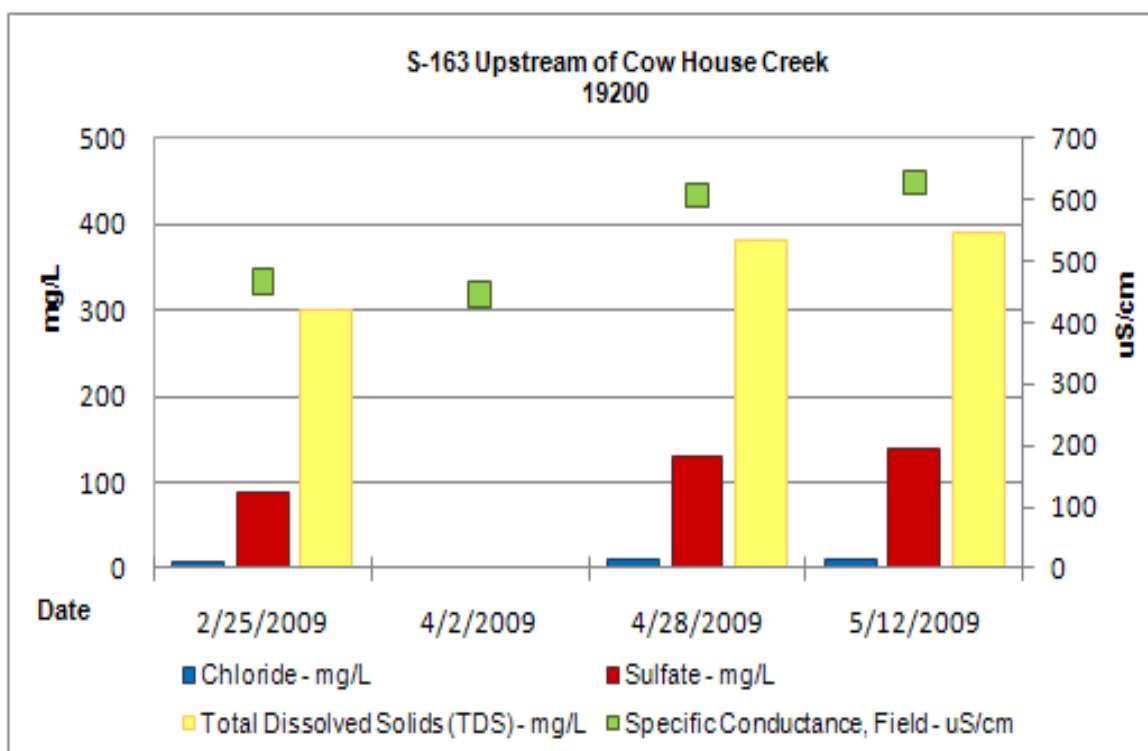
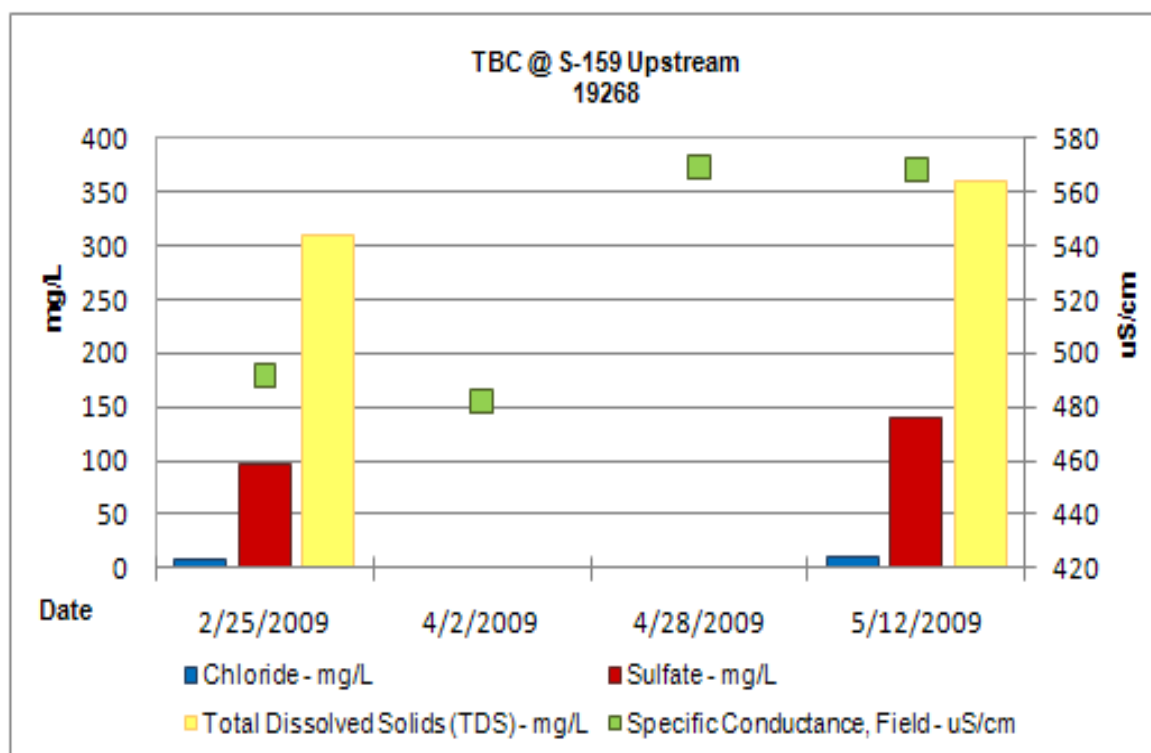
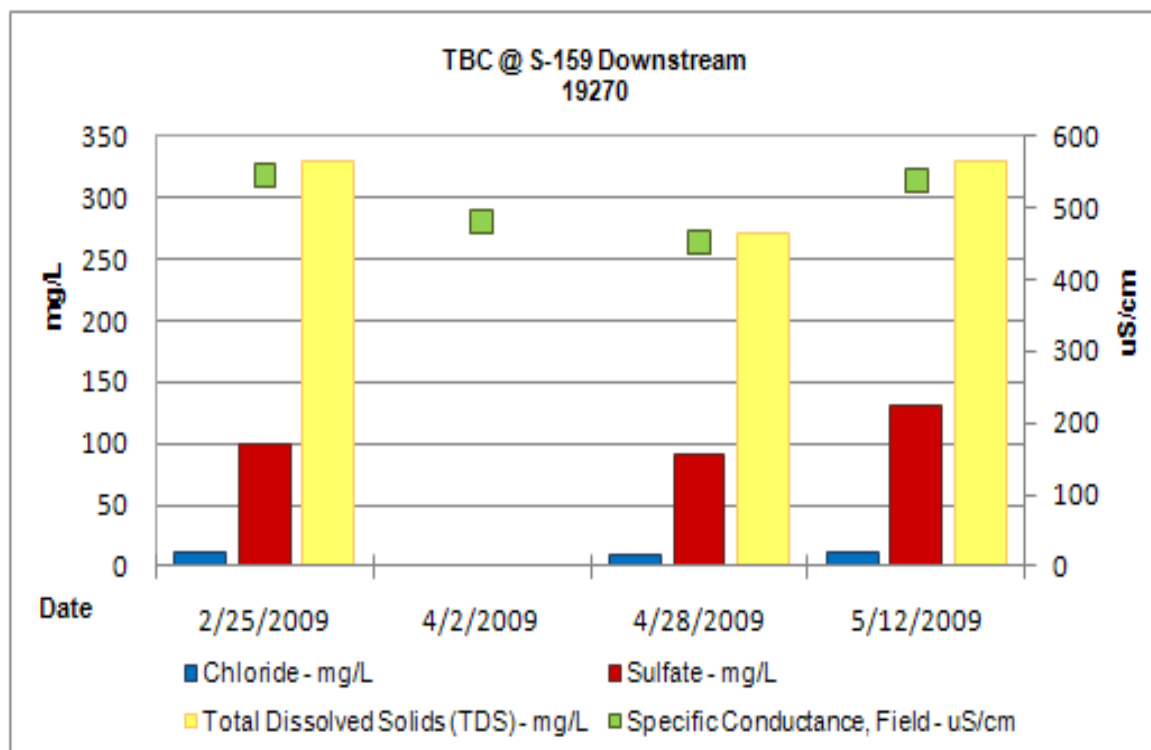
Figure 6.2-2 Select water quality parameters collected from surface water sites as part of the Morris Bridge Sink pumping test.
