# Revised Minimum Levels Based on Reevaluation of Levels Adopted for 41 Southwest Florida Water Management District Wetlands

November 23, 2020

Resource Evaluation Section  
Water Resources Bureau  
**Southwest Florida**  
*Water Management District*

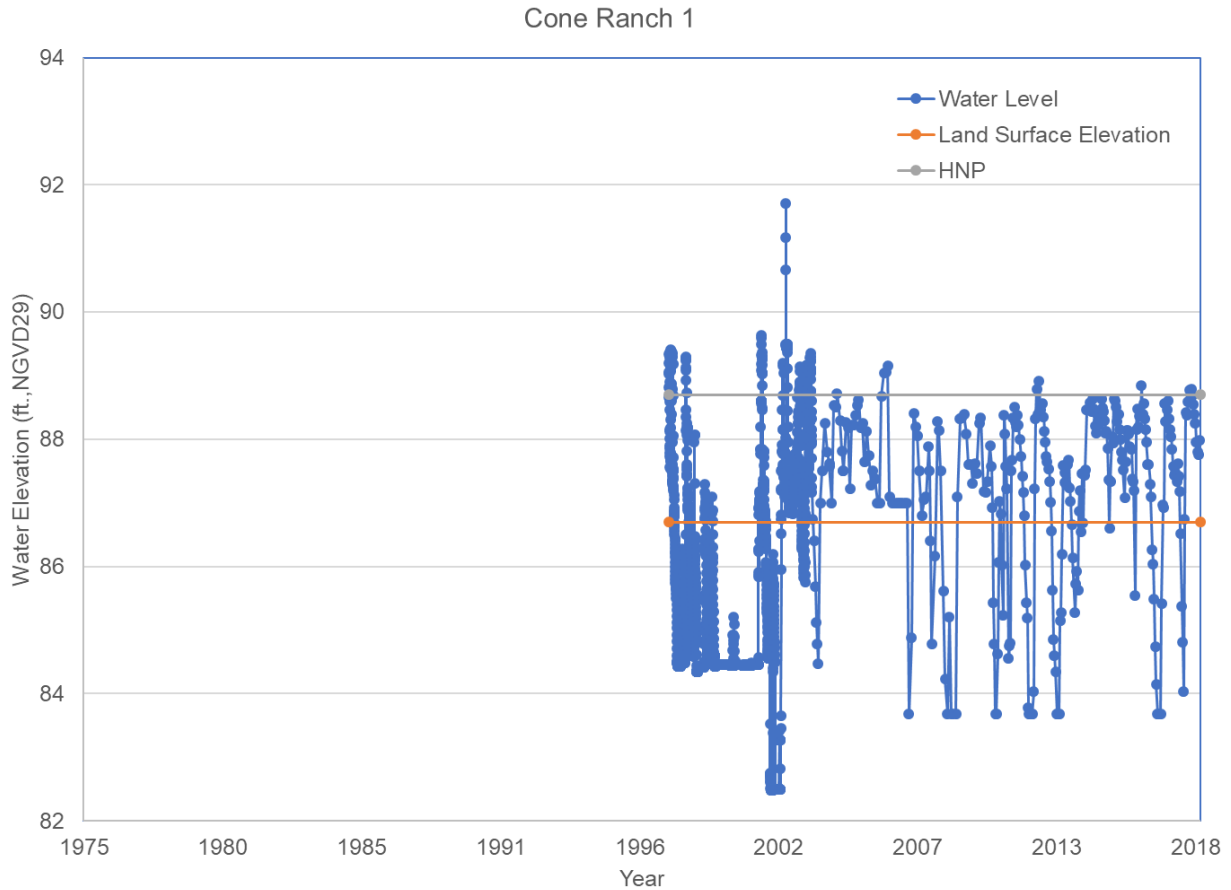
For general monitoring purposes, the District installed an upland well (SID 19357) (and an Upper Floridan aquifer monitor well) at this site in 1996. When the wetland was adopted as an MFL site, the District installed a wetland well (SID 19362) and a staff gage (SID 19361) in 2003 (Figure 4, Figure 5). The wetland well was damaged and replaced in 2007 (SID 701507). A WAP transect was established in 2005. With the exception of the upland well, the District has been exclusively collecting water level data from this site since 2010.

**Figure 5:** Cone Ranch 1 water levels

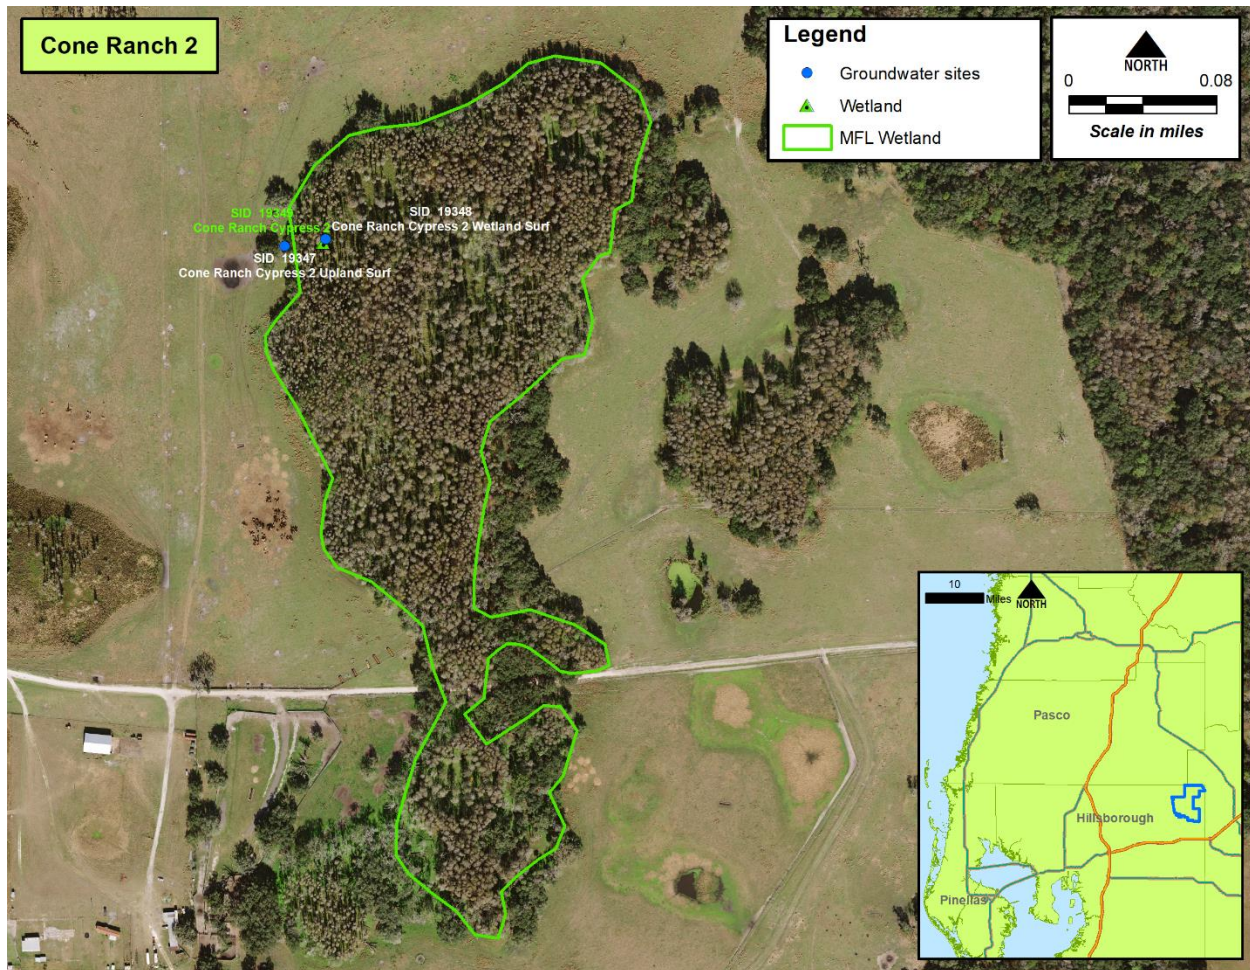
**Figure 6:** Cone Ranch 2 wetland

The Cone Ranch 2 wetland is located in the west-central area of the property, south of Cone Ranch 1 (Figure 3). Cone Ranch 2 is an isolated cypress wetland, and is approximately 30.0 acres in size (Figure 6).

Tampa Bay Water installed a staff gage in 1989 and an upland well in 1990 at this site. When the wetland was adopted as an MFL site, the District installed a staff gage (SID 19349), wetland well (SID 19348), and upland well in 2003 (SID 19347) (Figure 6, Figure 7). A WAP transect was established in 2005. The District has been exclusively collecting water level data from this site since 2010.

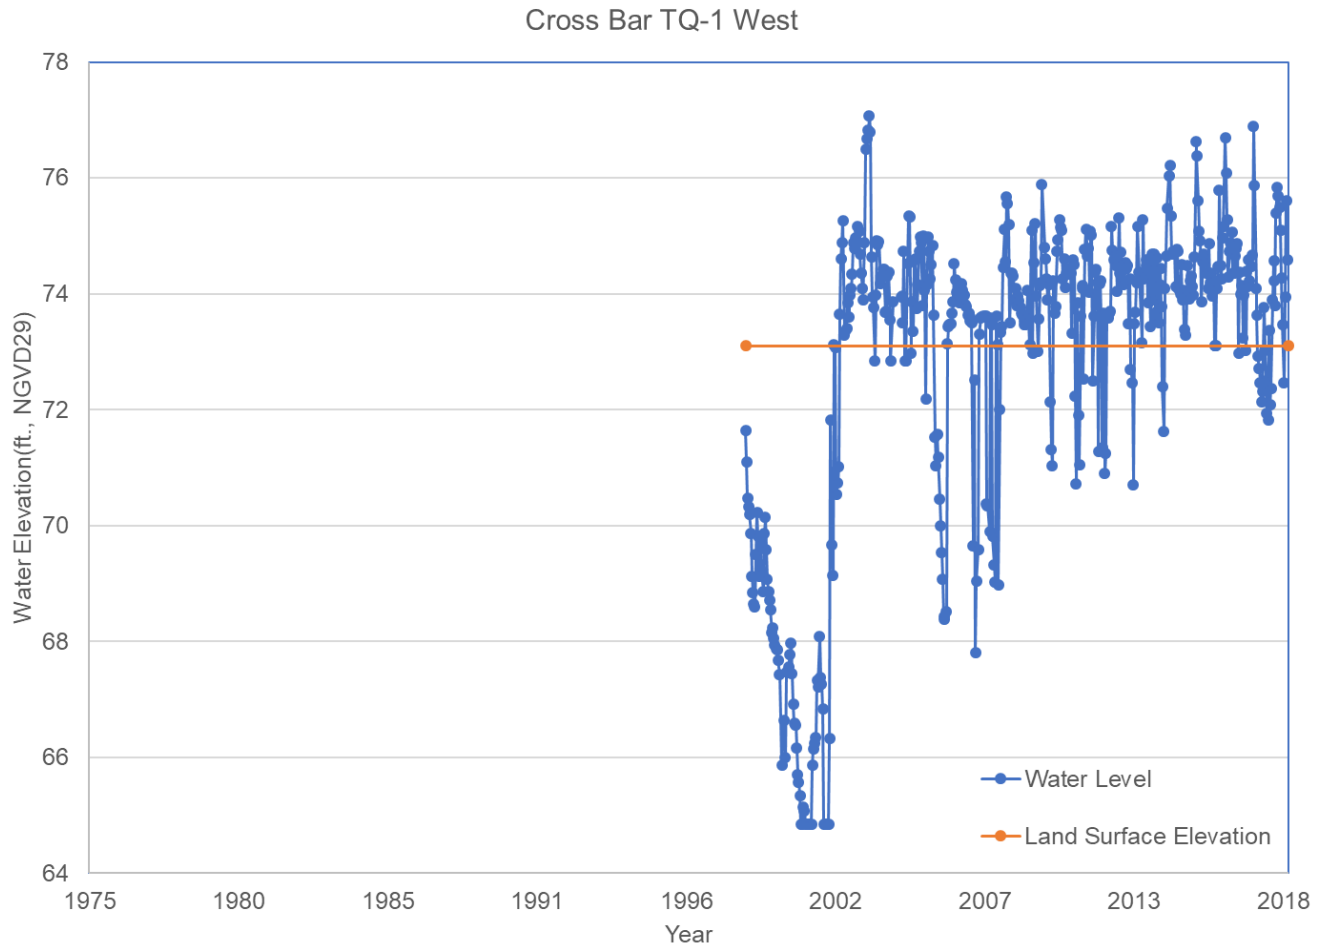
Although some water level data is available from when Pinellas County monitored this wetland, Tampa Bay Water installed a wetland well at this site in 1999 (it has been replaced at least twice). When the wetland was adopted as an MFL site, the District installed wetland (SID 20443) and upland (SID 20444) wells in 2001, and a staff gage in 2002 (SID 20445) (Figure 21, Figure 22). A WAP transect was established in 2005. The District has been exclusively collecting water level data from this site since 2010, and the wetland has been augmented using water withdrawn from the Upper Floridan aquifer by Pinellas County since 2002.

**Figure 22:** Cross Bar TQ-1 West water levels

Some subsidence has been noted at the Cross TQ-1 West wetland, and planted slash pine (recently harvested) has encroached into the transitional zone. Pinellas County began augmenting the wetland because it experienced prolonged dryness for several years. The wetland is surrounded by mostly soils classified as xeric, which is unusual for an isolated cypress swamp. Possibly because the wetland is xeric, an acceptable HNP has not been able to be established at this wetland.

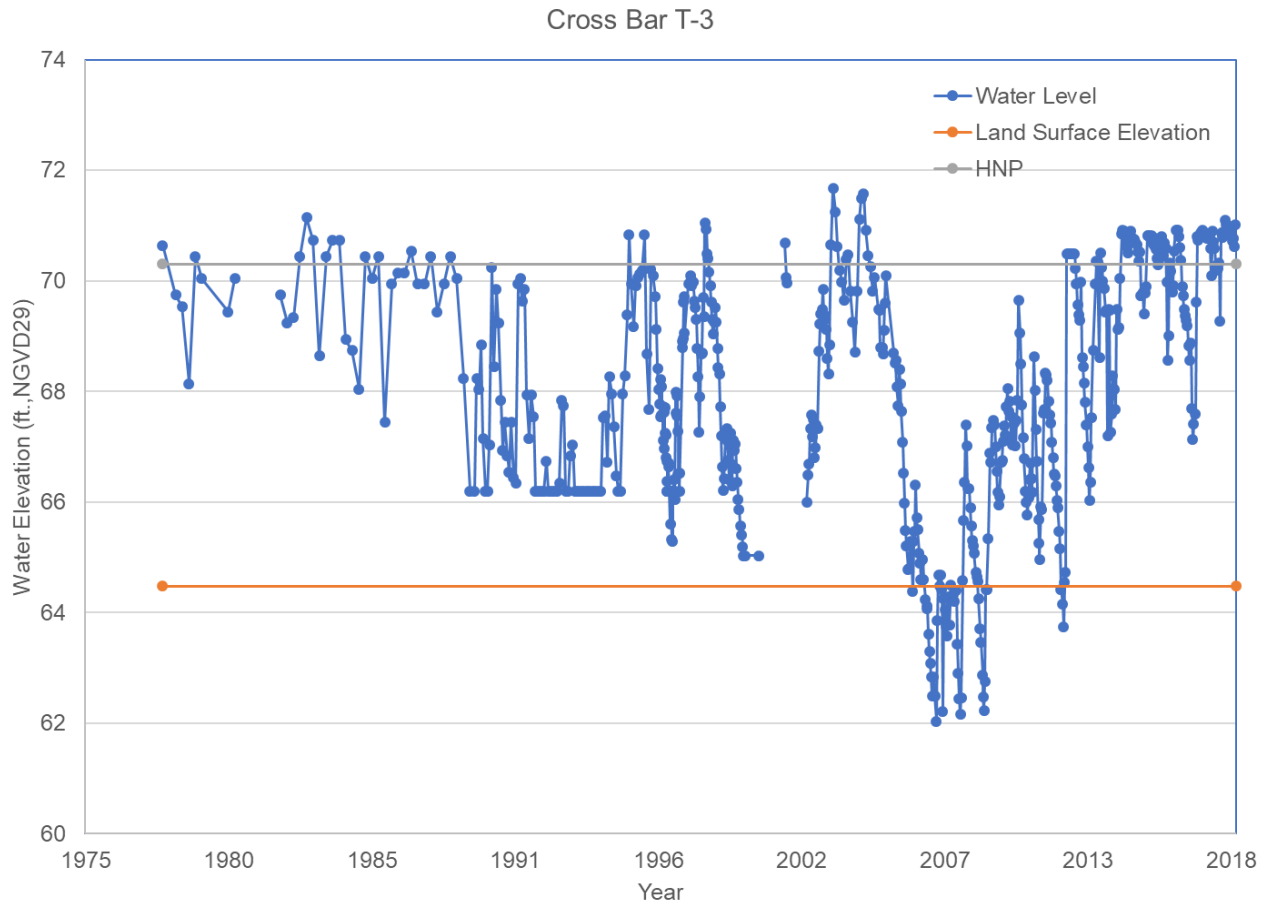
Tampa Bay Water and Pinellas County have monitored water levels in this wetland since the mid-1980s, but data is sparse in the early years. Many of the recorded values in the early years are dry. When the wetland was adopted as an MFL site, the District installed a wetland well (SID 20487) in 2001, and a staff gage (SID 20486) in 2002 (Figure 23, Figure 24). An existing upland well adjacent to the wetland (SID 20484) (with a paired Upper Floridan aquifer monitor well) was installed by the District in 1996 (CB 1SW Shallow), and was adopted as the upland well for this wetland. A WAP transect was established in 2005. The District has been exclusively collecting water level data from this site since 2010.

**Figure 24:** Cross Bar T-3 water levels

Significant subsidence and tree fall have been noted at the Cross Bar T-3 wetland. The wetland is surrounded by mostly soils classified as mesic. An acceptable HNP was established at this wetland using cypress inflection points near the wetland edge (to avoid potential subsidence) at 70.3 feet NGVD29, resulting in a proposed MFL of 68.5 feet NGVD29. The previously adopted MFL at this site was 68.8 feet NGVD29.

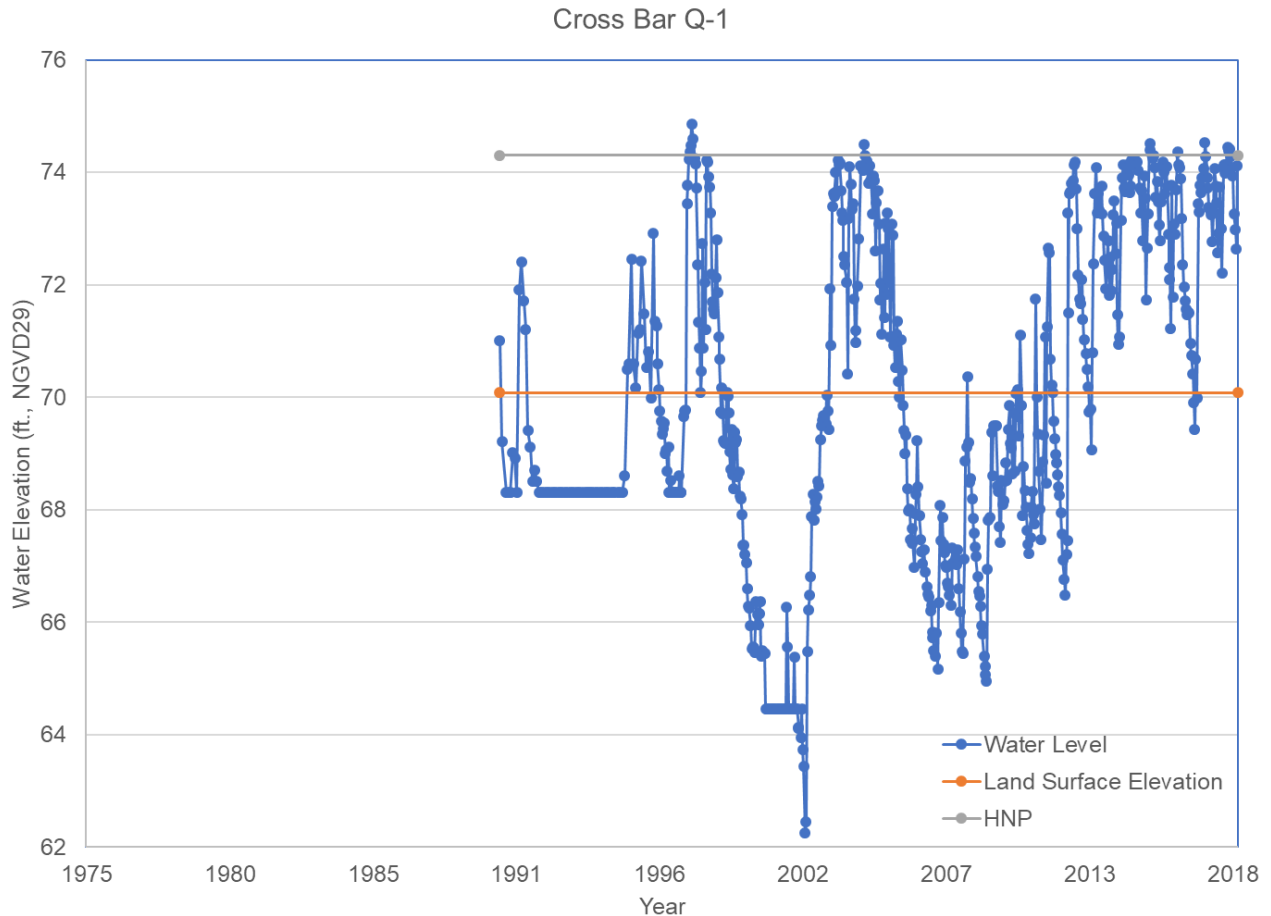
Tampa Bay Water has had various wetland wells installed in this wetland since 1990. When the wetland was adopted as an MFL site, the District installed wetland (SID 20447) and upland (SID 20453) wells in 2001, and a staff gage (SID 20446) in 2002 (Figure 28, Figure 29). A WAP transect was established in 2005. The District has been exclusively collecting water level data from this site since 2010.

**Figure 29:** Cross Bar Q-1 water levels

Significant subsidence and tree fall have been noted at the Cross Bar Q-1 wetland. The wetland is surrounded by mostly soils classified as mesic. An acceptable HNP was established at this wetland using cypress inflection points near the wetland edge (to avoid potential subsidence) at 74.3 feet NGVD29, resulting in an MFL of 72.5 feet NGVD29. The previously adopted MFL at this site was 72.7 feet NGVD29.

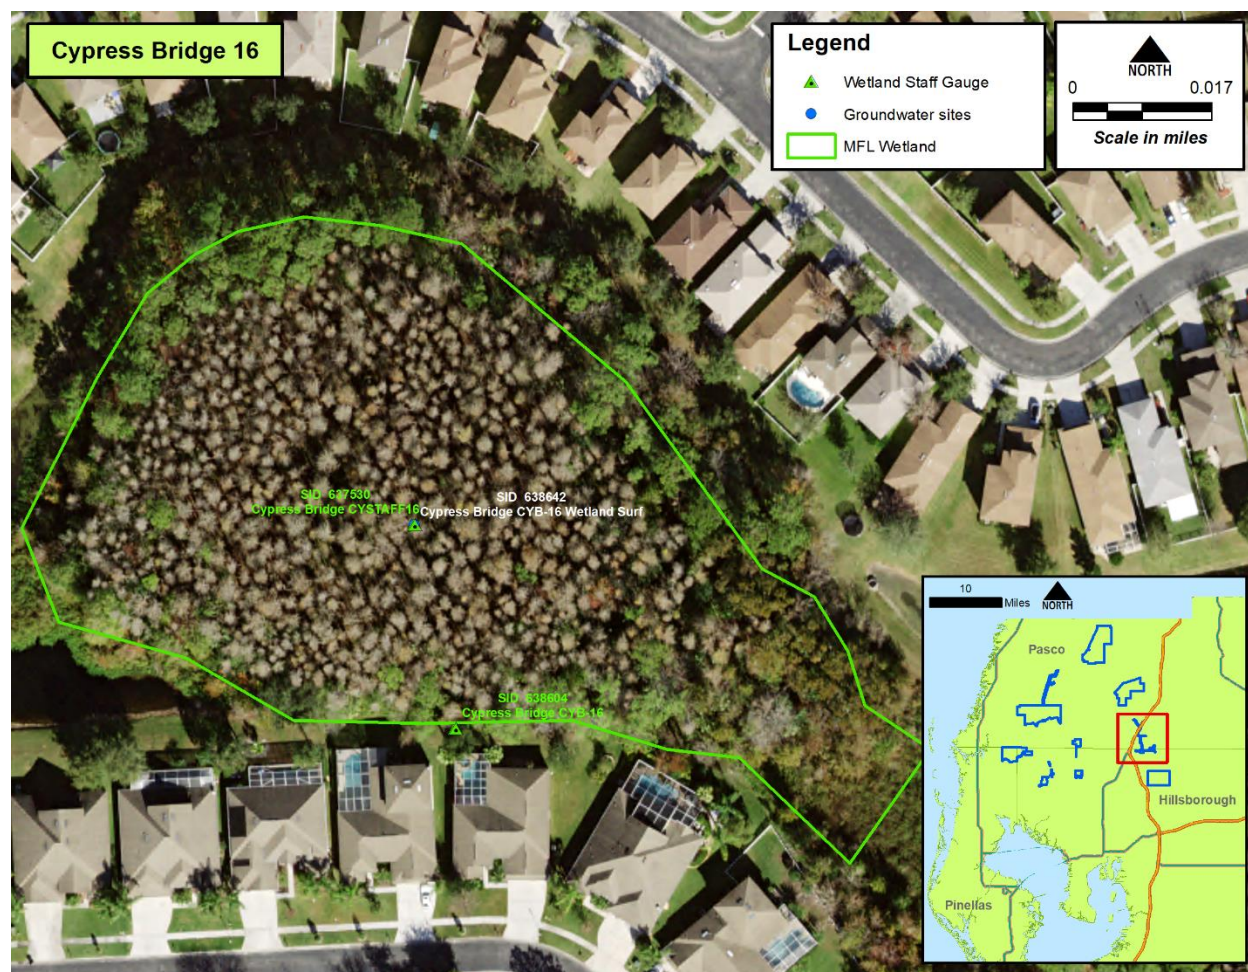
**Figure 31:** Cypress Bridge 16 wetland

Cypress Bridge 16 is located in the northern third of the Cypress Bridge wellfield in Pasco County (Figure 30). The wetland was surrounded by pasture when originally adopted as a MFL site, but is now surrounded by a subdivision. Cypress Bridge 16 is an isolated cypress wetland, and is approximately 2.9 acres in size (Figure 31).

Tampa Bay Water has had a staff gage (SID 637530) in the wetland since 1988, and a wetland well (SID 638642) since 1989. There is no upland well at this wetland (Figure 31, Figure 32). A WAP transect was established in 2005. The District has been exclusively collecting water level data from this site since 2010.

The drainage systems in the area of the Cypress Bridge 16 wetland have been altered as part of a surface water management system installed in the residential development that surrounds the wetland. However, the outlet remains to be a naturalized swale leading to another cypress area. The outlet was surveyed with a control elevation that is 0.8 feet below the HNP (see Appendix B). Figure 32 shows that water levels regularly reach an elevation a few tenths below the HNP, so the swale may be preventing water levels from reaching the natural Historic normal pool. The calculated Historic P50 is 0.6 feet above the MFL, so the MFL is clearly attainable. Therefore, there is no evidence implying significant structural alteration.

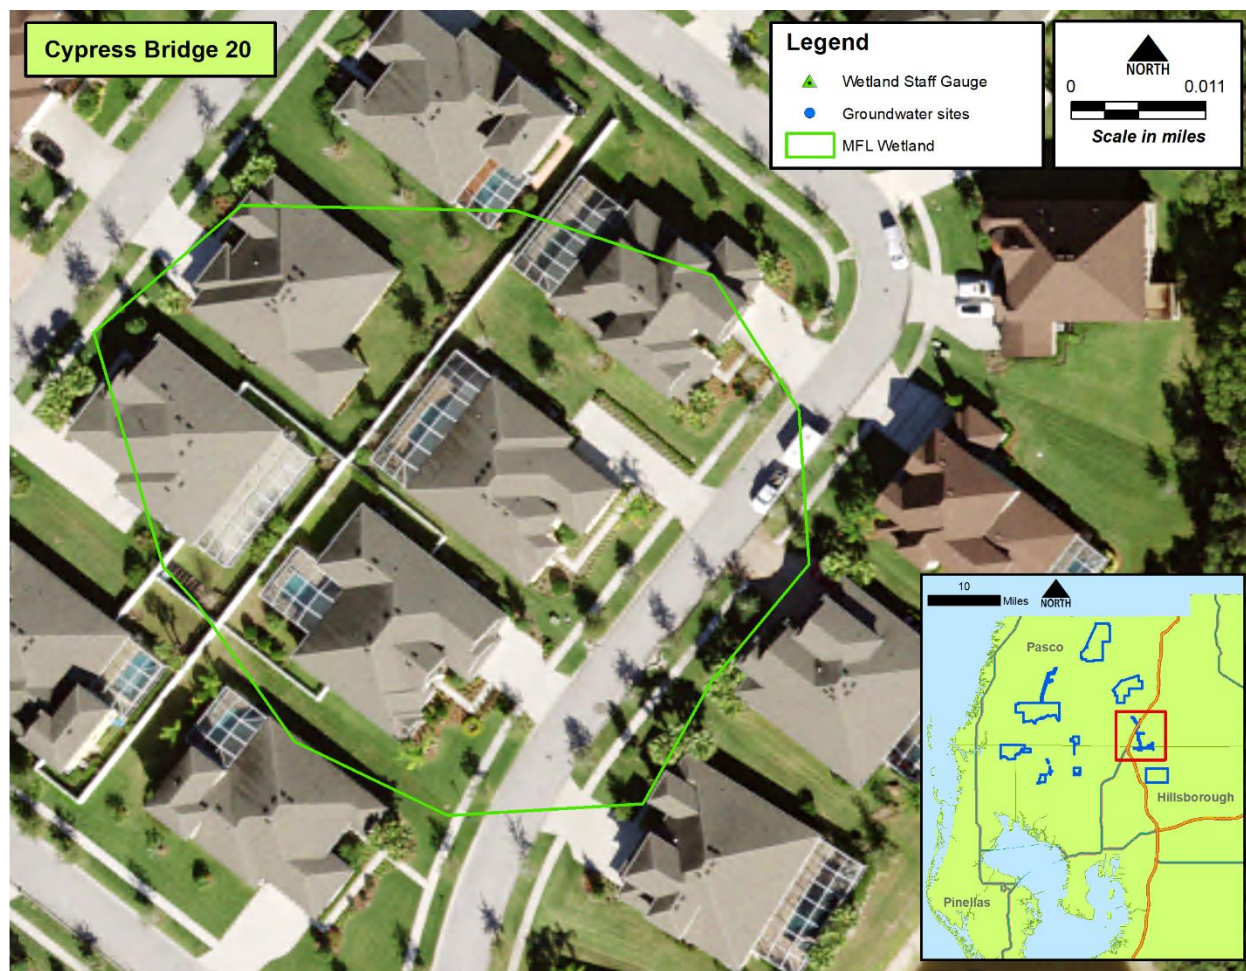
**Figure 41:** Former location of Cypress Bridge 20 wetland

Cypress Bridge 20 was located near the center of the Cypress Bridge wellfield in Pasco County (Figure 30). Cypress Bridge 20 was located in a pasture area when it was chosen as an MFL site, but was mitigated as part of a subdivision development, and no longer exists. Cypress Bridge 20 was an isolated cypress wetland, and was approximately 1.4 acres in size (Figure 41).

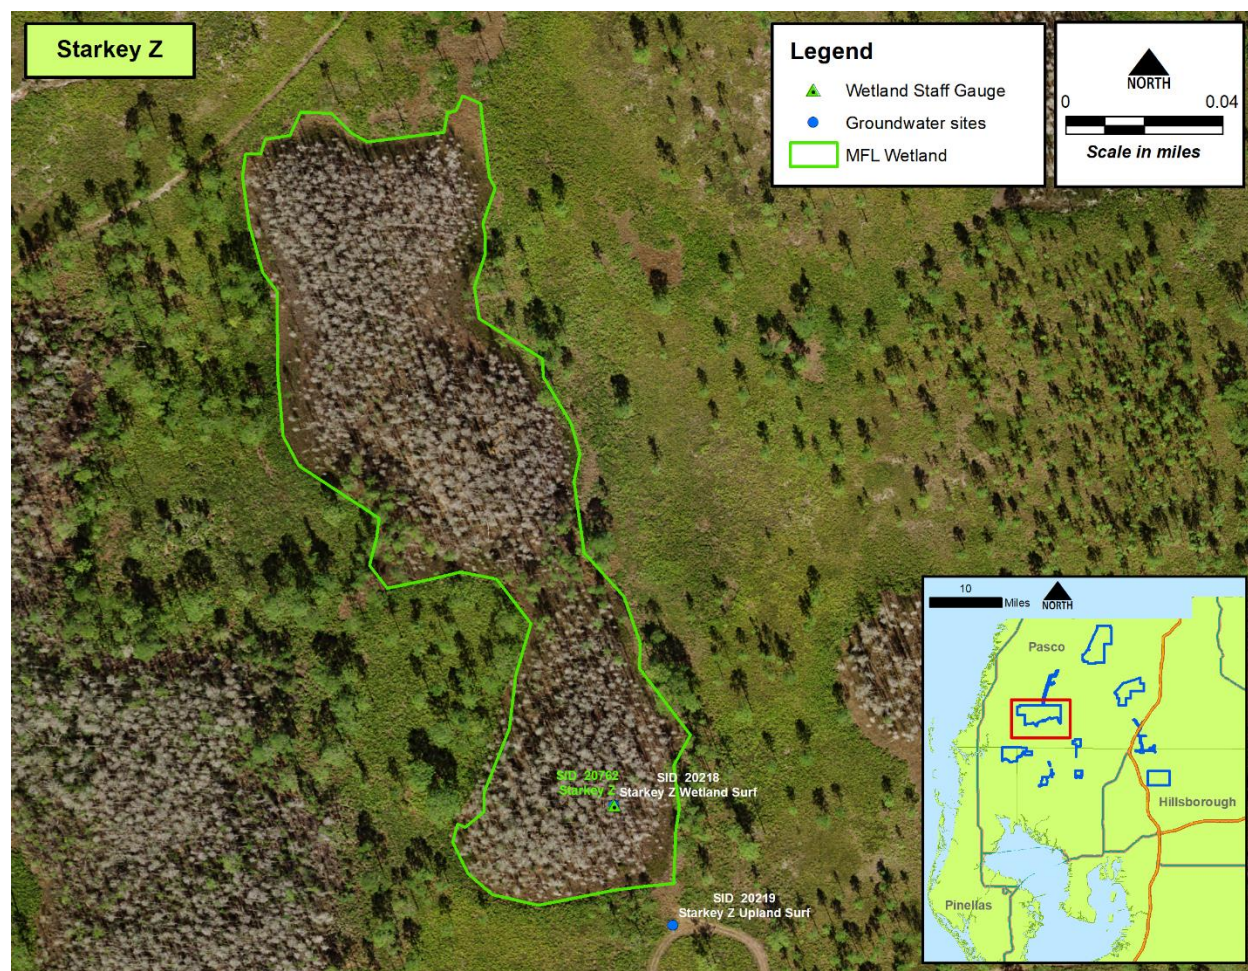
**Figure 93:** Starkey Z wetland

Starkey Z is located toward the center of the wellfield, southeast of Starkey Central, and is an approximately 6.6 acres in size isolated cypress wetland (Figure 85, Figure 93).

The District has had a staff gage (SID 20762) at this site since 1983, and added wetland (SID 20218) and upland (SID 20219) wells in 1999 (Figure 93, Figure 94). The District collects data from all District instruments at this site twice a month through present day. A WAP transect was established in 2005. The District has been exclusively collecting water level data from this site since 2010.
