## **Revised Minimum Levels Based on Reevaluation of Levels Adopted for 41 Southwest Florida Water Management District Wetlands**

April 14, 2020

Resource Evaluation Section

**Southwest Florida**  
*Water Management District*

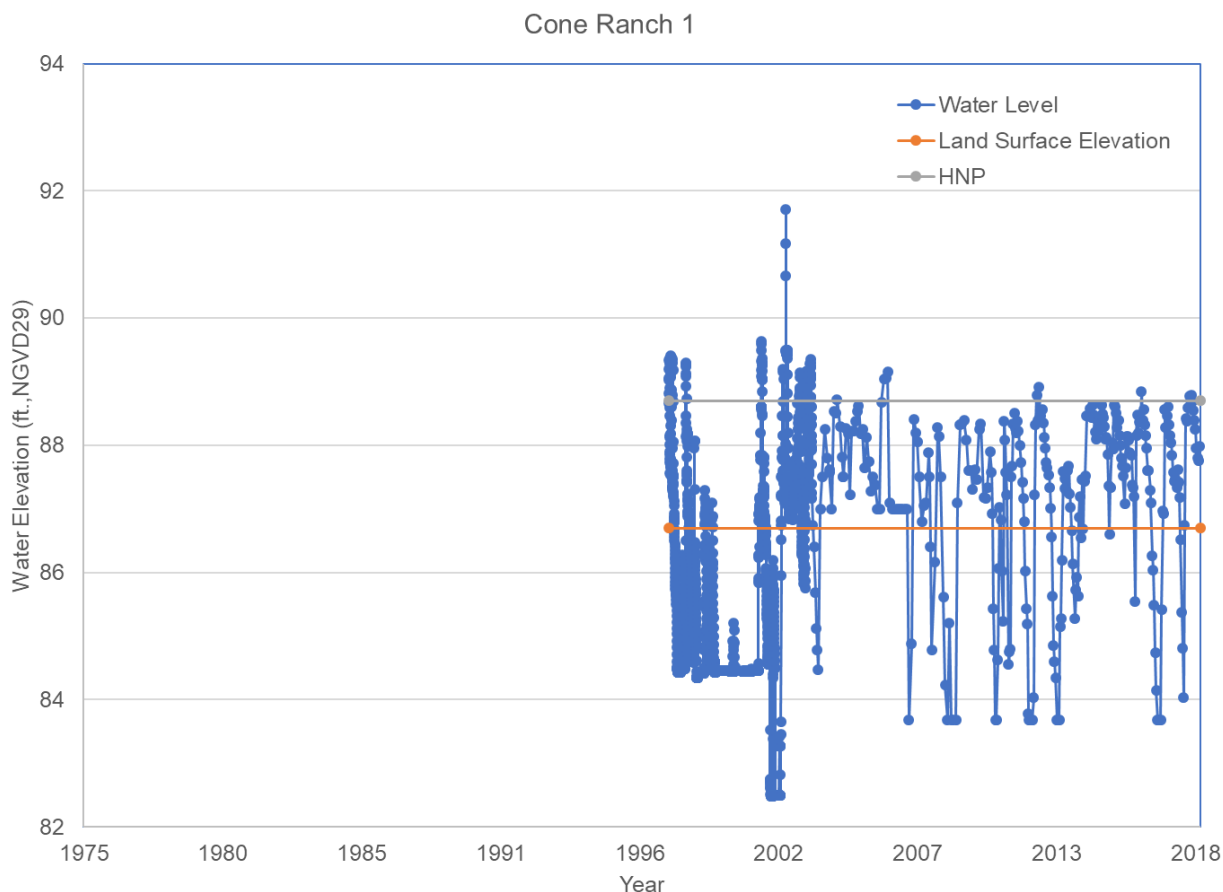
**Figure 5:** Cone Ranch 1 water levels

For general monitoring purposes, the District installed an upland well (SID 19357) (and an Upper Floridan aquifer monitor well) at this site in 1996. When the wetland was adopted as an MFL site, the District installed a wetland well (SID 19362) and a staff gage (SID 19361) in 2003 (Figure 4, Figure 5). The wetland well was damaged and replaced in 2007 (SID 701507). A WAP transect was established in 2005. With the exception of the upland well, the District has been exclusively collecting water level data from this site since 2010.

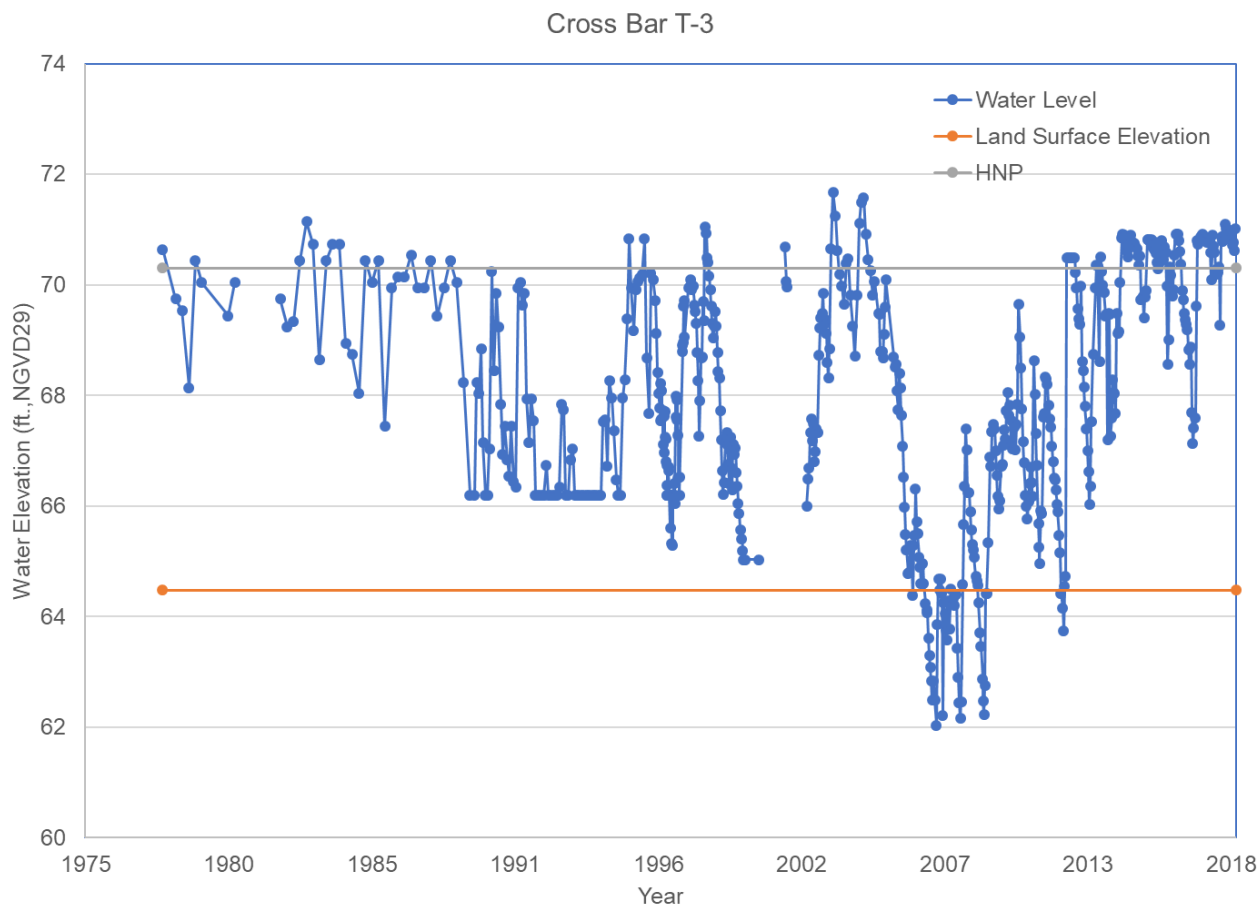
**Figure 24:** Cross Bar T-3 water levels

Tampa Bay Water and Pinellas County have monitored water levels in this wetland since the mid-1980s, but data is sparse in the early years. Many of the recorded values in the early years are dry. When the wetland was adopted as an MFL site, the District installed a wetland well (SID 20487) in 2001, and a staff gage (SID 20486) in 2002 (Figure 23, Figure 24). An existing upland well adjacent to the wetland (SID 20484) (with a paired Upper Floridan aquifer monitor well) was installed by the District in 1996 (CB 1SW Shallow), and was adopted as the upland well for this wetland. A WAP transect was established in 2005. The District has been exclusively collecting water level data from this site since 2010.

Significant subsidence and tree fall have been noted at the Cross Bar T-3 wetland. The wetland is surrounded by mostly soils classified as mesic. An acceptable HNP was established at this wetland using cypress inflection points near the wetland edge (to avoid potential subsidence) at 70.3 feet NGVD29, resulting in a proposed MFL of 68.5 feet NGVD29. The previously adopted MFL at this site was 68.8 feet NGVD29.

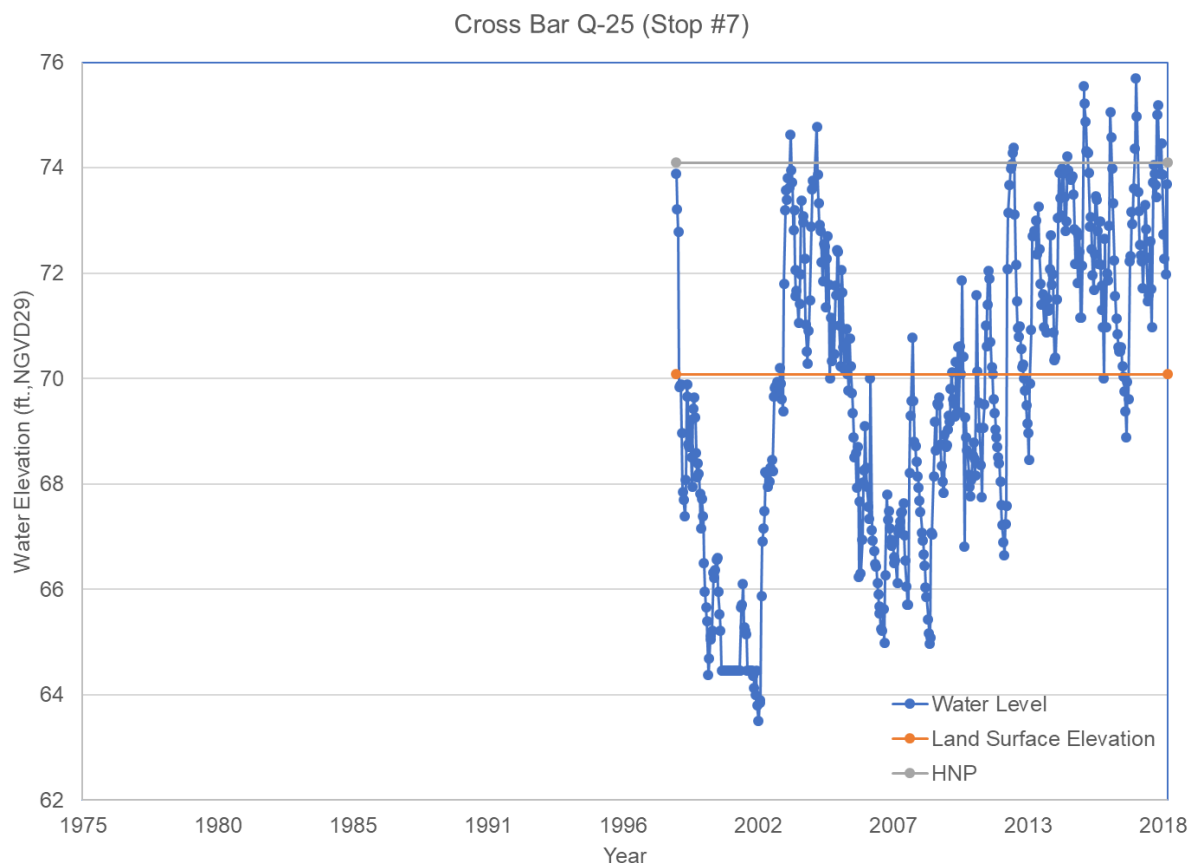
**Figure 26:** Cross Bar Q-25 (Stop #7) water levels

Tampa Bay Water installed a wetland well at this site in 1999. When the wetland was adopted as an MFL site, the District installed wetland (SID 20450) and upland (SID 20449) wells in 2001, and a staff gage (SID 20452) in 2002 (Figure 25, Figure 26). A WAP transect was established in 2005. The District has been exclusively collecting water level data from this site since 2010.

Significant subsidence and tree fall have been noted at the Cross Bar Q-25 (Stop #7) wetland. Upon further investigation, it was observed that the north and south sides of the wetland had normal pool indicators present at different elevations, indicating that the level of subsidence was not consistent across the whole wetland. Additionally, the variability amongst normal pool indicator elevations in the north side of the wetland were very large. The wetland is surrounded by mostly soils classified as mesic. The currently adopted MFL at this site is 72.3 feet NGVD29.

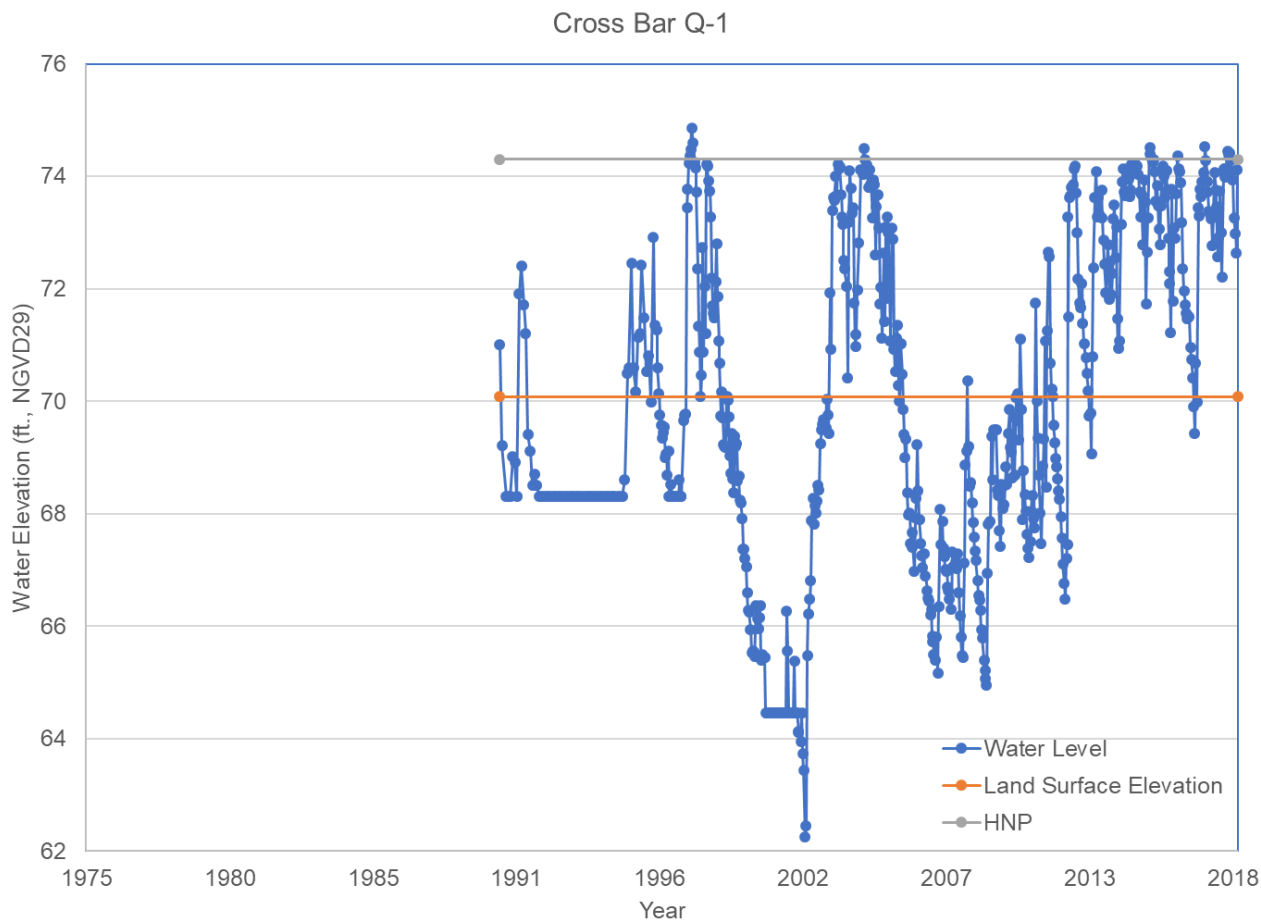
**Figure 29:** Cross Bar Q-1 water levels

Tampa Bay Water has had various wetland wells installed in this wetland since 1990. When the wetland was adopted as an MFL site, the District installed wetland (SID 20447) and upland (SID 20453) wells in 2001, and a staff gage (SID 20446) in 2002 (Figure 28, Figure 29). A WAP transect was established in 2005. The District has been exclusively collecting water level data from this site since 2010.

Significant subsidence and tree fall have been noted at the Cross Bar Q-1 wetland. The wetland is surrounded by mostly soils classified as mesic. An acceptable HNP was established at this wetland using cypress inflection points near the wetland edge (to avoid potential subsidence) at 74.3 feet NGVD29, resulting in an MFL of 72.5 feet NGVD29. The previously adopted MFL at this site was 72.7 feet NGVD29.
