Environmental Monitoring of Crystal River/Kings Bay

Published on June 26, 2025

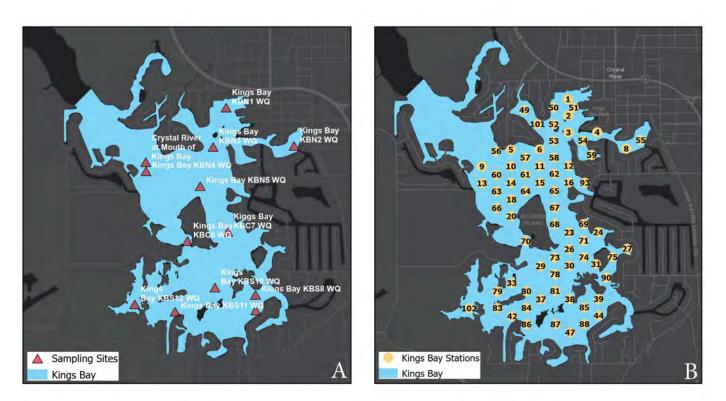
Figure 2: Sampling locations for (A) surface water sites and (B) submerged aquatic vegetation in Kings Bay.

The maps below (Fig 2) indicate the sampling locations for some of the environmental conditions collected within Kings Bay.

At each of these locations (Fig 2A), surface water samples and measurements are collected and include parameters such as water clarity, total nitrogen, total phosphorus, chlorophyll, specific conductance, and temperature. Water clarity is recorded from horizontal secchi measurements. Chlorophyll, total nitrogen, and total phosphorus data are reported as an average of the twelve surface water sites. Water clarity data are recorded from horizontal secchi measurements at KBN2 for Hunter Cove and at KBN1, KBN3, KBN4, KBN5, KBC6, KBC7, KBS8, KBS10, KBS11, and KBS12 for Kings Bay Proper (Fig 2A).

Seventy-one sampling locations (Fig 2B), which are referred to as stations, are used to evaluate SAV in Kings Bay and are currently mapped during the winter and summer of each year. SAV data may be requested by emailing the Springs Team at SpringsTeam@WaterMatters.org.

Submerged aquatic vegetation (SAV) is mapped in the winter and summer of each year at specified locations called stations (see Fig 2B). Quadrats, which are square frames made of PVC pipe as seen in Figure 8, are used to measure coverage of species present. At each of these stations, three 0.25 m^2 quadrats are randomly tossed. The average of these three quadrats is used to capture the percent coverage at each station.

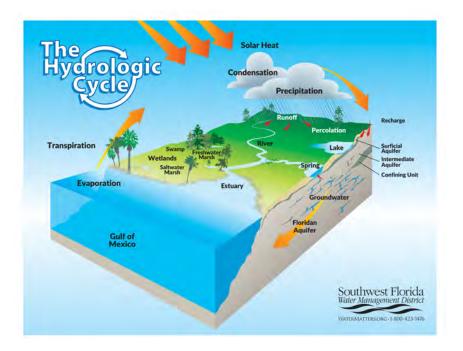
Figure 5: Hydrologic cycle showing how recharge occurs.

The amount of rainfall a region receives affects the amount of water that flows from a spring. As rain falls to the ground, it is absorbed and percolates downward into the limestone bedrock. The limestone holds the water like a sponge, and the water becomes part of the Floridan Aquifer. This natural replenishment of the aquifer through rainfall is referred to as recharge, and is demonstrated in Figure 5.

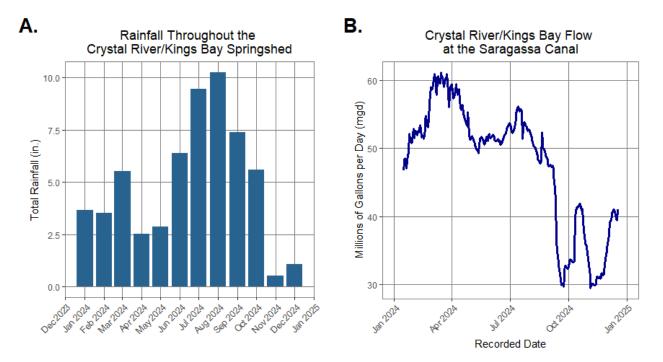
Figure 6: (A) Rainfall in the Crystal River/Kings Bay Springshed influences the (B) amount of springflow.

Due to the complexity of the aquifer system, travel time can take days to years before the water reaches the spring vent. However, patterns between rainfall and spring flow (Figure 6) can still be seen.

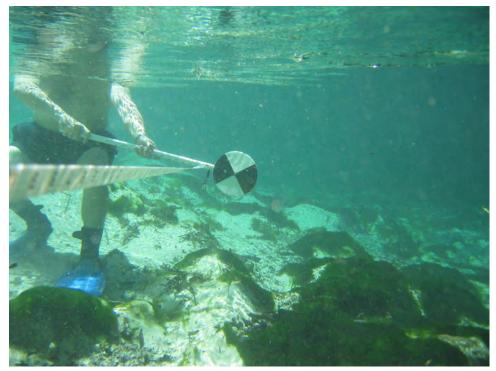
Figure 7: A secchi disk is used to measure water clarity.

Water clarity is measured using horizontal secchi measurements. A secchi disk is a black and white circular disk used by scientists to measure the distance until the disk is no longer visible. This method is often used by lowering the disk from a boat, but water clarity in springs often exceeds river depth. Horizontal secchi measurements are therefore conducted, where a diver swims until the disk is no longer visible. An example of this process is shown in Figure 7.

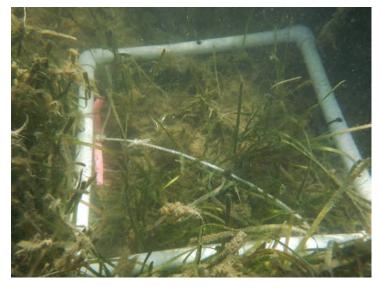
Figure 8: A quadrat is used to measure percent coverage of SAV species in Kings Bay.

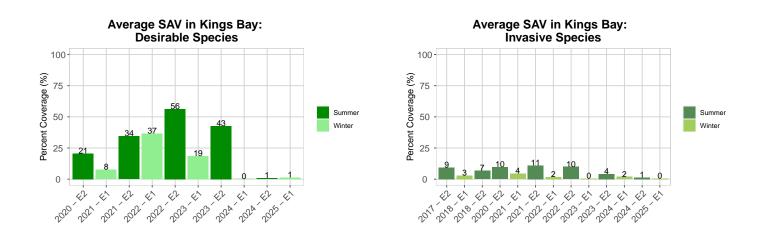
The below graphs show the average desirable and invasive SAV species present in Kings Bay.
