Lake Tarpon Surface Water Improvement and Management (SWIM) Plan Update

August 2024 DRAFT

Southwest Florida
Water Management District

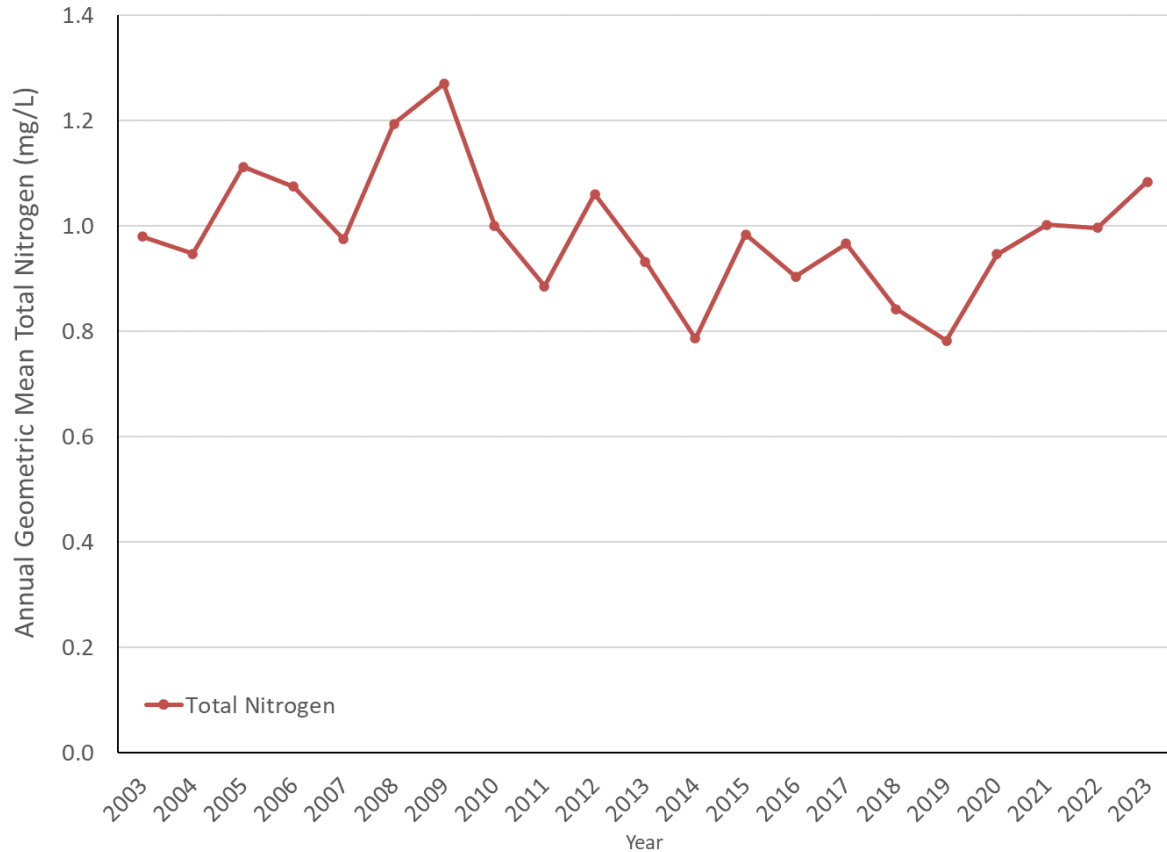
Figure 4 – Time series of TN (mg/L) annual geometric means for the period 2003 to 2023

Annual geometric means for total nitrogen concentrations in Lake Tarpon over the period 2003-2023 ranged from approximately 0.8 – 1.27 mg/L (Figure 4). At no time did the TN concentrations exceed the TN NNC of 1.27 mg/L. In 2009, the annual geometric mean equaled the TN NNC (Figure 4). As the data sets met the requirements of parametric statistical analysis of normality and homogeneity of variance, linear regression was used. This analysis did not detect a trend over time ($p>0.05$).

Statistical analysis did not detect a significant trend

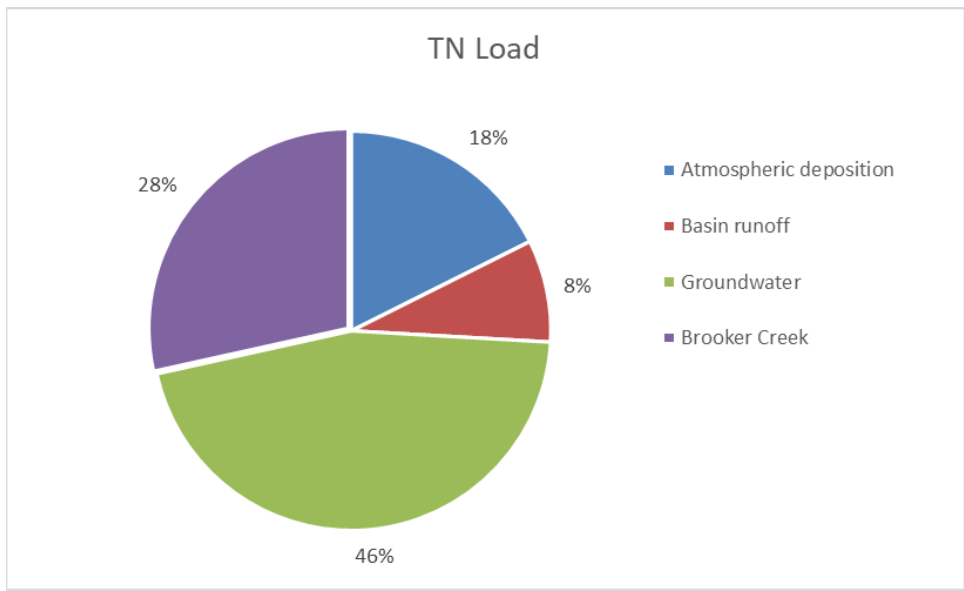
Figure 10 - Pie chart of TN loads from all sources during 2013 to 2023

Figures 10 and 11 partition out TN and TP loads into the sources of atmospheric deposition, basin runoff, groundwater inflows, and loads from Brooker Creek, respectively.

For both TN and TP, the dominant loading source appears to be surficial groundwater inflows. These findings are consistent with the results of the loading model included in the Lake Tarpon Water Quality Management Plan (Atkins/ESA, 2017). However, there is a substantial amount of variability in estimates of sources of TN and TP loads, as well as the quantities involved.

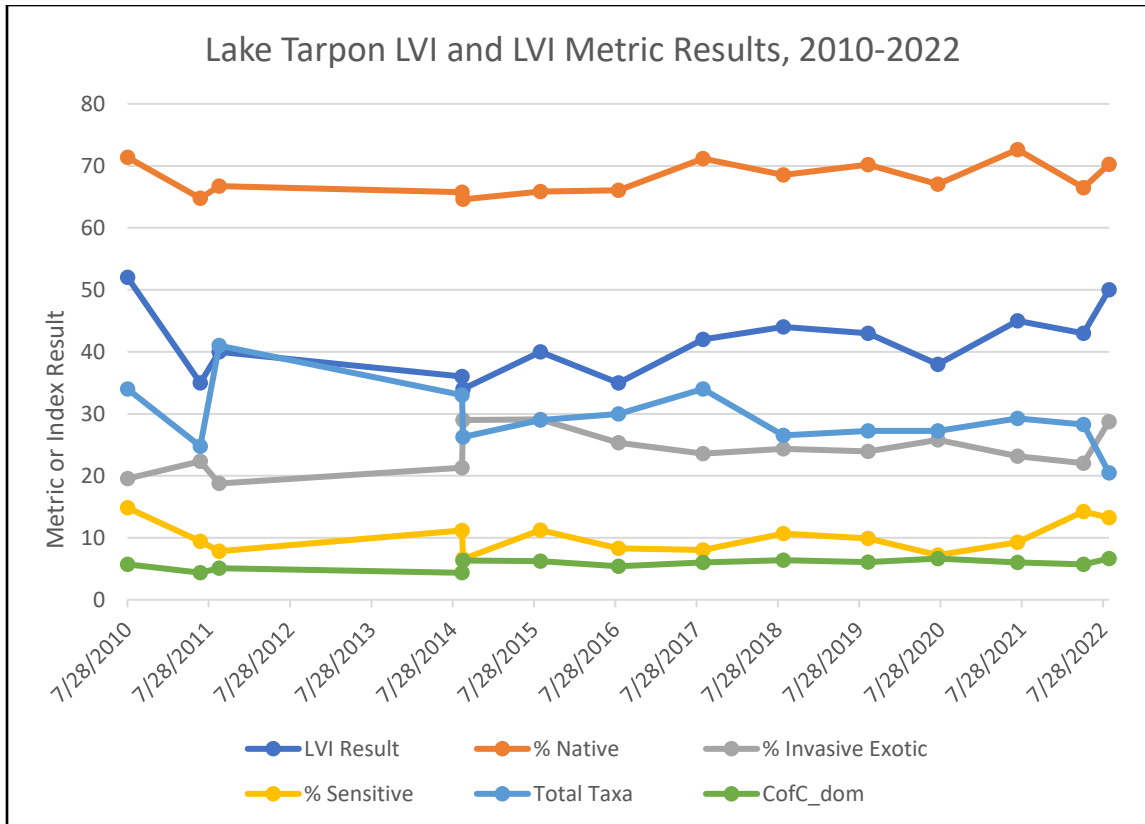
Figure 12 – Total LVI score, total taxa observed, and average scores for LVI metrics

For each LVI assessment listed in Table 3.

As reported by the FDEP, the range of scores does not clearly indicate an upward or downward trend, but rather is a result of the variability in the relative abundance of taxa from year to year, the inherent variability in the method, and other factors such as water level and management activities. LVI metric data also show generally consistent quality of codominant plants, and consistent percentages of native, sensitive, and invasive exotic plants, which are affected by the total number of plant species observed (Figure 12). Since three of the LVI scores are calculated based on species presence/absence, minimal occurrence of exotic and nuisance plant species can depress the final LVI score, even if more desirable plants are dominant or codominant. The LVI survey includes emergent vegetation in addition to submerged vegetation. In Lake Tarpon, the emergent vegetation composition has been affected by water level control because maintenance of high water allowed cattails to expand along the shorelines. While cattails are native plants, they are fairly tolerant species and therefore contribute to low LVI scores. Active restoration efforts are underway in areas where cattails are abundant to replace them with a more diverse array of native plants.

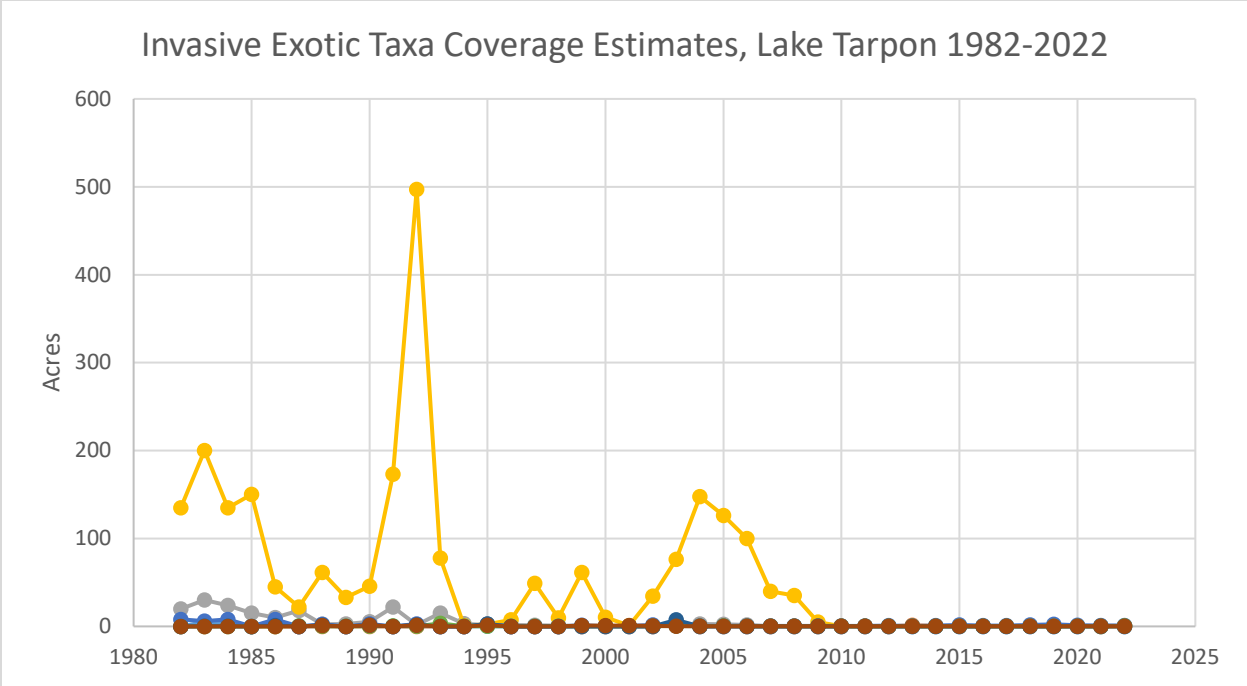
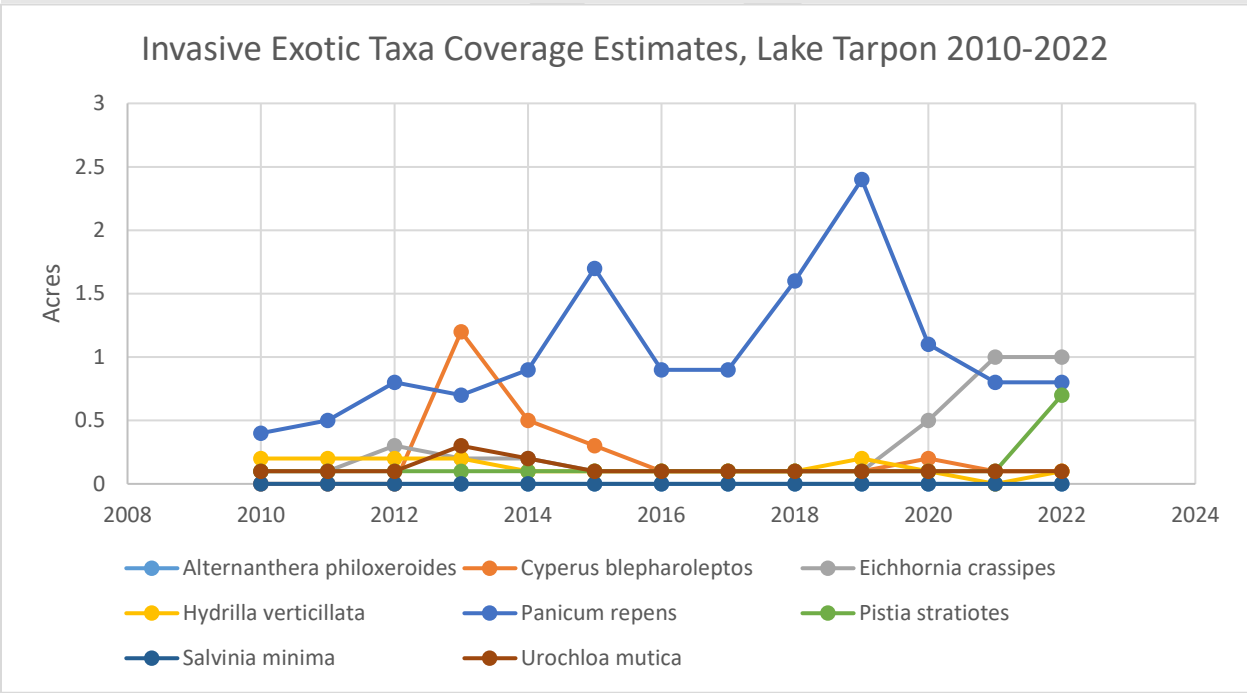
Figure 13 – Total acres of invasive exotic plants observed per year on Lake Tarpon

Based on the long term IPM data, large expanses of the invasive non-native submerged hydrilla were present in Lake Tarpon from 1982 to 2008 (Figure 13), with a maximum of 500 acres observed in 1992. While invasive exotic species are still present on the lake, they are much less abundant (Figure 14). Since 2010, fewer than 100 cumulative acres have been treated annually (Figure 14). Atkins/ESA (2017) suggested that higher annual average Chl-a concentrations were associated with larger scale hydrilla treatments in Lake Tarpon from 1994 to 2002.

From 1982 to 2022, shown on the upper graph, with the period of 2010-2022 shown on a smaller scale in the lower graph. Taxa were included if they had > 1 acre coverage in at least one year. Source: FWC Invasive Plant Management Section (<https://gis.myfwc.com/whoml/>).

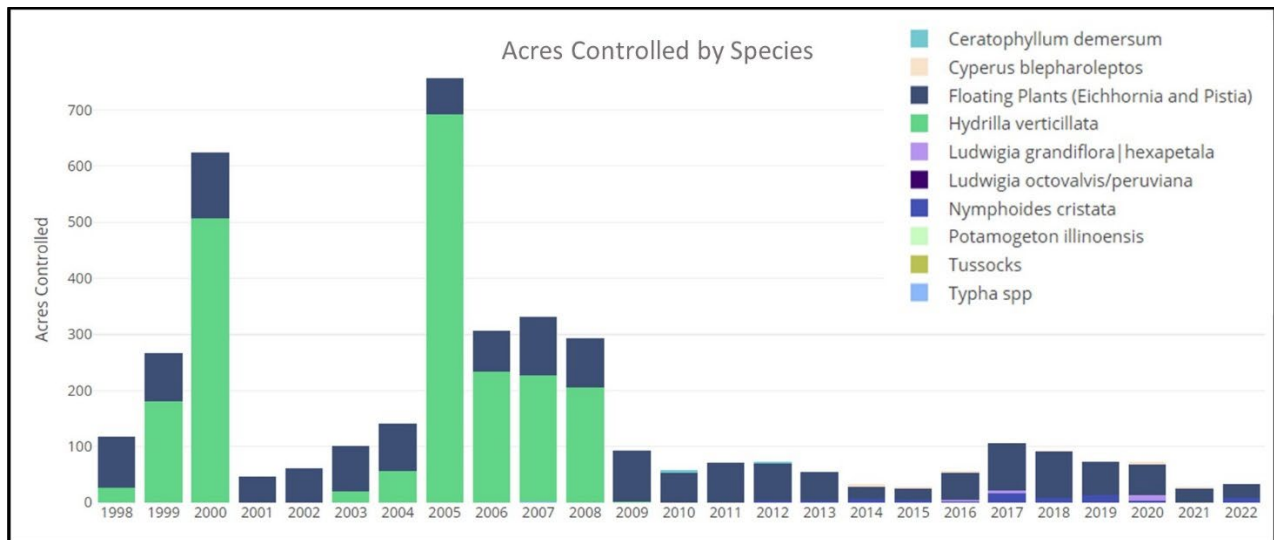
Figure 14 - Acres of plants controlled on Lake Tarpon

1998-2022. Acres represent the cumulative acres treated throughout each year. Source: FWC Invasive Plant Management Section (<https://gis.myfwc.com/whoml/>).

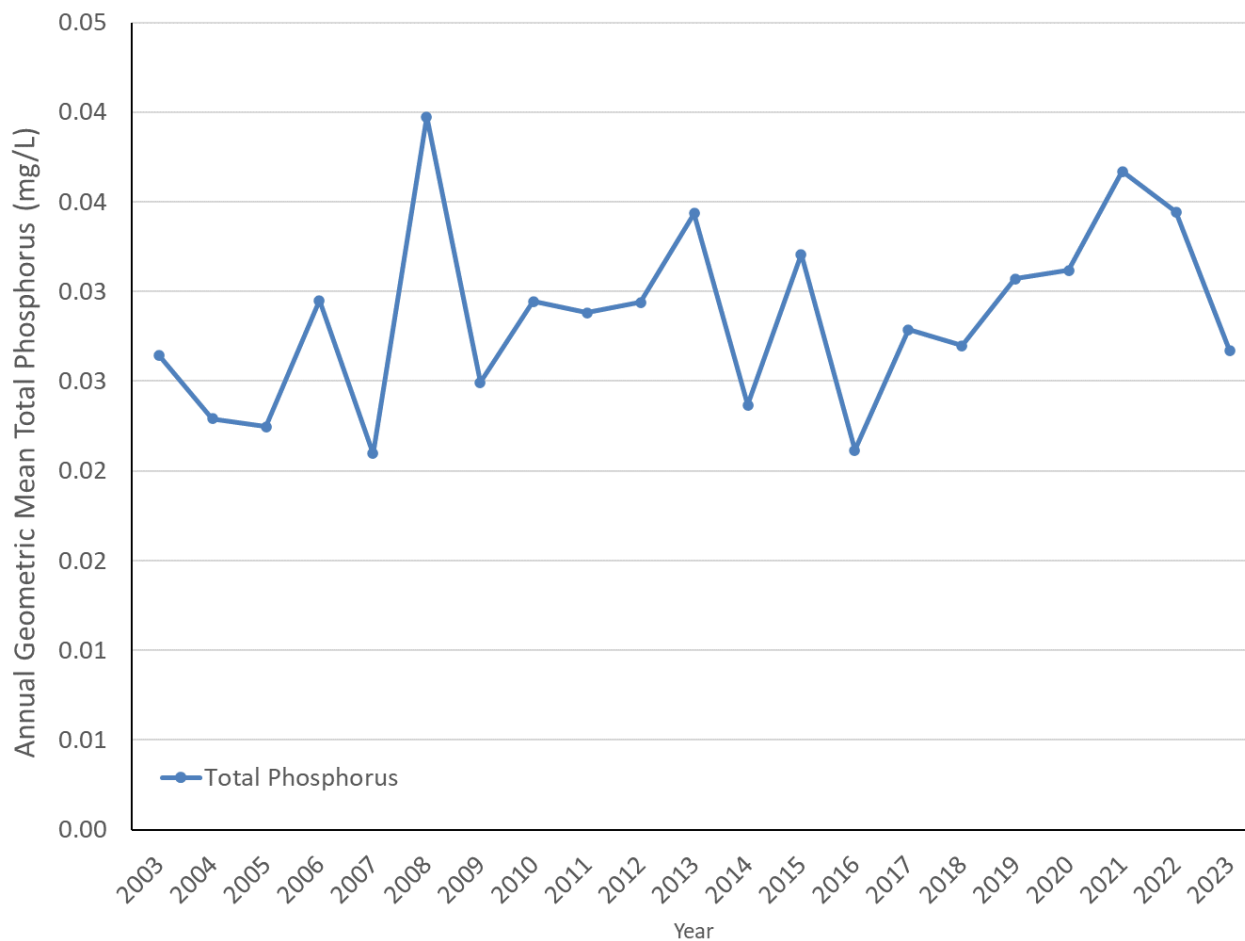
Figure 3 - Time series of TP (mg/L) annual geometric means.

Annual geometric means for Total Phosphorus for Lake Tarpon over the period of 2003 to 2023 are displayed in Figure 3.

The NNC values for TP for high-color, alkaline lakes like Lake Tarpon vary with the annual geometric mean for Chlorophyll-a for a given year. When annual geometric mean values of Chlorophyll-a values exceed 20 µg/L, FDEP would consider Lake Tarpon to be elevated for phytoplankton, and the NNC target value for TP would decrease from 0.160 down to 0.050 mg/L. Therefore, for those 14 years when annual geometric means for Chlorophyll-a exceeded 20 µg/L, the more restrictive NNC value for TP would be in place. At no time did the annual geometric mean for TP exceed the most restrictive NNC of 0.050 mg/L. As the data sets met the requirements of parametric statistical analysis of normality and homogeneity of variance, linear regression was used. This analysis did not detect a trend over time ($p > 0.05$).

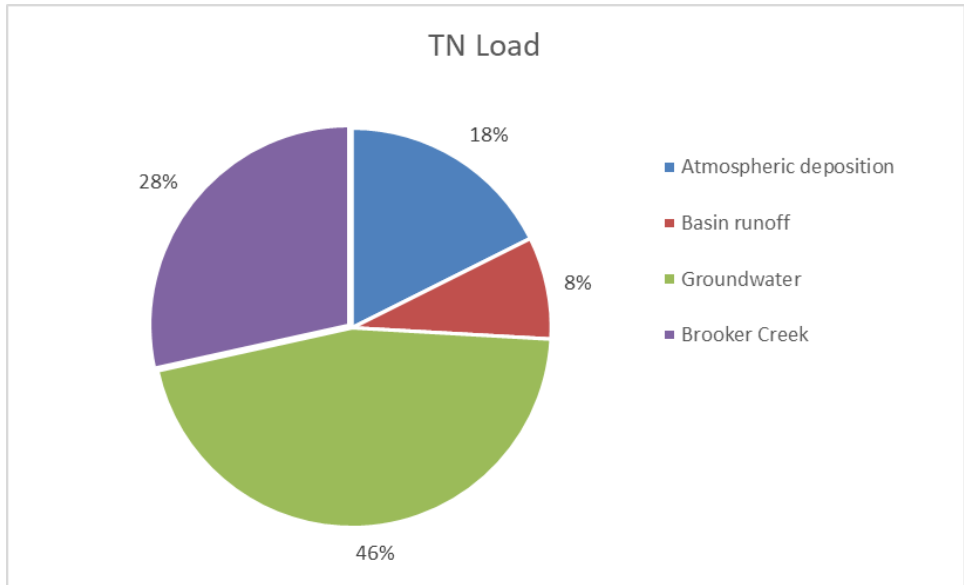
Figure 6 - Pie chart of TN loads from all sources during 2013 to 2023.

Figures 6 and 7 partition out TN and TP loads into the sources of atmospheric deposition, basin runoff, groundwater inflows, and loads from Brooker Creek, respectively.

For both TN and TP, the dominant loading source appears to be surficial groundwater inflows. These findings are consistent with the results of the loading model included in the Lake Tarpon Water Quality Management Plan (Atkins/ESA, 2017). However, there is a substantial amount of variability in estimates of sources of TN and TP loads, as well as the quantities involved.
