Lake Tarpon Surface Water Improvement and Management (SWIM) Plan Update

February 2025 FINAL DRAFT

Southwest Florida
Water Management District

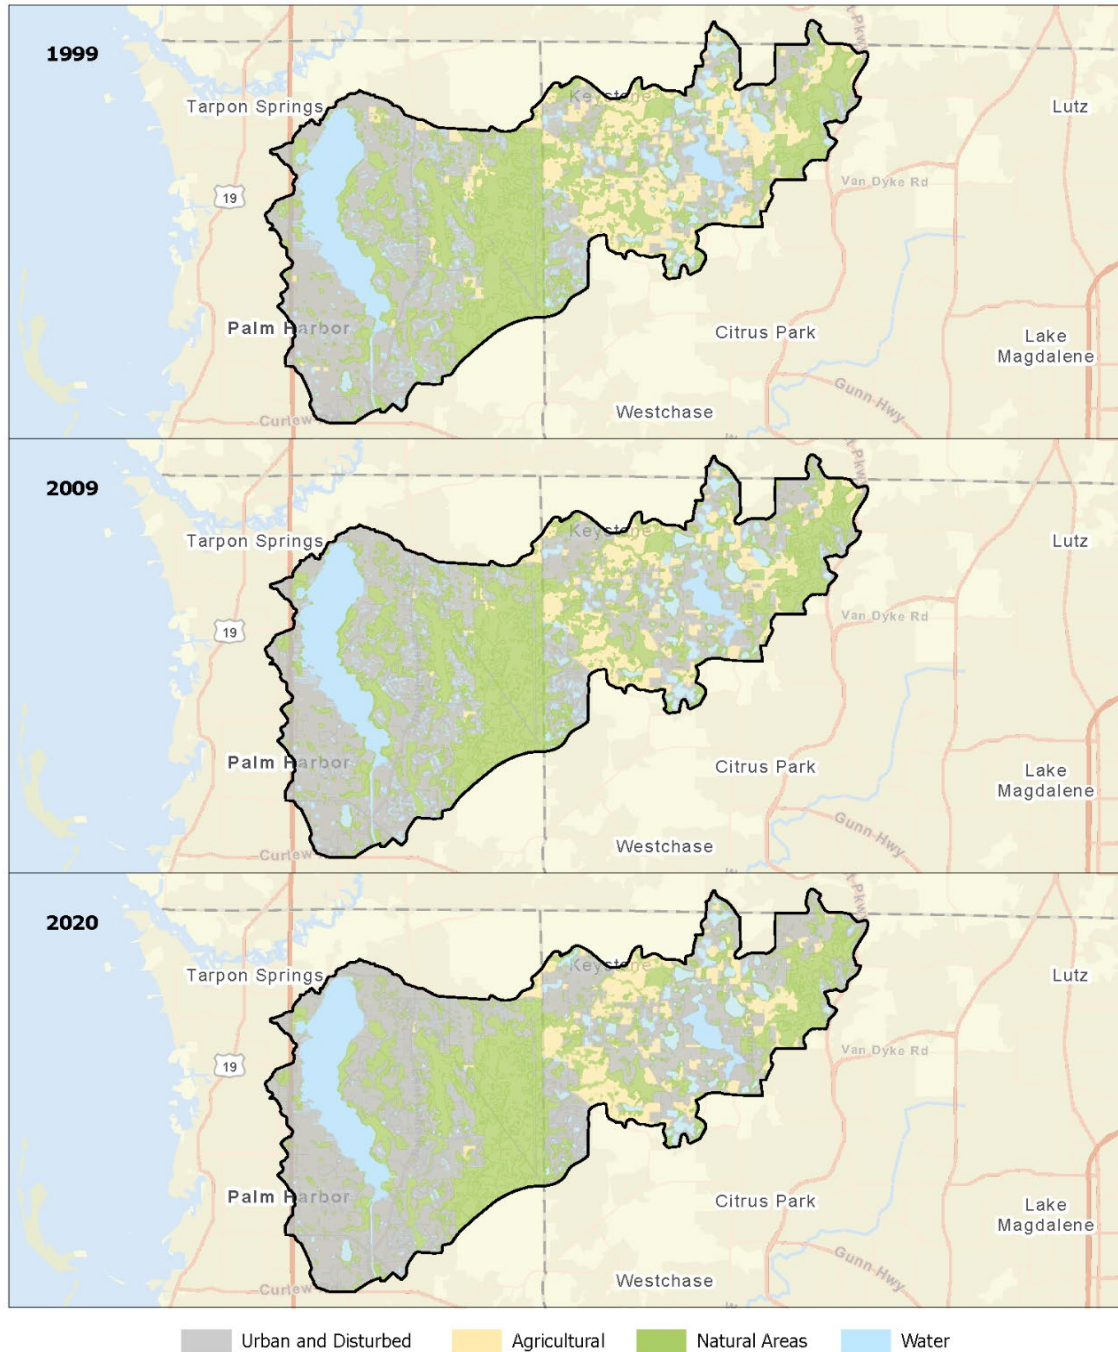
Figure 2 – Land use change map for Lake Tarpon for the years 1999, 2009, and 2020

decline of 177 acres. This relatively small decline in natural areas is a function of the number of publicly owned lands within the watershed including the Brooker Creek Preserve, the Upper Brooker Creek Preserve, and other protected natural areas (Figure 2).

Lake Tarpon Watershed Land Use in 1999, 2009, and 2020

Lake Tarpon and its surrounding watershed cover nearly 37,000 acres, predominantly characterized by natural areas and open water. Using data from 1999, which aligns with the recently updated Tampa Bay SWIM Plan, natural areas accounted for 33% of the watershed, totaling 12,212 acres, while open water comprised 13%, amounting to 5,096 acres (Table 1). By 2020, the area designated as natural areas had decreased to 12,035 acres, while open water has slightly increased to 5,147 acres (Table 1).

In 1999, urban and disturbed land constituted 38% of the watershed (14,080 acres). In 2020, urban and disturbed land comprised 45.2% of the watershed, an increase of 2,576 acres (Table 1).

This increase in urban and disturbed land was accompanied by a corresponding decline in natural areas and agricultural lands (Table 1). Agricultural lands decreased from 14.7% in 1999 to 8.1% in 2020. Natural areas remained relatively consistent with only a slight decline from 33.2% of the watershed in 1999 to 32.7% in 2020, a

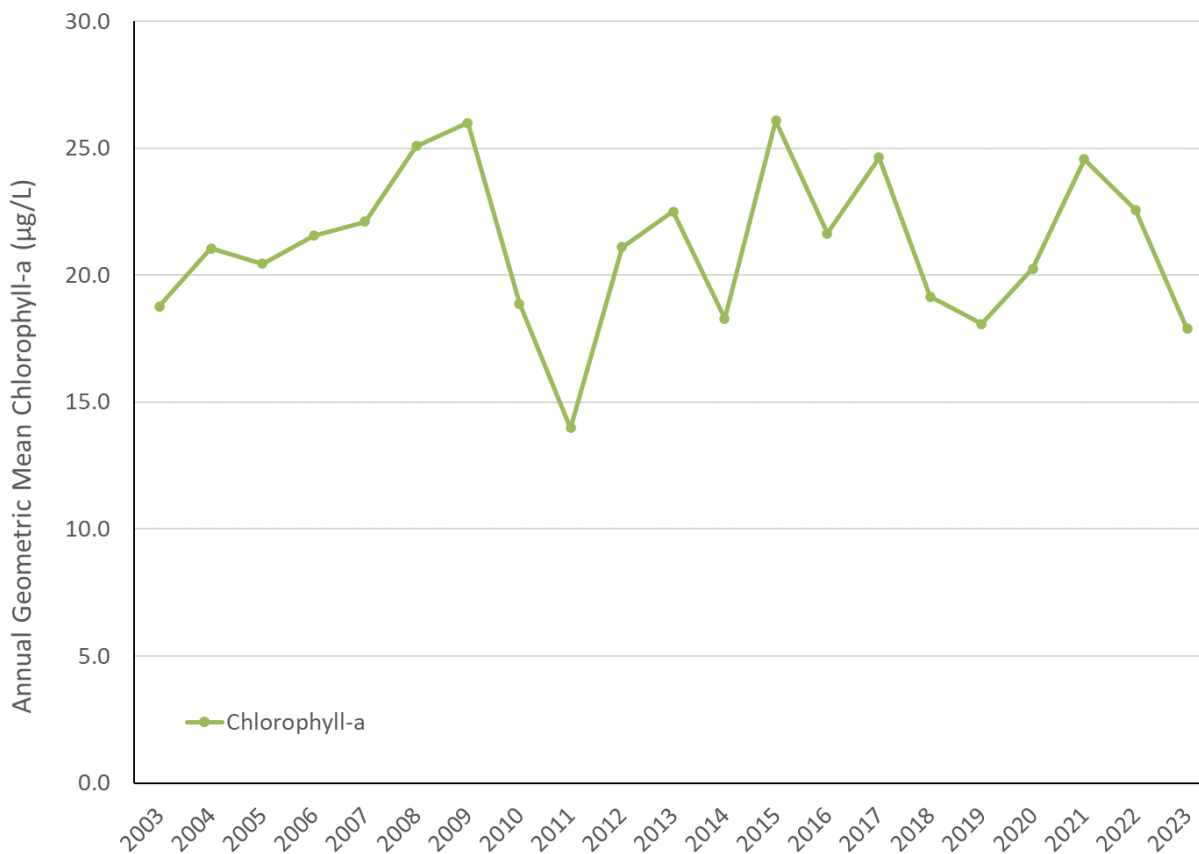
Figure 3 – Time series of Chlorophyll-a (µg/L) annual geometric means

Annual geometric means for Chlorophyll-a for Lake Tarpon between 2003 to 2023 are displayed in Figure 3. Results were tested for trends over time using annual geometric means as the dependent variable, and years as the independent variable. As the data sets met the requirements of parametric statistical analysis of normality and homogeneity of variance, linear regression was used. This analysis did not detect a trend over time ($p>0.05$).

Statistical analysis did not detect a significant trend over the period 2003-2023

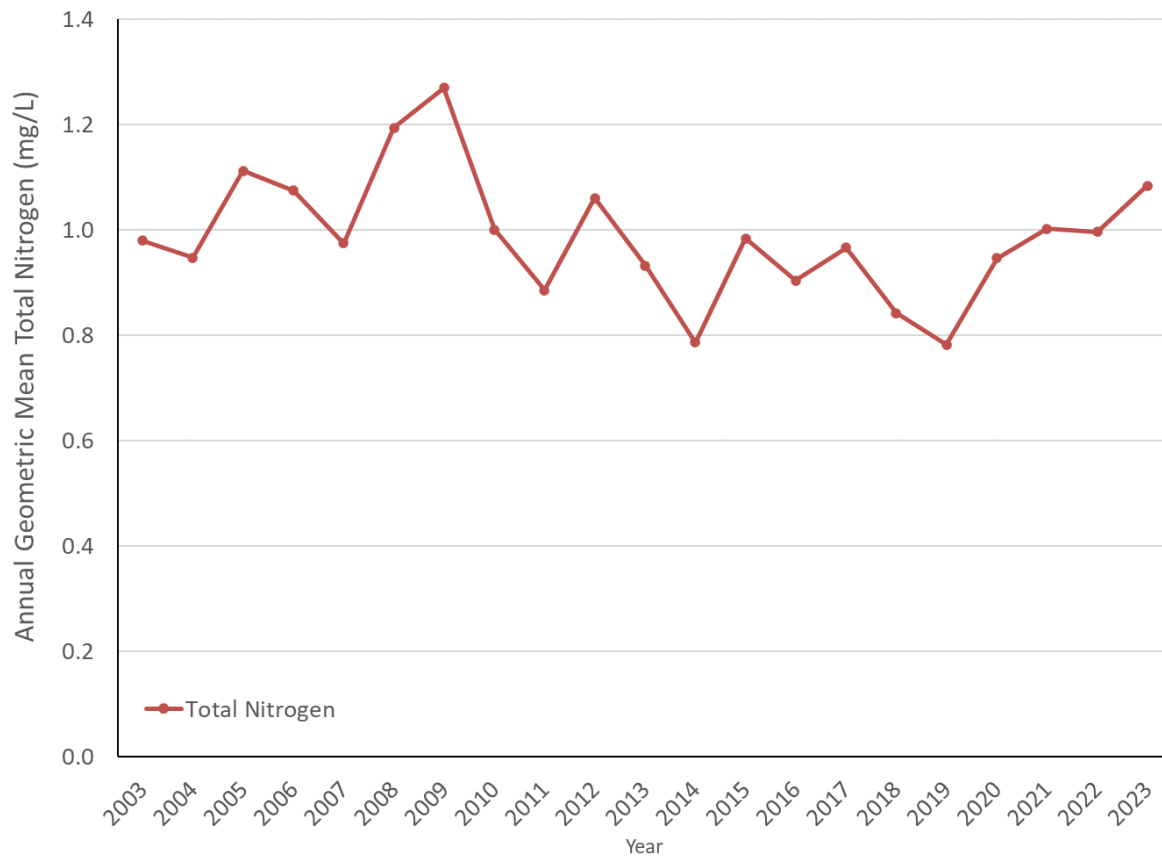
Figure 4 – Time series of TN (mg/L) annual geometric means for the period 2003 to 2023

Annual geometric means for total nitrogen concentrations in Lake Tarpon over the period 2003-2023 ranged from approximately 0.8 – 1.27 mg/L (Figure 4). At no time did the TN concentrations exceed the TN NNC of 1.27 mg/L. In 2009, the annual geometric mean equaled the TN NNC (Figure 4). As the data sets met the requirements of parametric statistical analysis of normality and homogeneity of variance, linear regression was used. This analysis did not detect a trend over time ($p>0.05$).

Statistical analysis did not detect a significant trend

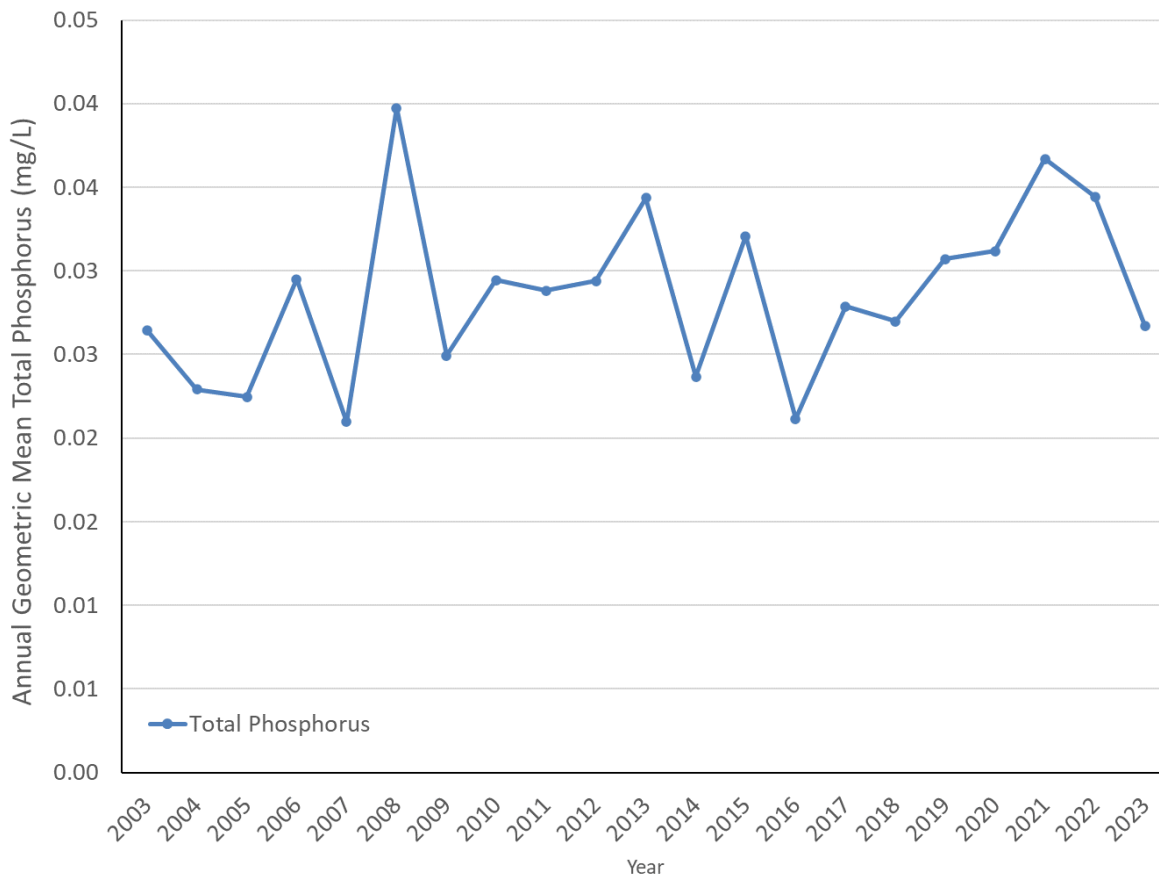
Figure 5 – Time series of TP (mg/L) annual geometric means

Annual geometric means for total phosphorous concentrations in Lake Tarpon over the period 2003-2023 ranged from approximately 0.02 – 0.04 mg/L (Figure 5). At no time did the TP concentrations exceed the TP NNC of 0.05 mg/L. As the data sets met the requirements of parametric statistical analysis of normality and homogeneity of variance, linear regression was used. This analysis did not detect a trend over time ($p>0.05$).

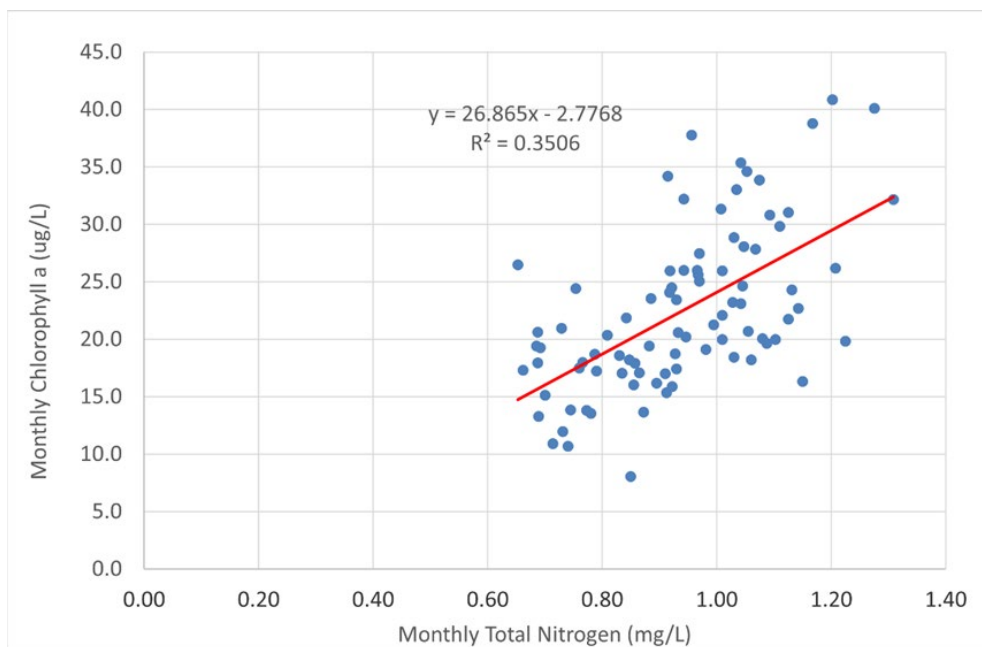
Figure 6 - Plot of Chlorophyll-a vs. TN concentrations

As had been previously noted in the 2001 Lake Tarpon SWIM Plan and the Lake Tarpon Water Quality Management Plan (2017) there is a strong relationship between TN concentrations and Chlorophyll-a (Figure 6) but no evidence of a similar relationship between TP and chlorophyll-a (Figure 7).

For monthly mean lake values 2013-2018 (N=25). Red line represents the best fit linear regression line ($p < 0.001$).

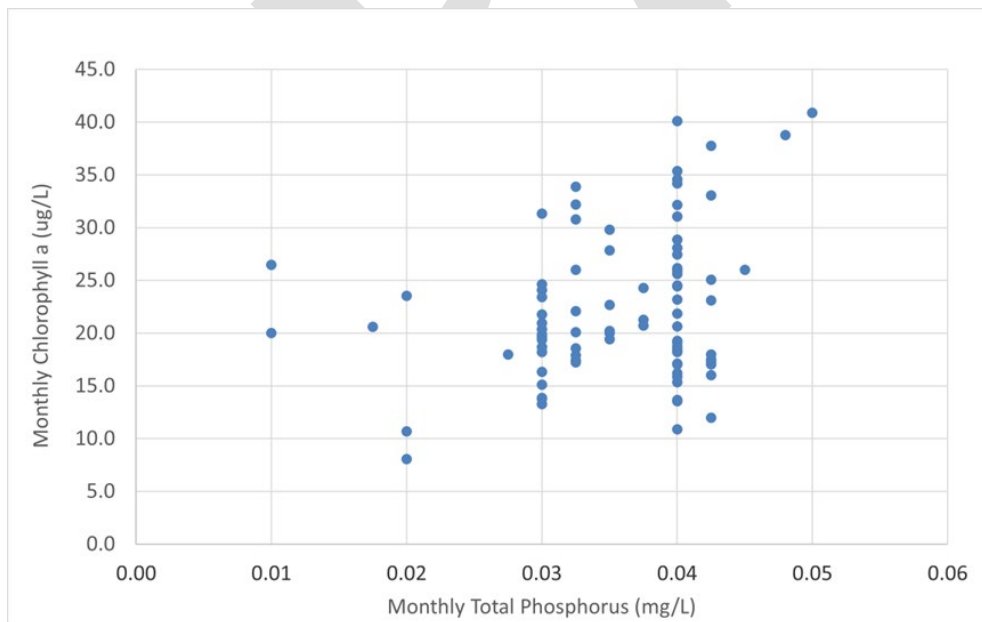
Figure 7 - Plot of Chlorophyll-a vs. TP concentrations

For monthly mean lake values 2013-2018 (N=25)

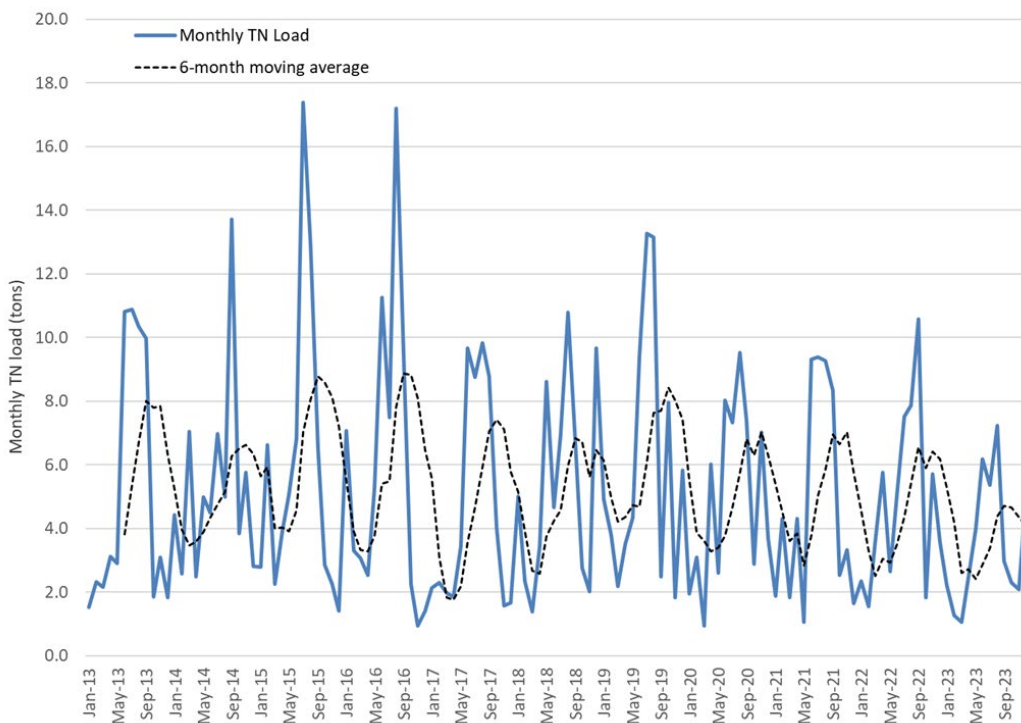
Figure 8 - Monthly TN loads from all sources during 2013 to 2023

Using the statistical relationships between rainfall and nutrient loadings, monthly rainfall values from District rain gages in Pinellas County were used to estimate TN and TP loads from all sources, over the period of 2013 to 2023 (Tables of rainfall and loads from all sources between 2013 and 2023 are included in the Technical Memo in Appendix A). Figures 8 and 9 show the TN and TP loads to Lake Tarpon varied substantially on a monthly time step. During wet periods in 2015 and 2016, TN loads exceeded 16 tons per month, while dry months typically had TN loads less than 2 tons per month.

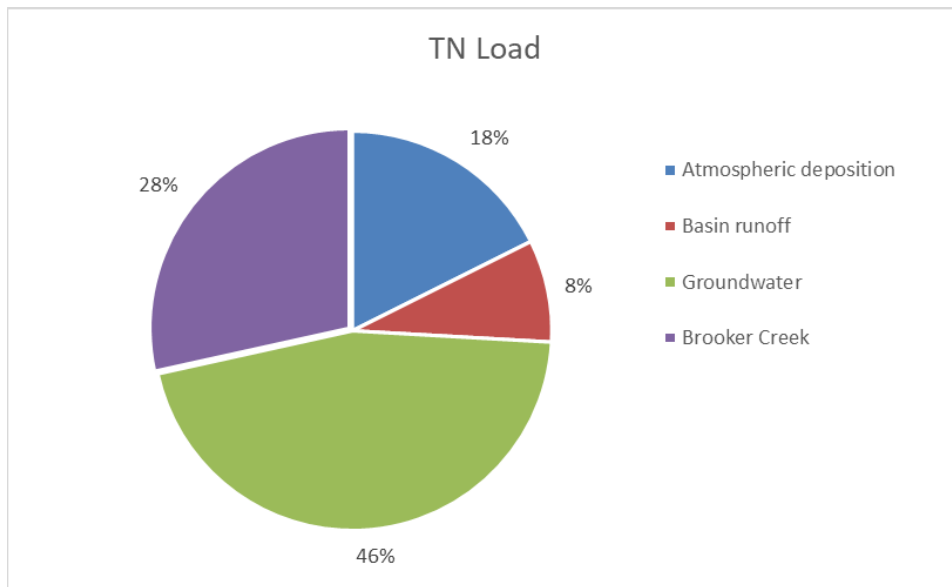
Figure 10 - Pie chart of TN loads from all sources during 2013 to 2023

Figures 10 and 11 partition out TN and TP loads into the sources of atmospheric deposition, basin runoff, groundwater inflows, and loads from Brooker Creek, respectively.

For both TN and TP, the dominant loading source appears to be surficial groundwater inflows. These findings are consistent with the results of the loading model included in the Lake Tarpon Water Quality Management Plan (Atkins/ESA, 2017). However, there is a substantial amount of variability in estimates of sources of TN and TP loads, as well as the quantities involved.

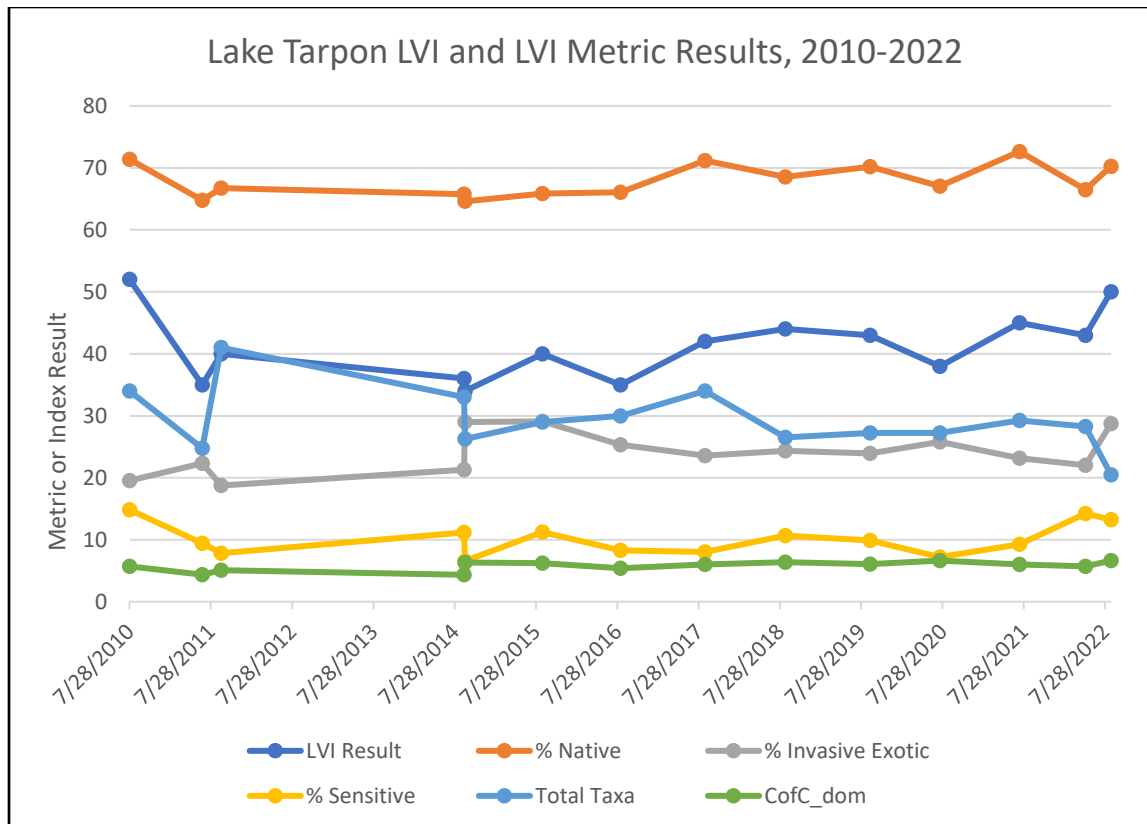
Figure 12 – Total LVI score, total taxa observed, and average scores for LVI metrics

For each LVI assessment listed in Table 3.

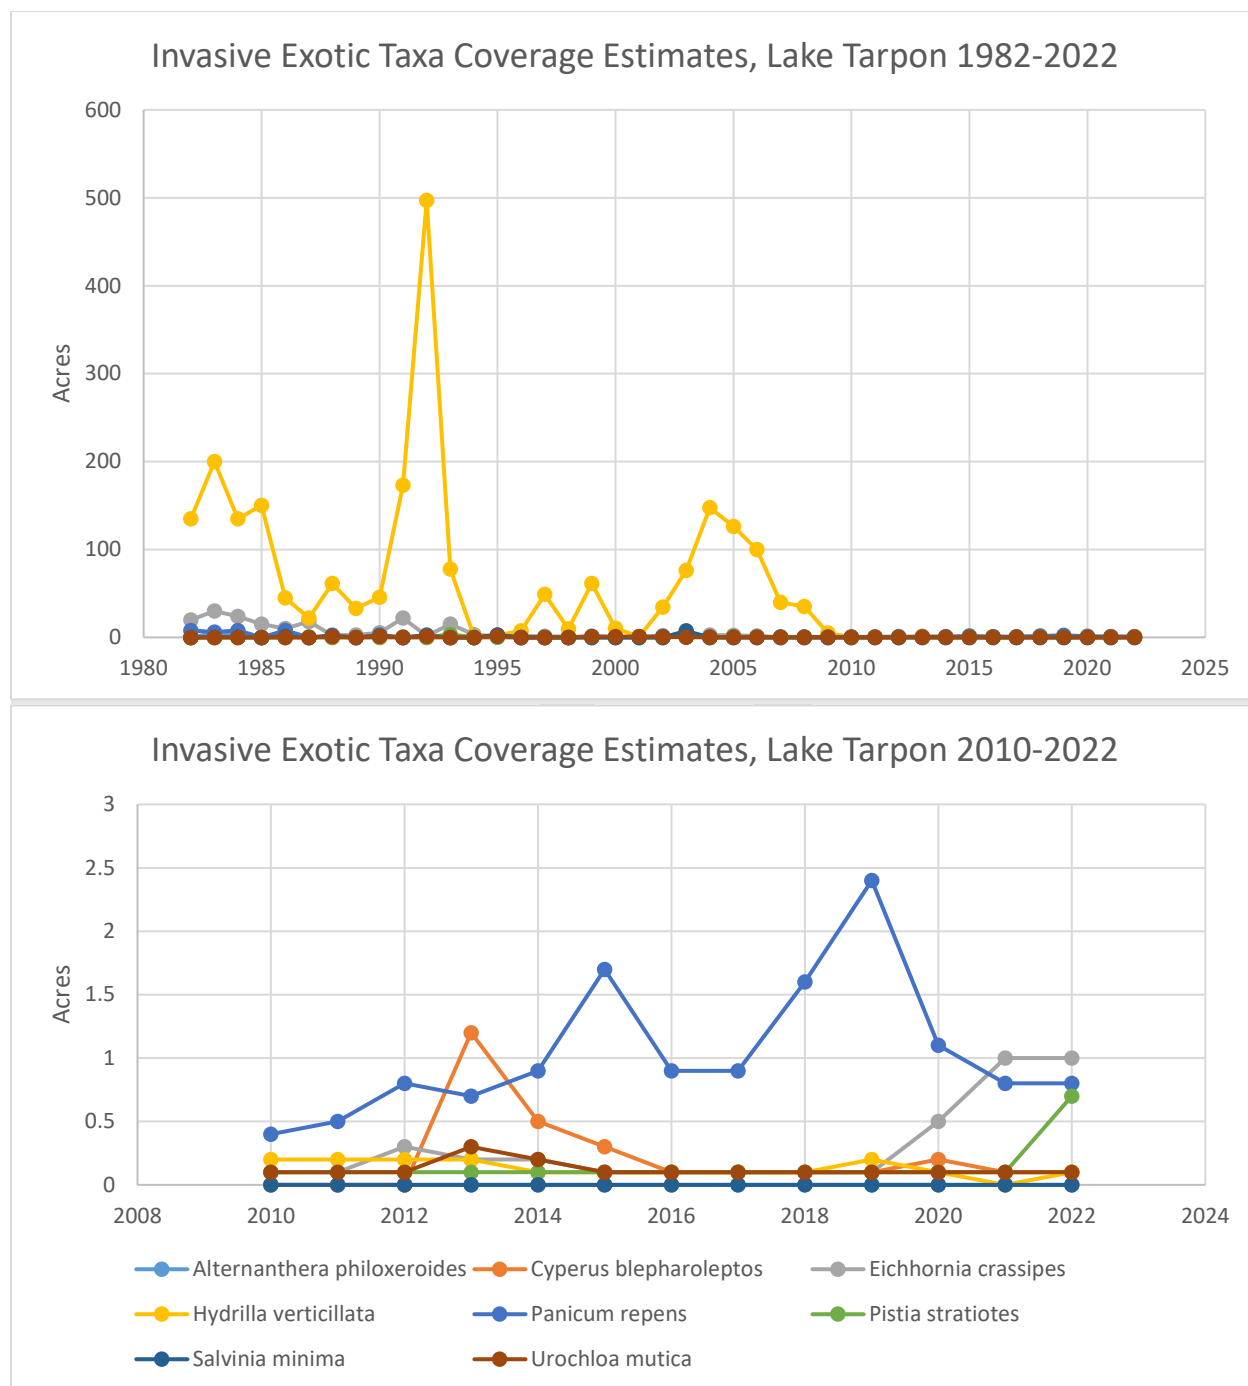
Figure 13 – Total acres of invasive exotic plants observed per year on Lake Tarpon

Based on the long term IPM data, large expanses of the invasive non-native submerged hydrilla were present in Lake Tarpon from 1982 to 2008 (Figure 13), with a maximum of 500 acres observed in 1992. While invasive exotic species are still present on the lake, they are much less abundant (Figure 14). Since 2010, fewer than 100 cumulative acres have been treated annually (Figure 14). Atkins/ESA (2017) suggested that higher annual average Chl-a concentrations were associated with larger scale hydrilla treatments in Lake Tarpon from 1994 to 2002.

From 1982 to 2022, shown on the upper graph, with the period of 2010-2022 shown on a smaller scale in the lower graph. Taxa were included if they had > 1 acre coverage in at least one year. Source: FWC Invasive Plant Management Section (<https://gis.myfwc.com/whoml/>).

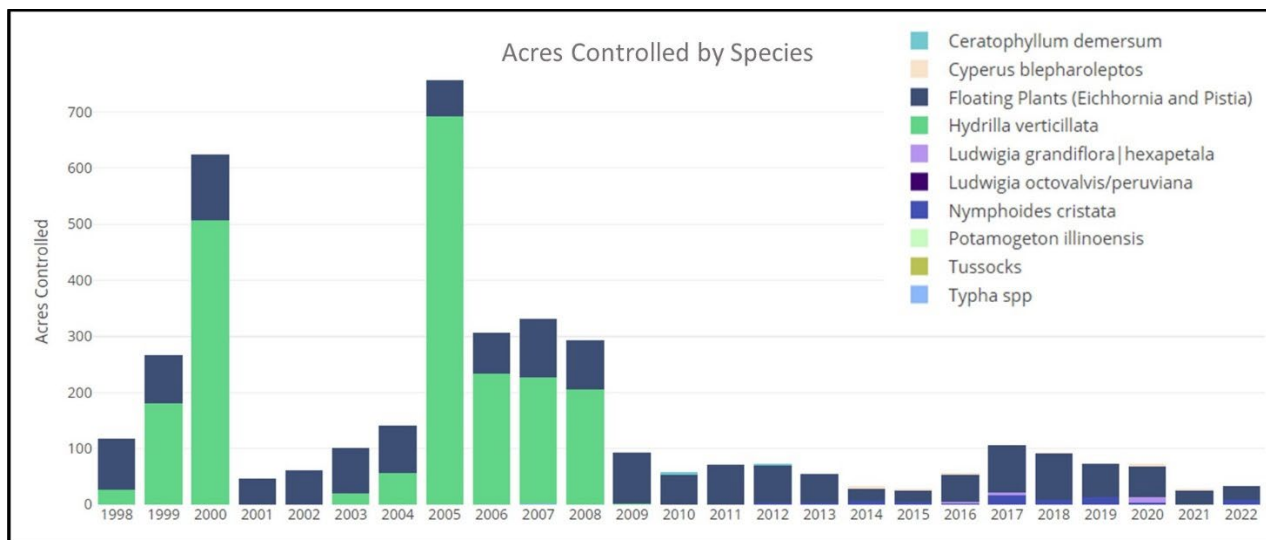
Figure 14 - Acres of plants controlled on Lake Tarpon

1998-2022. Acres represent the cumulative acres treated throughout each year. Source: FWC Invasive Plant Management Section (<https://gis.myfwc.com/whoml/>).

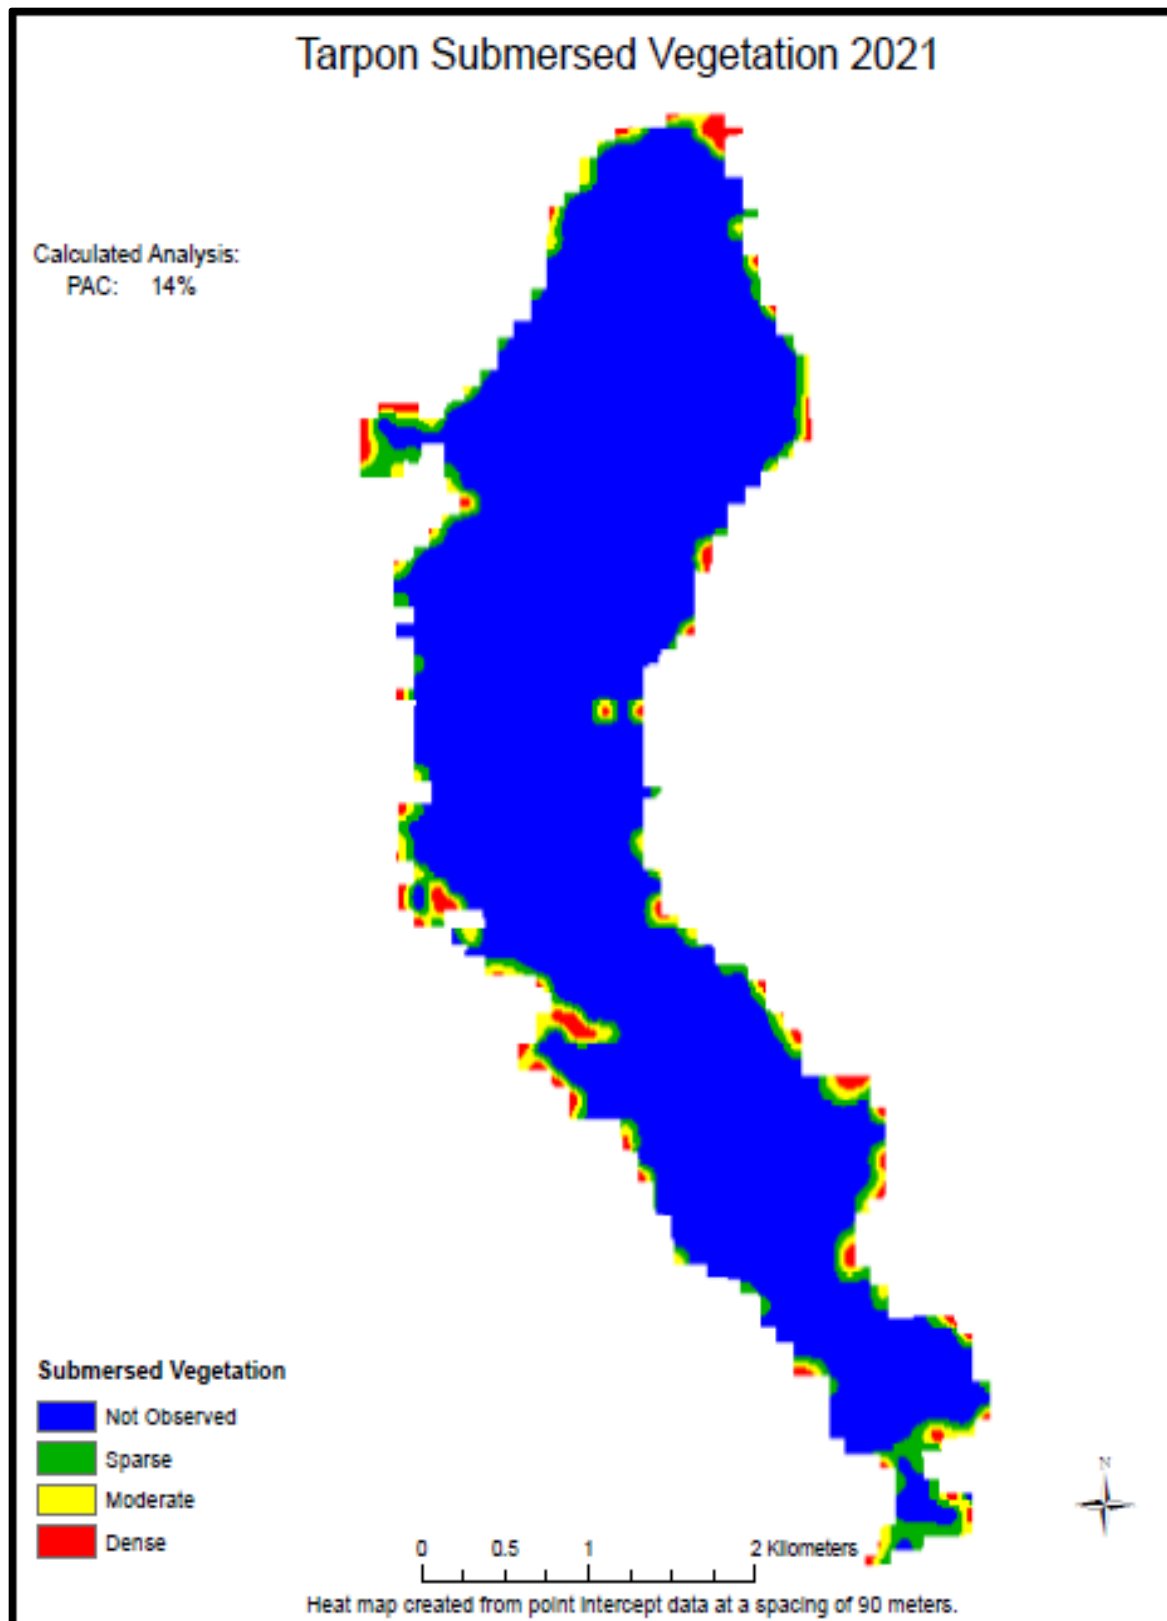
Figure 15 – The location and density ranks of submerged aquatic vegetation in Lake Tarpon

Due to the lake's bathymetry, results show that the SAV was restricted to the perimeter of Lake Tarpon (Figure 15), and the average deep edge of the SAV beds was typically 7-8 feet. The PAC for FWC surveys was around 20% for all years. Similarly, the USF survey results for 2015 and 2019 showed PAC values of 16% and 20%, respectively. The PVI values for the two USF surveys are 1.6% and 1.9%, respectively, while PVI values for the FWC surveys ranged from 5% to 9%. These PVI estimates probably differ between investigators due to variation in calculation approaches and/or bathymetry data used to estimate volume.

As seen in FWC's 2021 survey

FWC and USF mapped submerged aquatic vegetation (SAV) in Lake Tarpon from 2015 to 2021 using underwater sonar coupled with field verification. These surveys include bathymetric mapping along pre-defined grids throughout the lake and detection of SAV with underwater sonar. The sonar data were processed to calculate percent area covered (PAC) and percent volume inhabited (PVI) by vegetation in Lake Tarpon. The sonar mapping quantified the amount of SAV but not the species composition. To determine which SAV species were present, both USF and FWC used an underwater rake at verification points throughout the areas where SAV signals were picked up by underwater sonar. Emergent species observed at the verification points were noted. FWC investigators noted the density of each taxon at the verification points as sparse, moderate, or dense. Percent coverage of each species sampled with the rake was calculated from the total number of vegetated points.

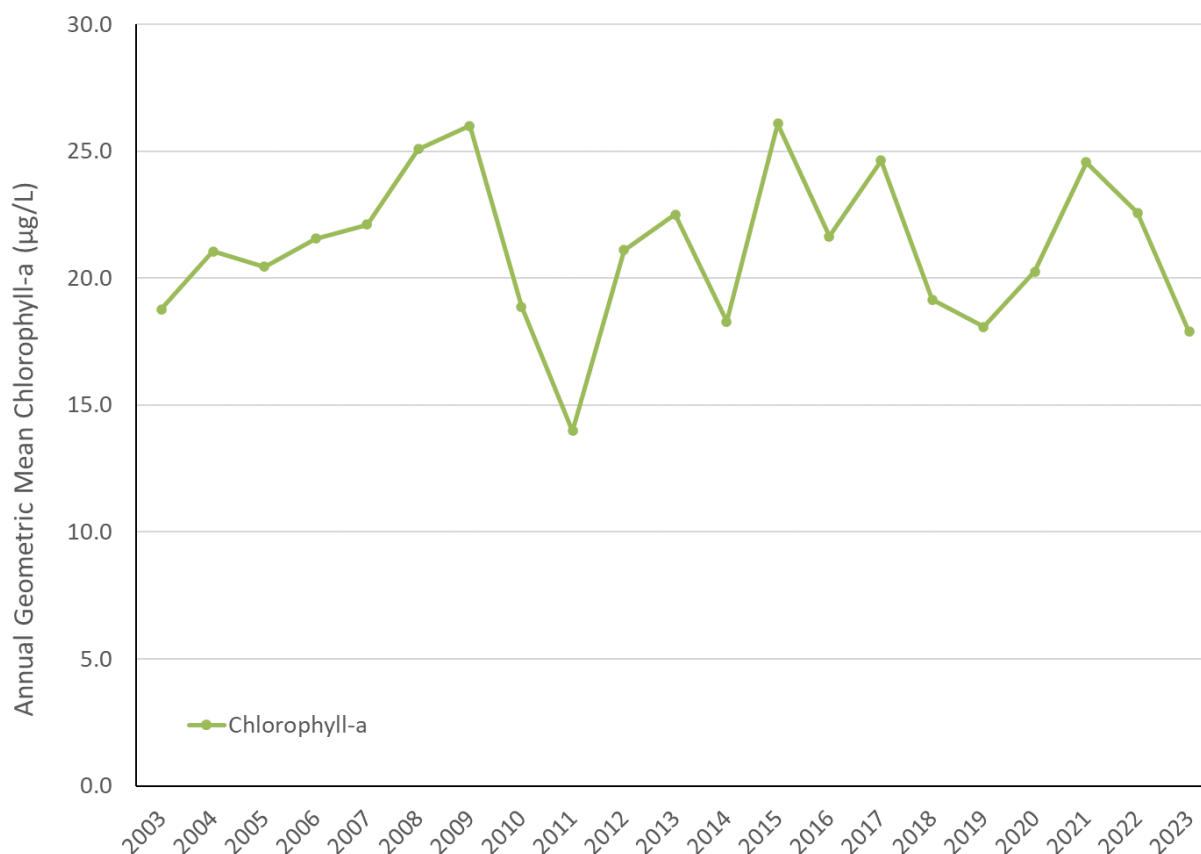
Figure 1 - Time series of Chlorophyll-a (µg/L) annual geometric means.

Annual geometric means for Chlorophyll-a for Lake Tarpon over the period of 2003 to 2023 are displayed in Figure 1. Annual geometric means for Chlorophyll-a exceeded NNC criteria of 20 µg/L on 14 of 21 years (67% of years). Results were tested for trends over time using annual geometric means as the dependent variable, and years as the independent variable. As the data sets met the requirements of parametric statistical analysis of normality and homogeneity of variance, linear regression was used. This analysis did not detect a trend over time ($p > 0.05$).

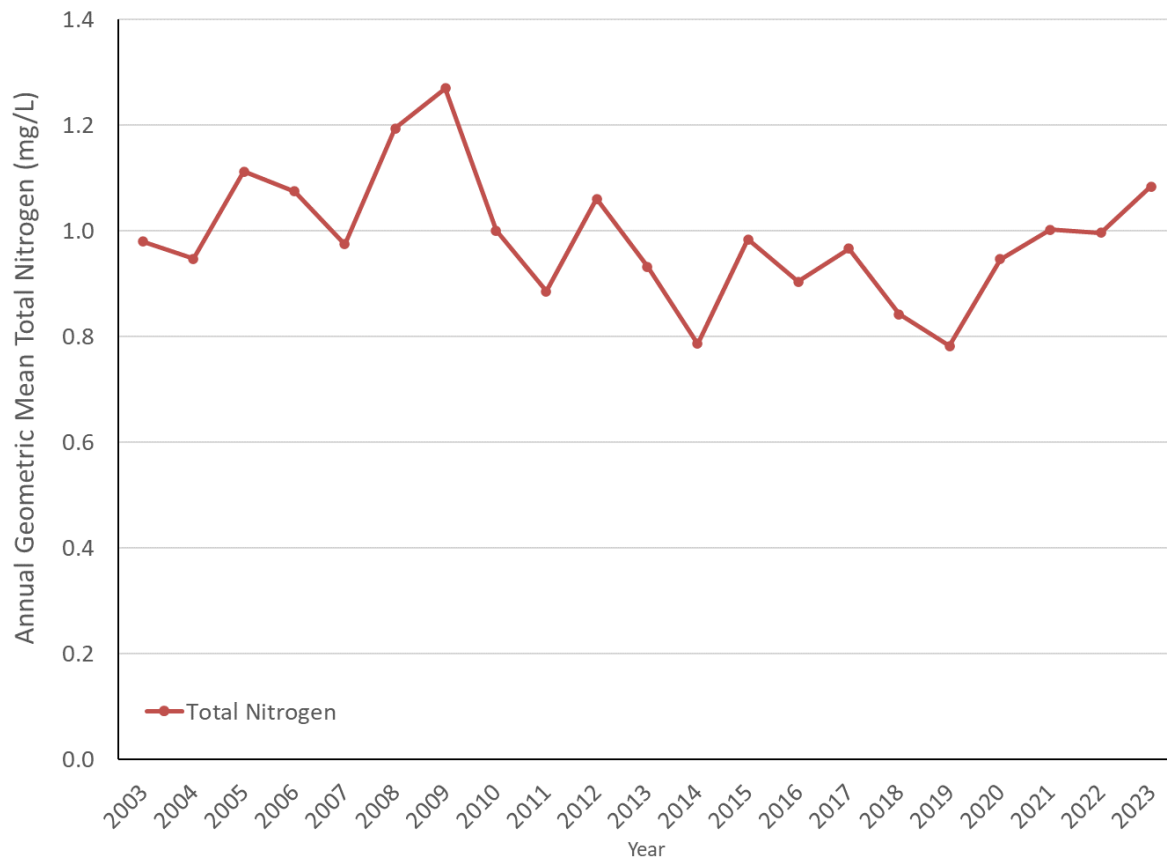
Figure 2 - Time series of TN (mg/L) annual geometric means.

Annual geometric means for Total Nitrogen for Lake Tarpon over the period of 2003 to 2023 are displayed in Figure 2.

The NNC values for TN for high-color, alkaline lakes like Lake Tarpon vary with the annual geometric mean for Chlorophyll-a for a given year. For years when annual geometric mean values of Chlorophyll-a values exceed 20 µg/L, FDEP would consider Lake Tarpon to be elevated for phytoplankton, and the NNC target value for TN would decrease from 2.23 down to 1.27 mg/L. Thus, for those 14 years when annual geometric means for Chlorophyll-a exceeded 20 µg/L, the more restrictive NNC value for TN would be in place. Even with that more restrictive TN value, only in the year 2009 did the annual geometric mean for TN match (but not exceed) the most restrictive TN criteria. At no time did the annual geometric mean for TN exceed the less restrictive NNC criterion of 2.23. As the data sets met the requirements of parametric statistical analysis of normality and homogeneity of variance, linear regression was used. This analysis did not detect a trend over time ($p > 0.05$).

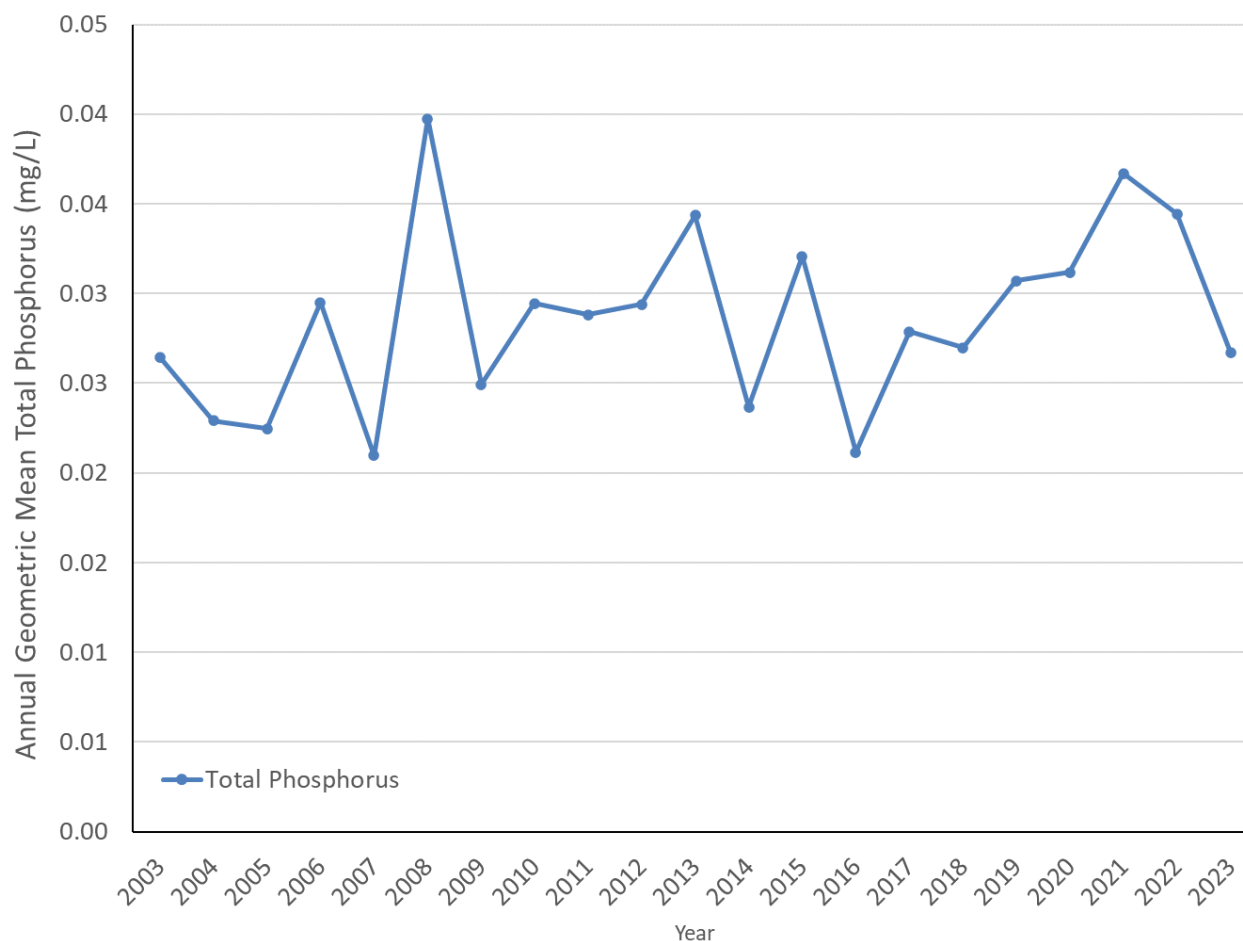
Figure 3 - Time series of TP (mg/L) annual geometric means.

Annual geometric means for Total Phosphorus for Lake Tarpon over the period of 2003 to 2023 are displayed in Figure 3.

The NNC values for TP for high-color, alkaline lakes like Lake Tarpon vary with the annual geometric mean for Chlorophyll-a for a given year. When annual geometric mean values of Chlorophyll-a values exceed 20 µg/L, FDEP would consider Lake Tarpon to be elevated for phytoplankton, and the NNC target value for TP would decrease from 0.160 down to 0.050 mg/L. Therefore, for those 14 years when annual geometric means for Chlorophyll-a exceeded 20 µg/L, the more restrictive NNC value for TP would be in place. At no time did the annual geometric mean for TP exceed the most restrictive NNC of 0.050 mg/L. As the data sets met the requirements of parametric statistical analysis of normality and homogeneity of variance, linear regression was used. This analysis did not detect a trend over time ($p > 0.05$).

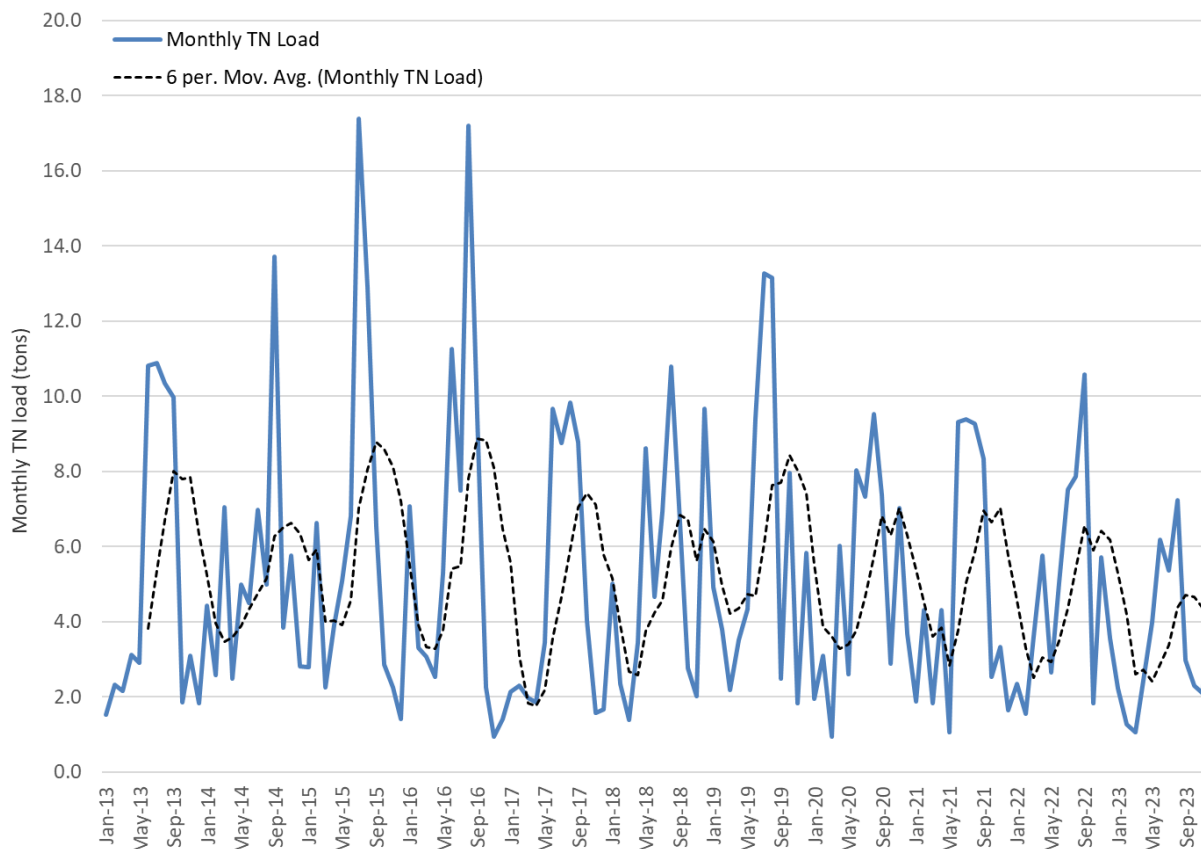
Figure 4 – Monthly TN loads from all sources during 2013 to 2023.

Using previously developed statistical relationships between rainfall and nutrient loadings (ESA, 2021), monthly rainfall values from District rain gages in Pinellas County were used to estimate TN and TP loads from all sources, over the period of 2013 to 2023. Figures 4 and 5 show that the TN and TP loads to Lake Tarpon varied substantially over both monthly time steps and 6-month moving average values. During wet periods in 2015 and 2016, TN loads exceeded 16 tons per month, while dry months typically had TN loads less than 2 tons per month. Appendices 1 and 2 provide a tabular breakdown of monthly rainfall and loads from all sources for the period 2013-2023.

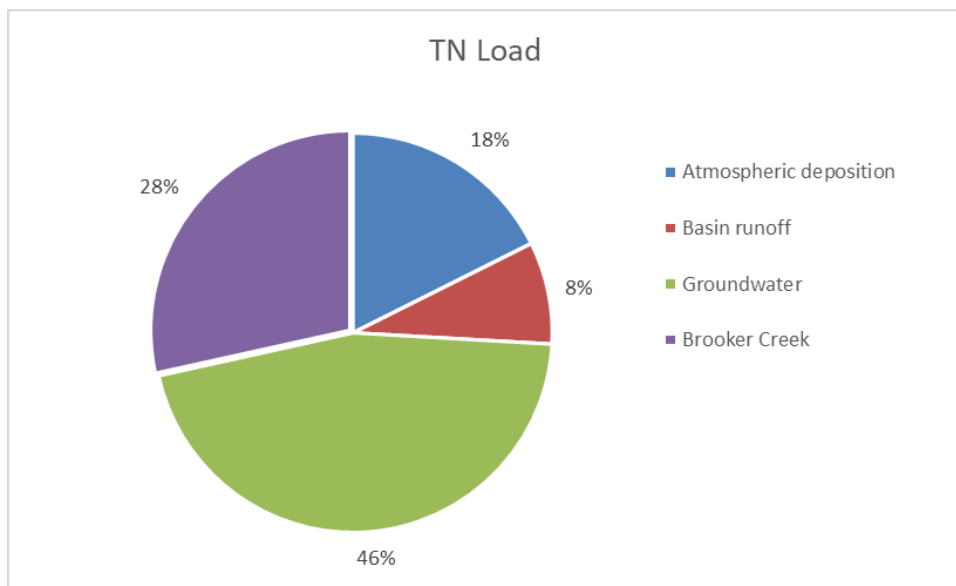
Figure 6 - Pie chart of TN loads from all sources during 2013 to 2023.

Figures 6 and 7 partition out TN and TP loads into the sources of atmospheric deposition, basin runoff, groundwater inflows, and loads from Brooker Creek, respectively.

For both TN and TP, the dominant loading source appears to be surficial groundwater inflows. These findings are consistent with the results of the loading model included in the Lake Tarpon Water Quality Management Plan (Atkins/ESA, 2017). However, there is a substantial amount of variability in estimates of sources of TN and TP loads, as well as the quantities involved.

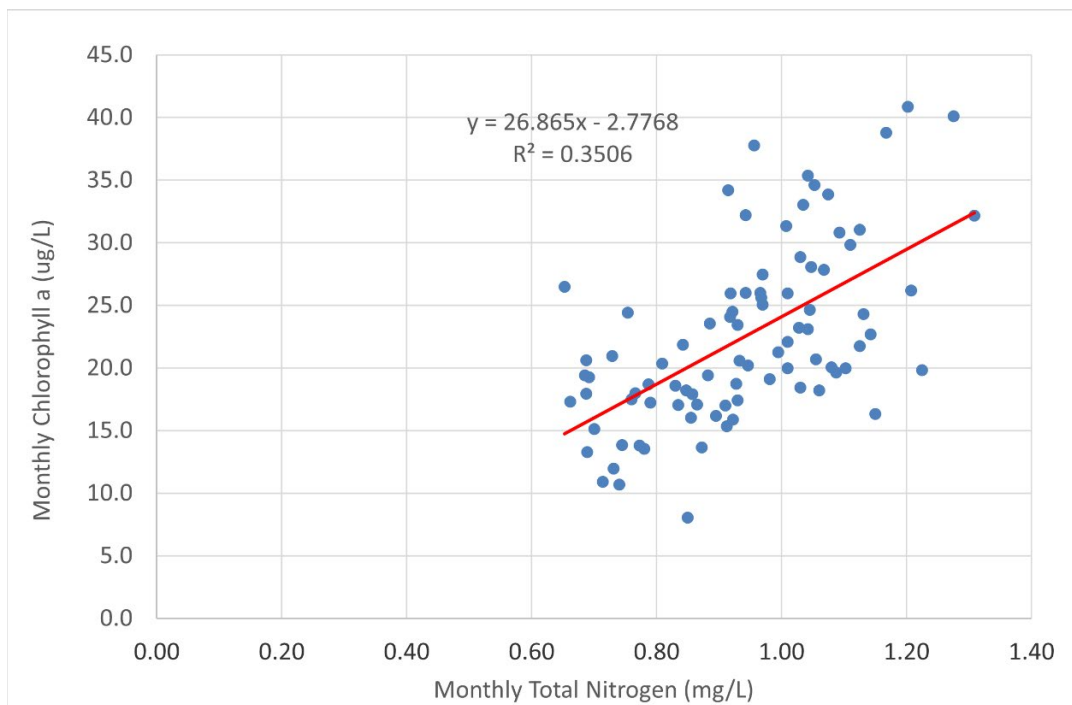
Figure 8 - Plot of Chlorophyll-a vs. TN concentrations for monthly mean lake values 2013–2023 (N=85).

As had been previously noted in the last adopted Lake Tarpon SWIM Plan (2001) and the Lake Tarpon Water Quality Management Plan (2017) there is a strong relationship between TN concentrations and Chlorophyll-a, but there is no evidence of a similar relationship between TP and Chlorophyll-a. Figures 8 and 9 show plots of paired monthly Chlorophyll-a vs. TN and TP concentrations, respectively, over the period 2013-2023 during which rainfall and nutrient loads were highly variable. As shown in these plots, there is a strong relationship between TN and Chlorophyll-a concentrations (Figure 8 - line represents best-fit linear relationship), but no such relationship between TP and Chlorophyll-a concentrations (Figure 9). These findings support previous determinations that Lake Tarpon is primarily Nitrogen limited with regard to phytoplankton growth.
